Marine Composites

Structural Failure Case Histories

Eric Greene, Naval Architect

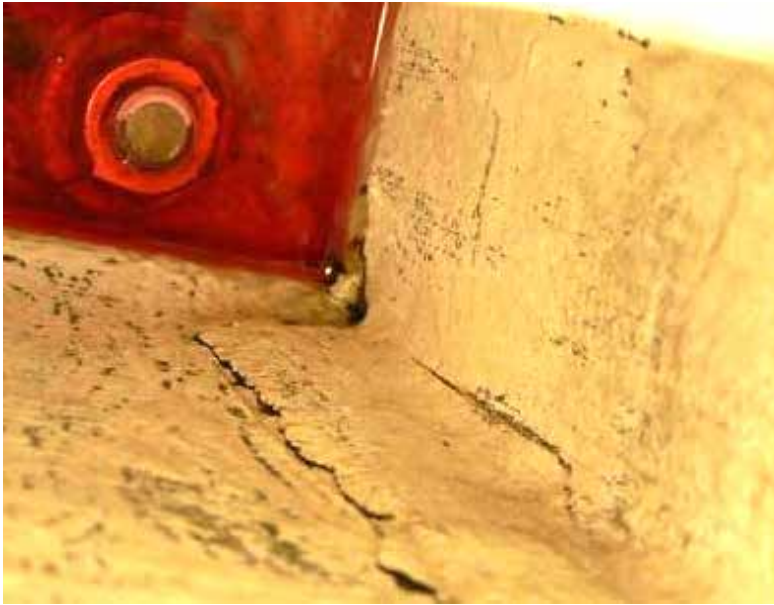
Tabbing Failure

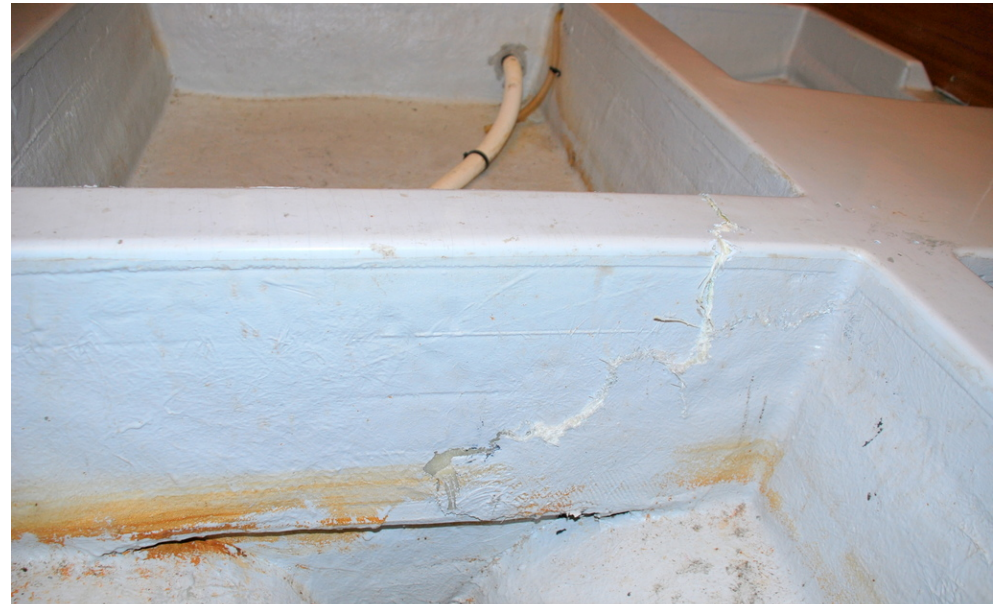
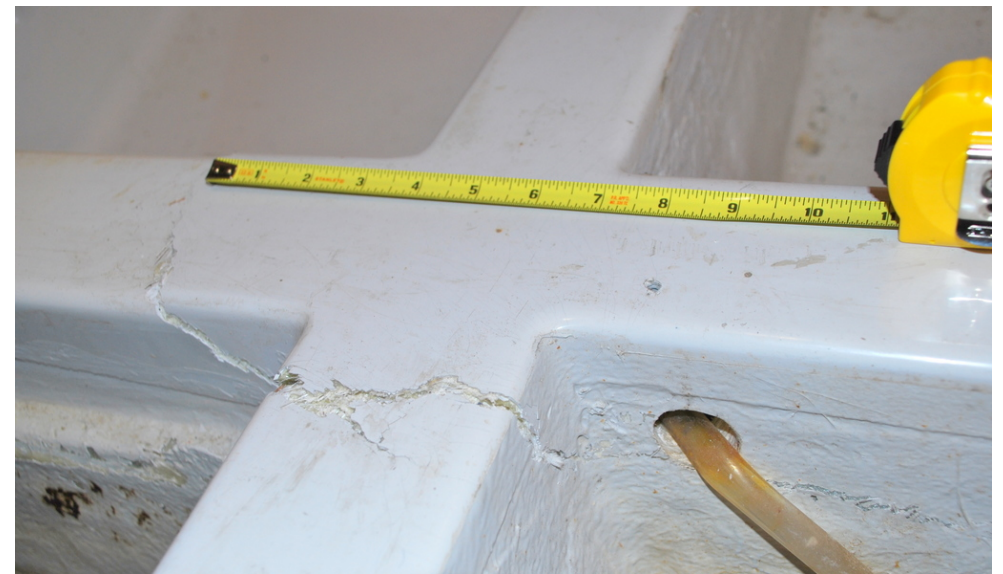
Stiffener Failure

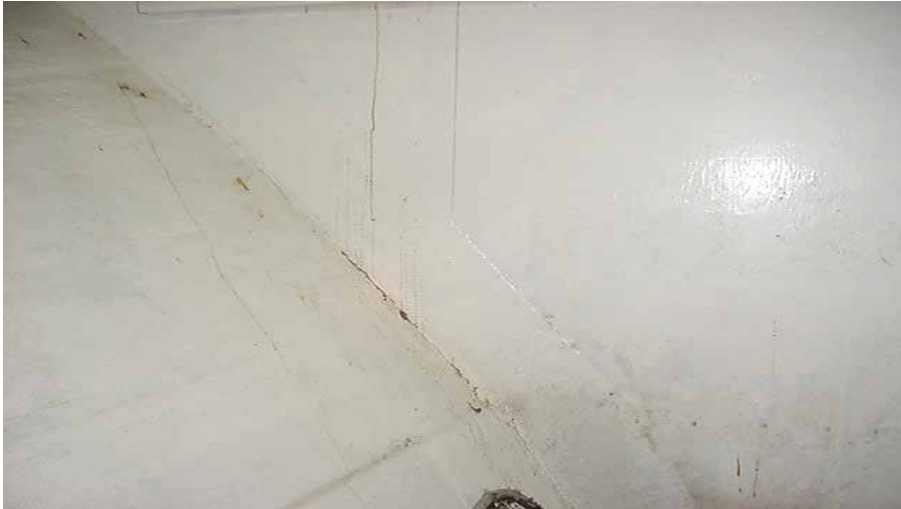
Tabbing Failures

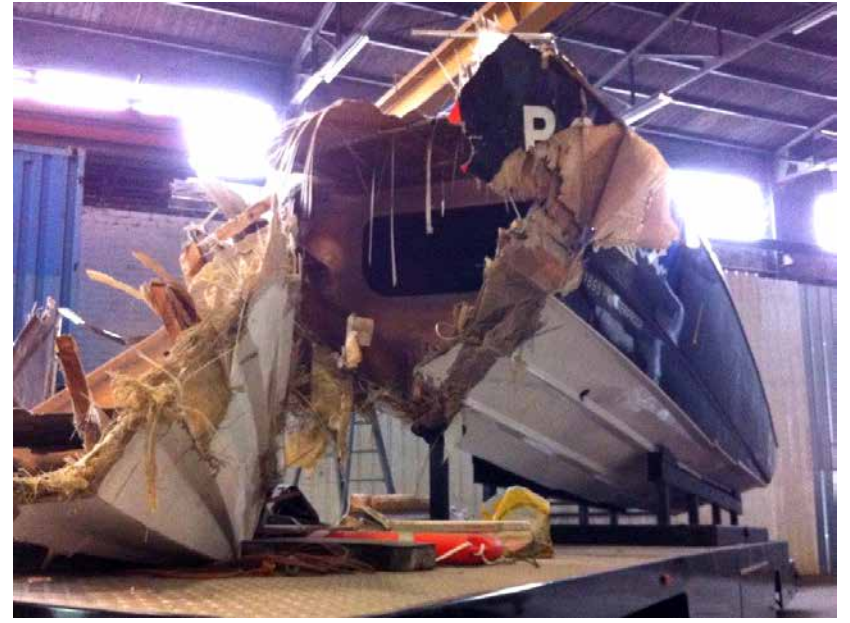
Crashed Racing Powerboats

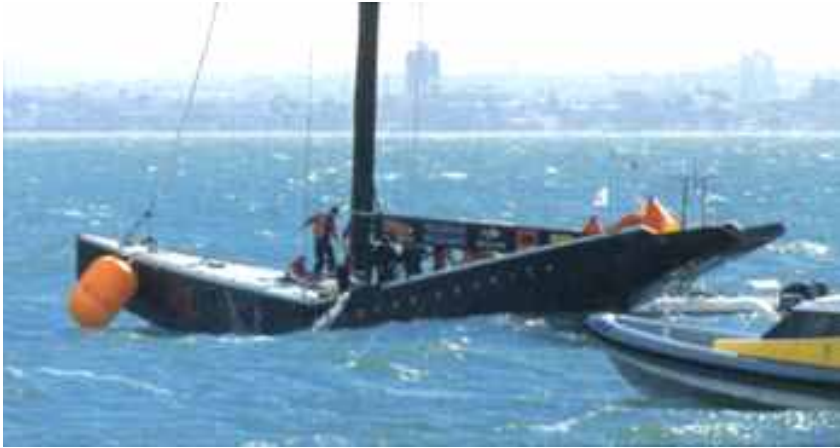
Racing Sailboat Damage

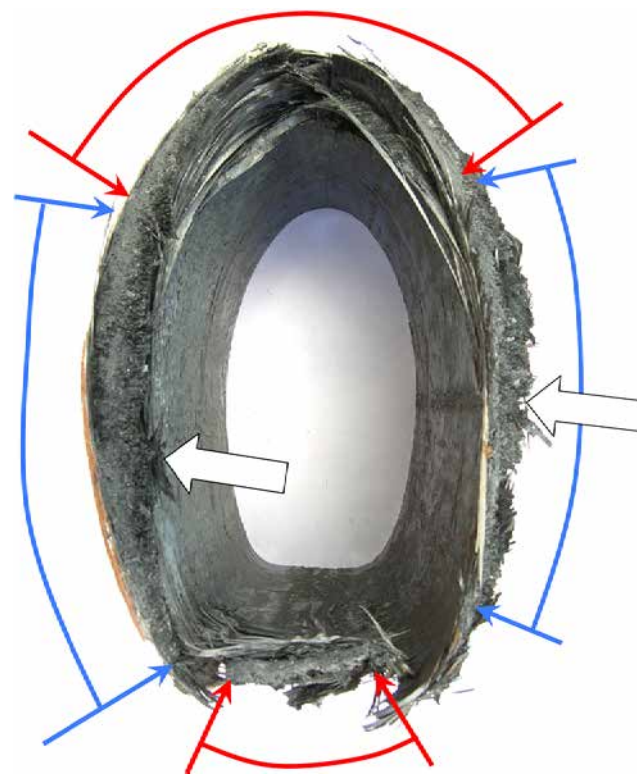
The break showing eroded edges (red regions) and frayed fibers (blue regions with white arrows)

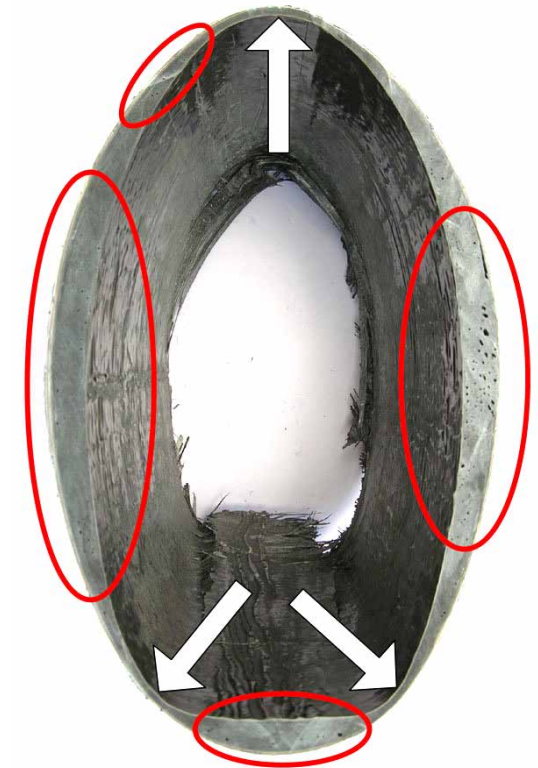
This is the other end of the same sample. Note the area of extreme thinness (white arrows) and air pockets in the laminate (red ovals).

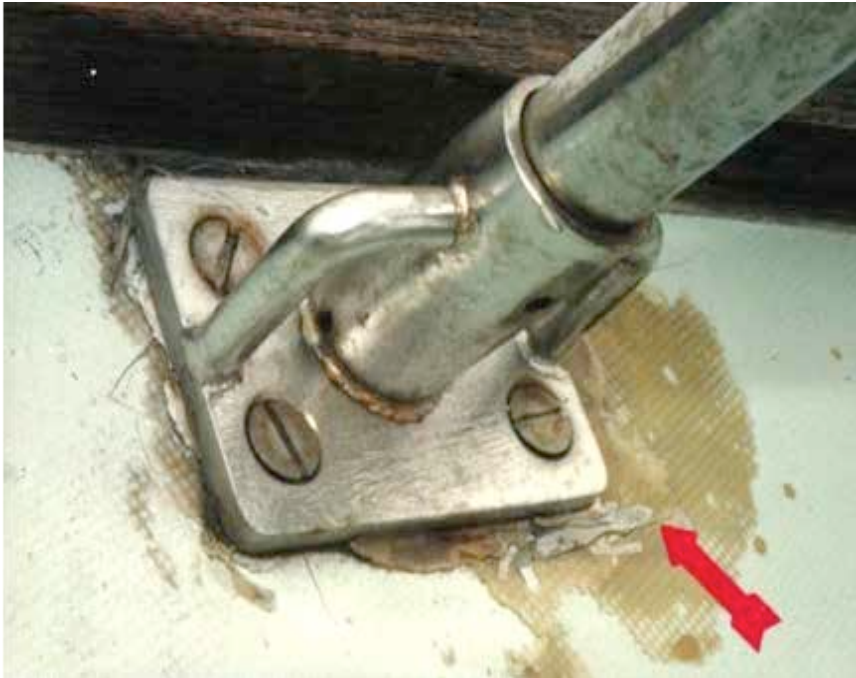
Laminate cracking and failure at stanchion bases

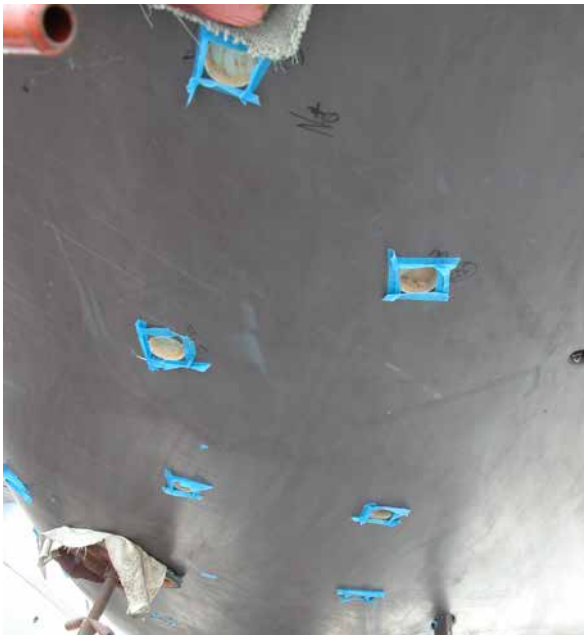
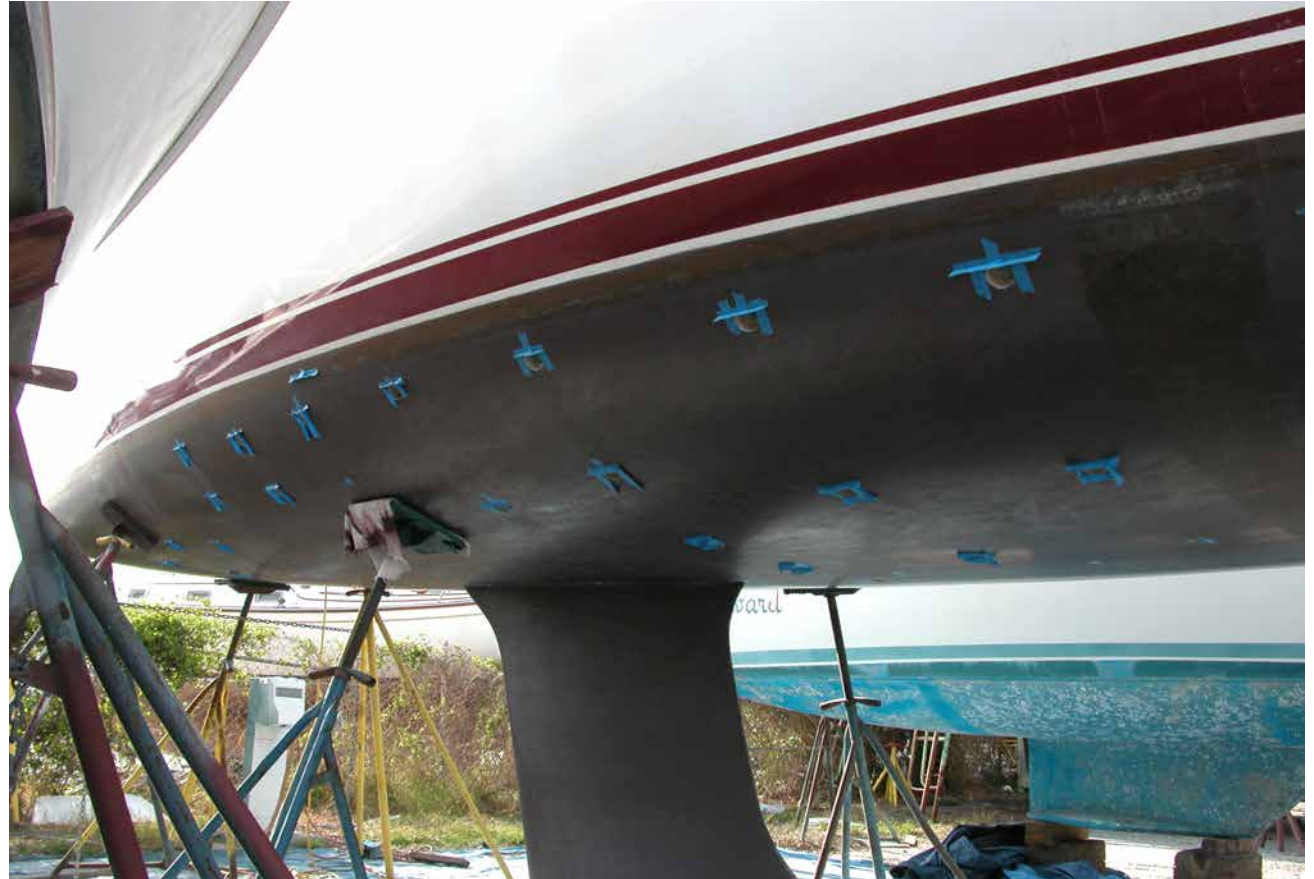
Excessive Hole-Saw Destructive Testing

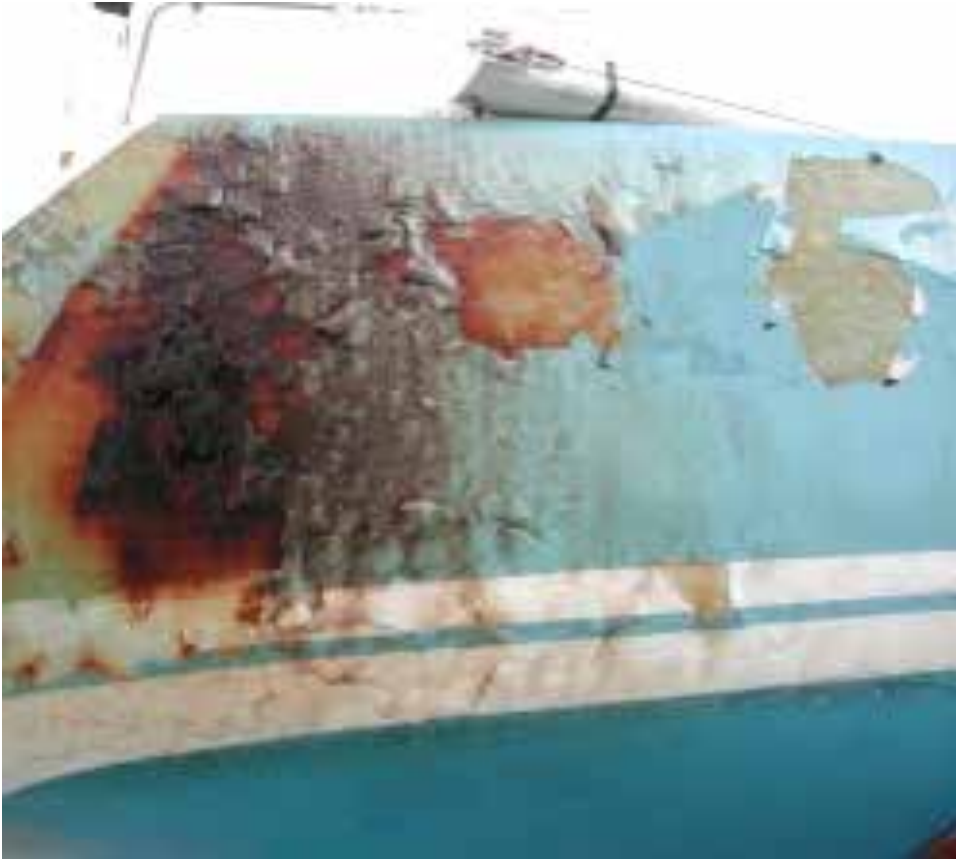
Thermal Damage

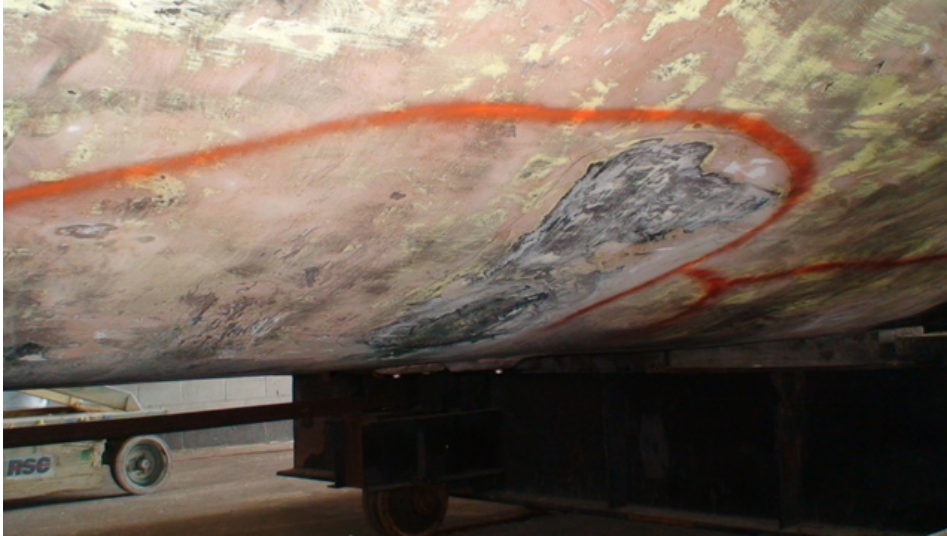
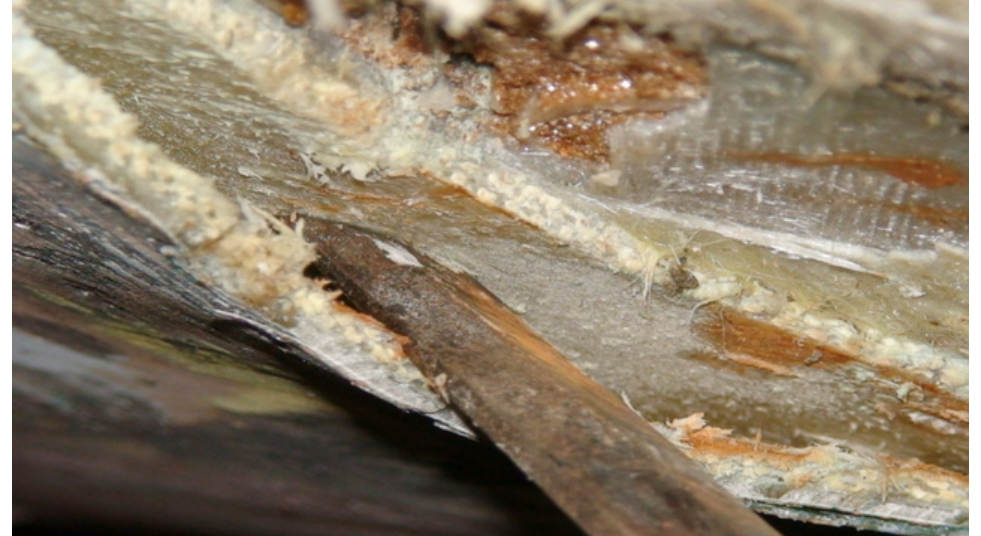
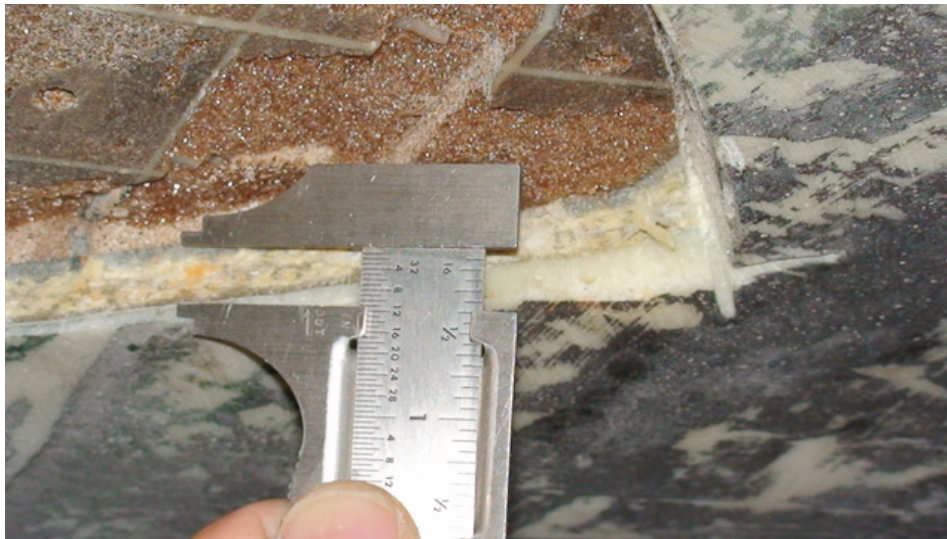
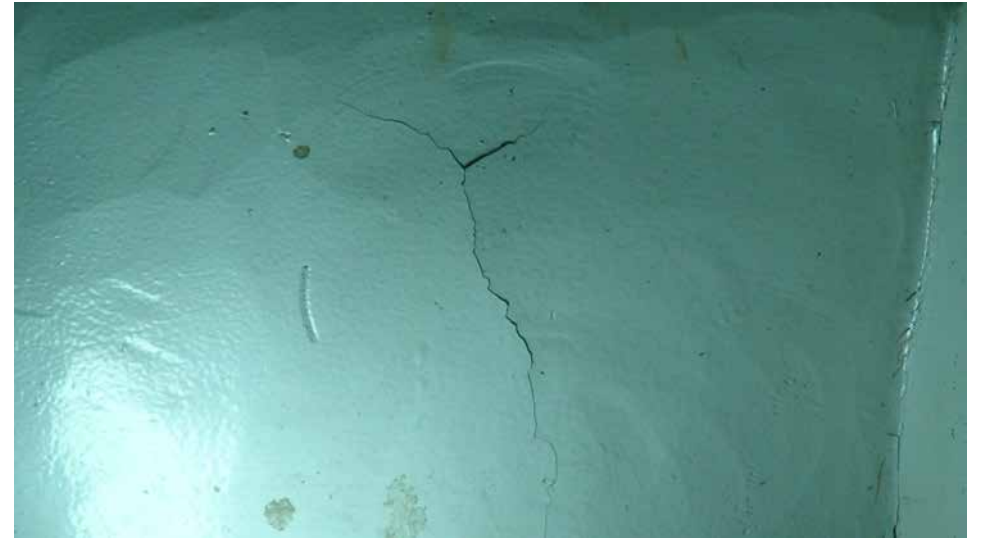
Grounding Damage

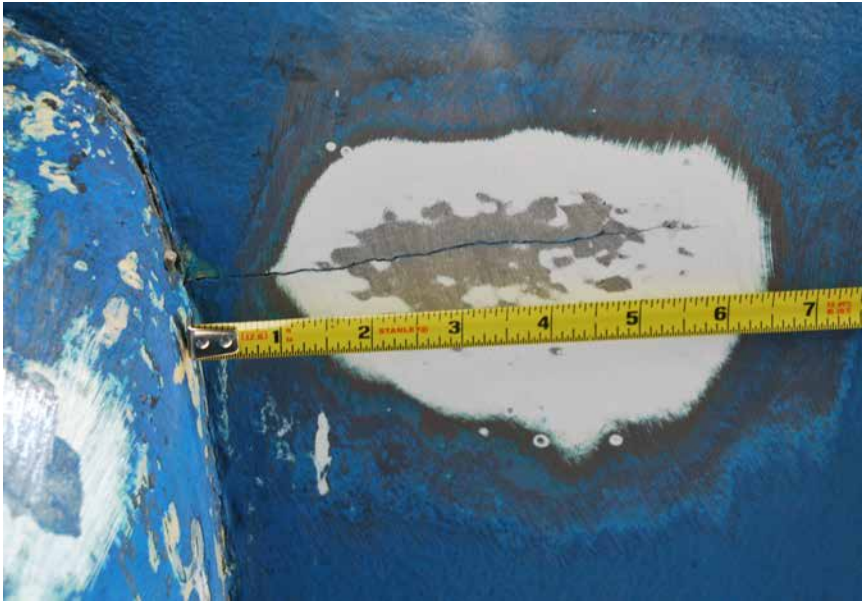
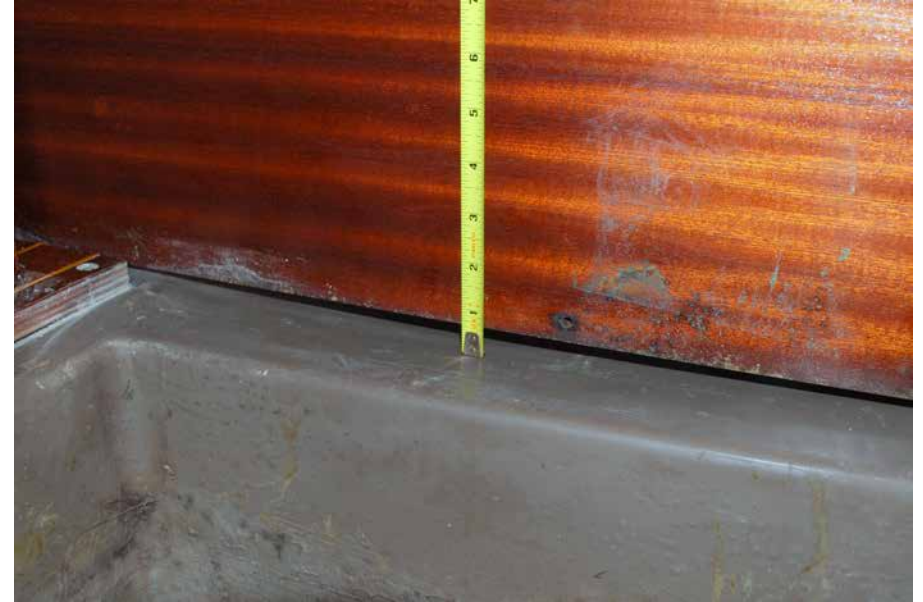
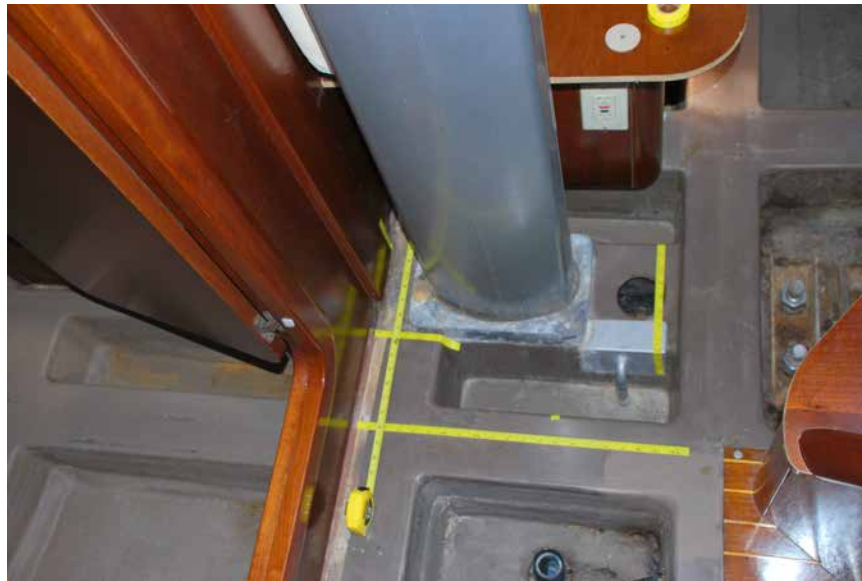
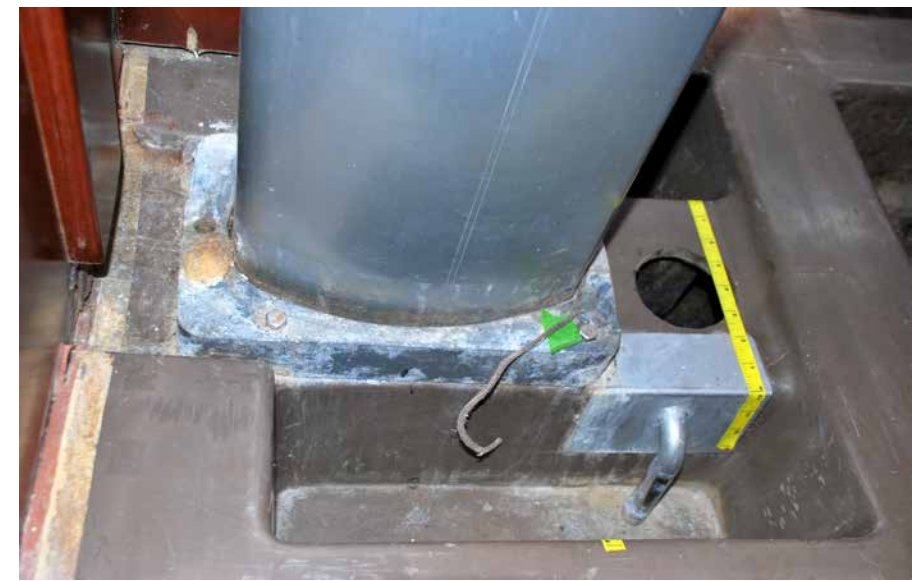
Failed Transverse Stiffener

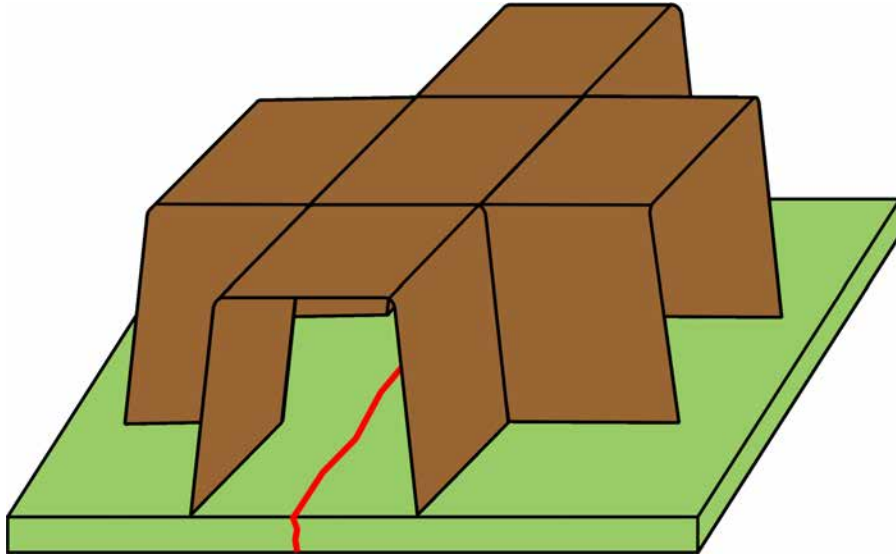
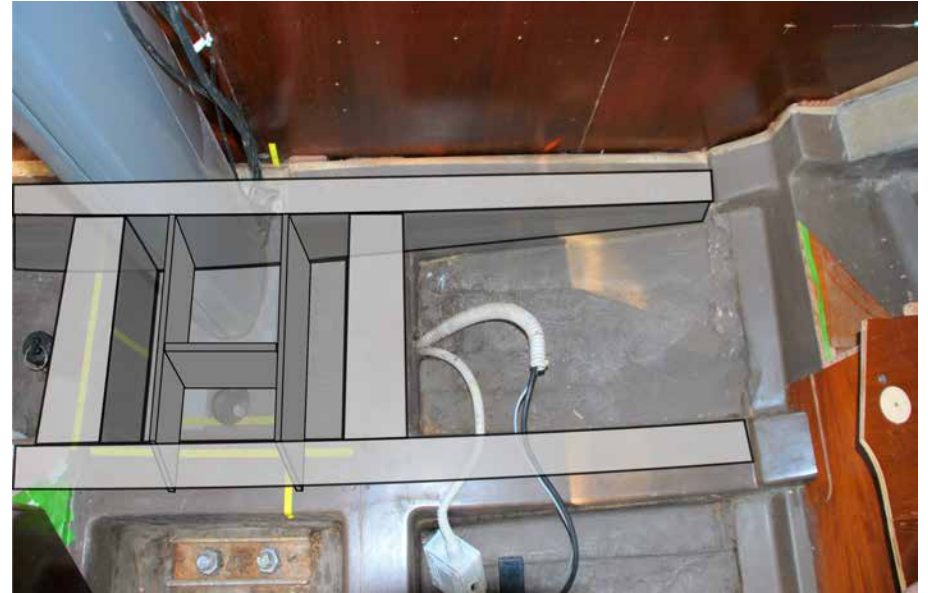
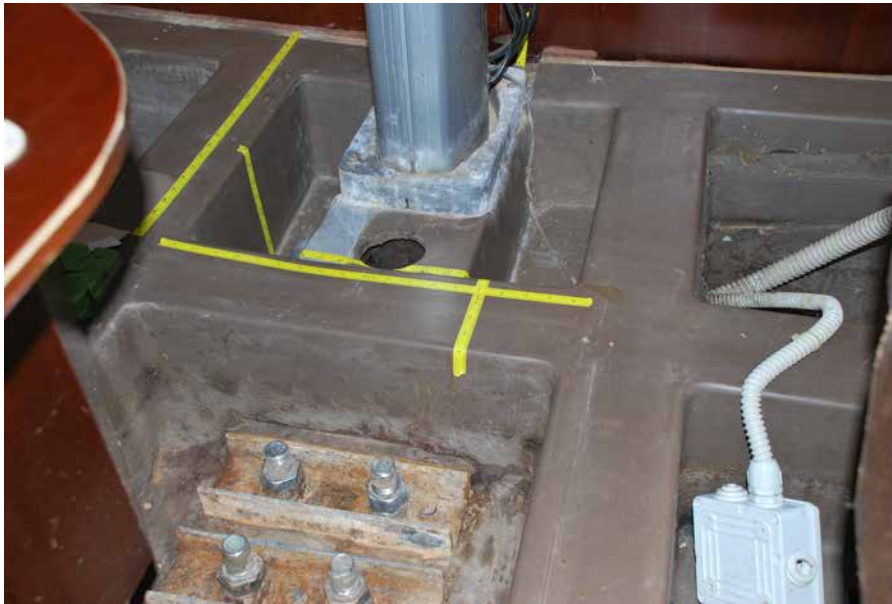
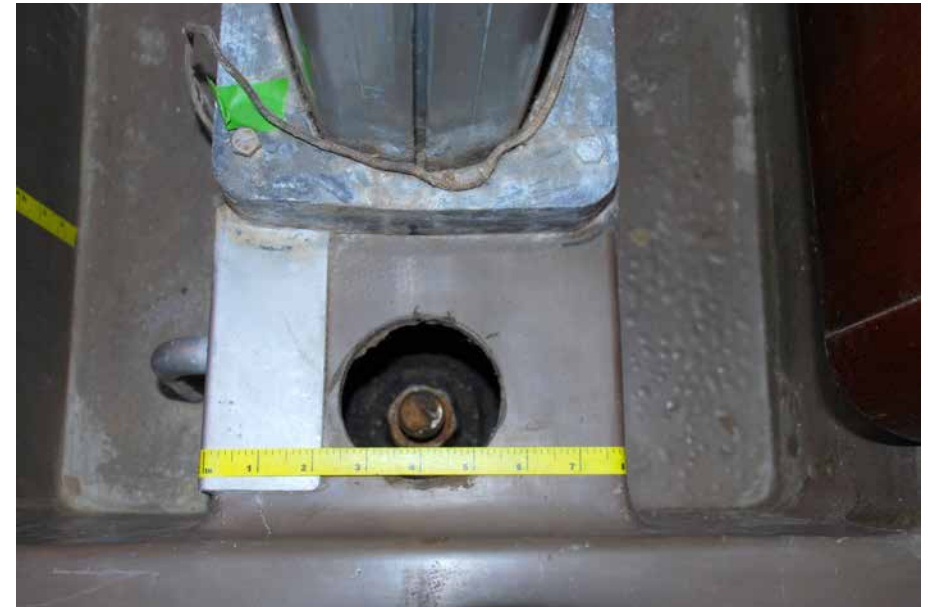
Failure at Stiffener Junction

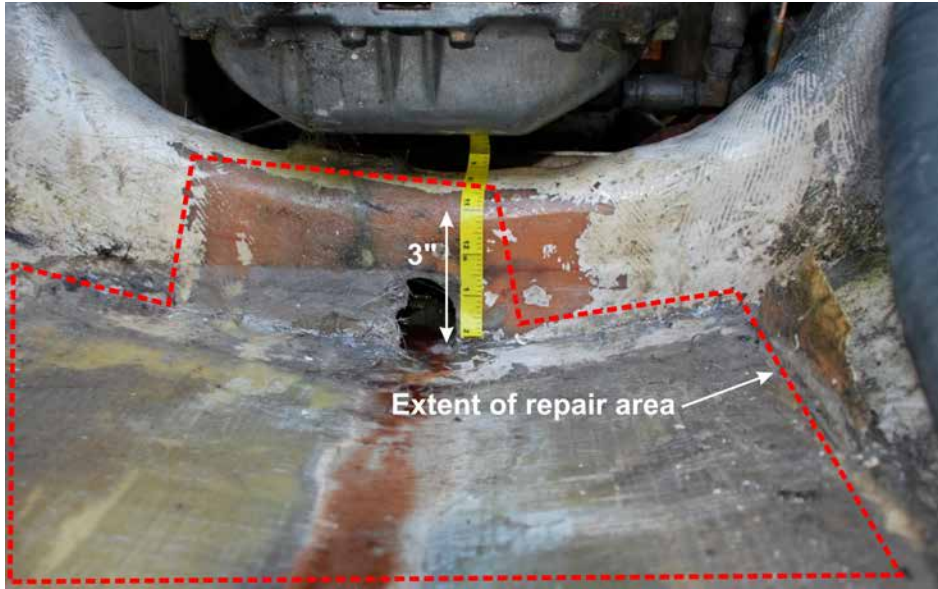
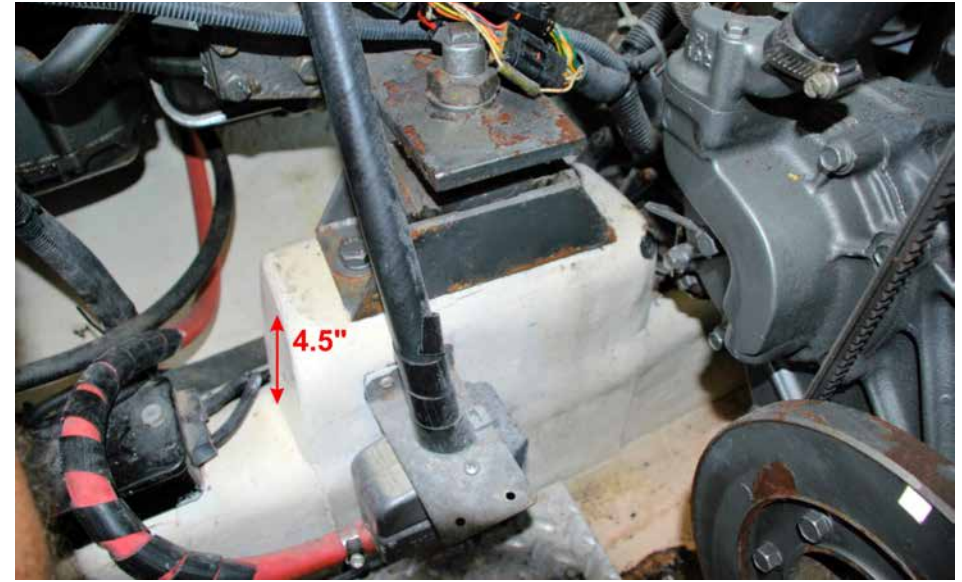
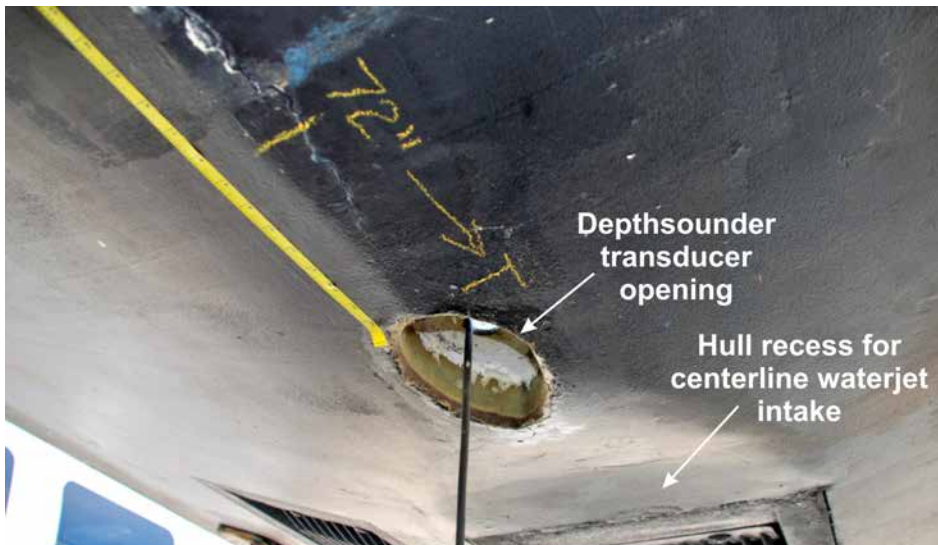
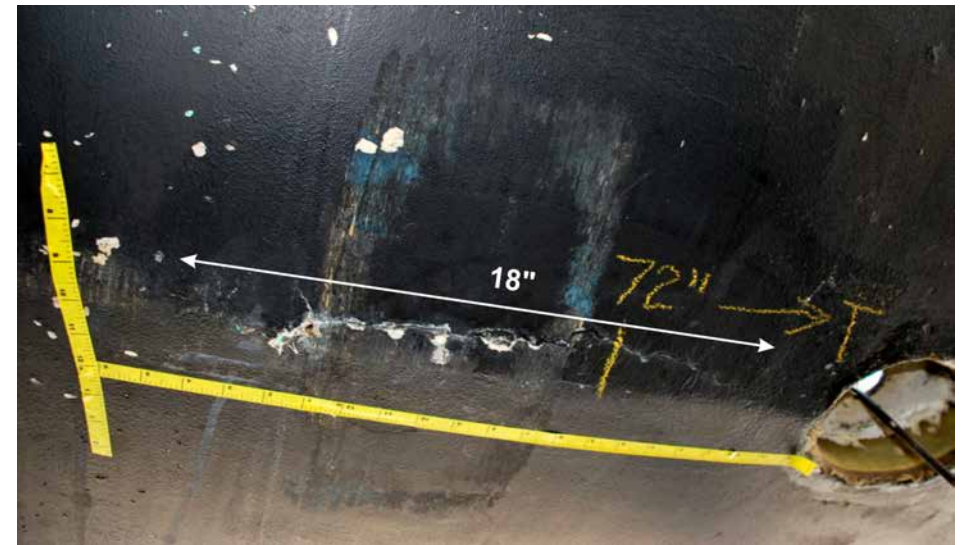
Failed Engine Girder

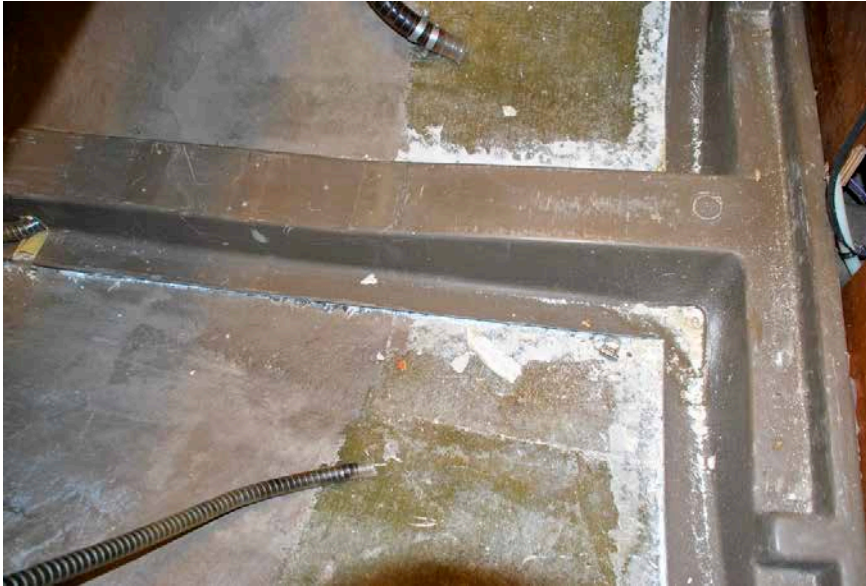
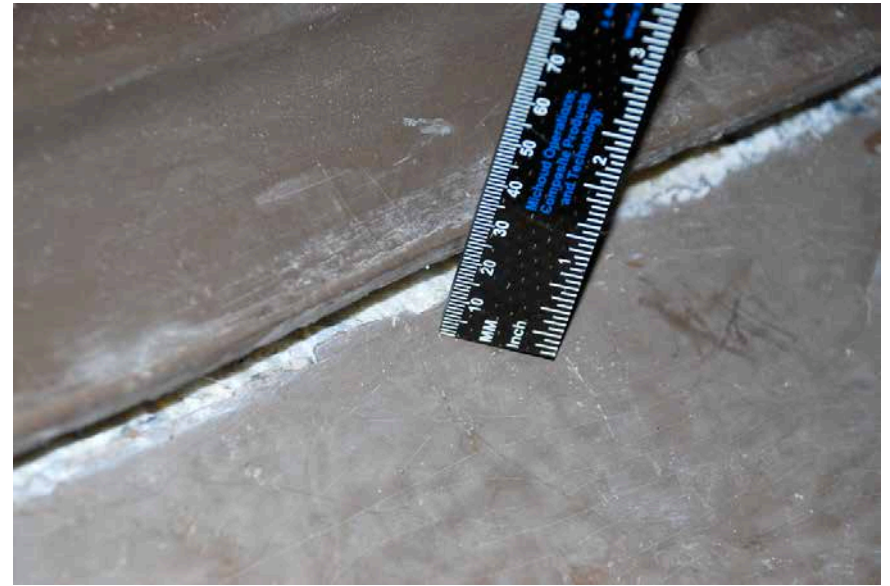
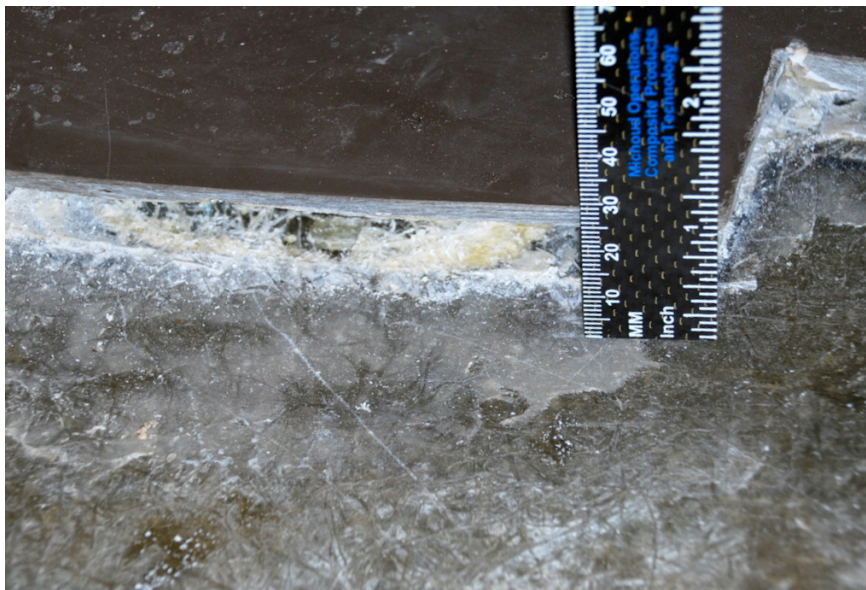
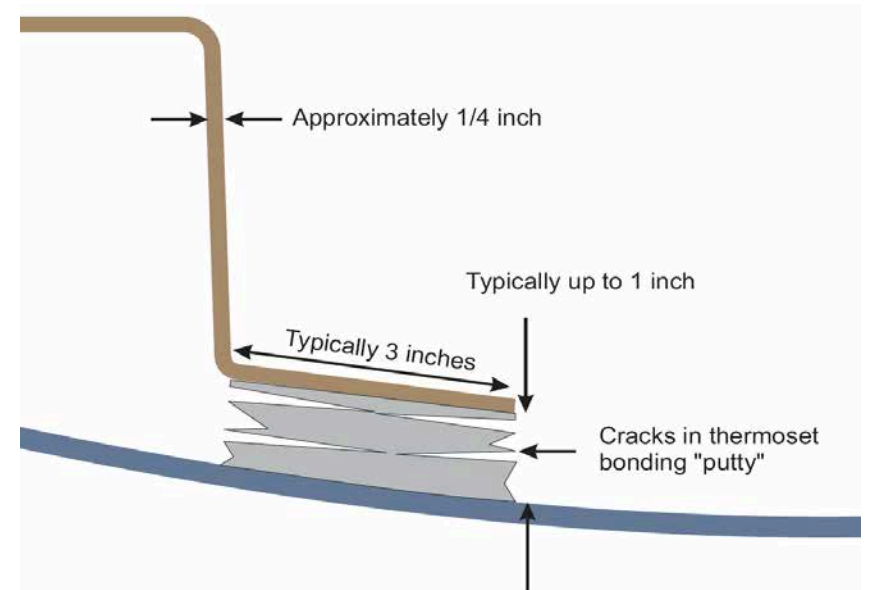
Disbonded Structural Grid

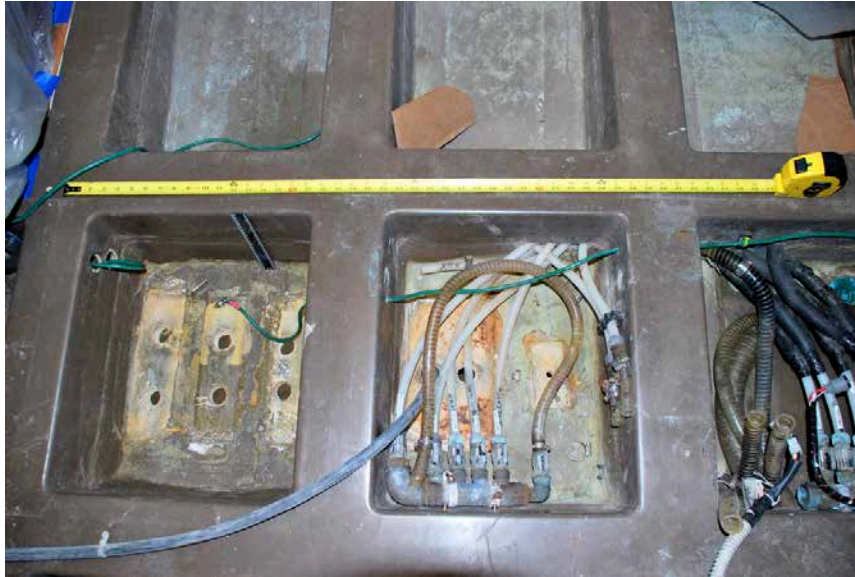
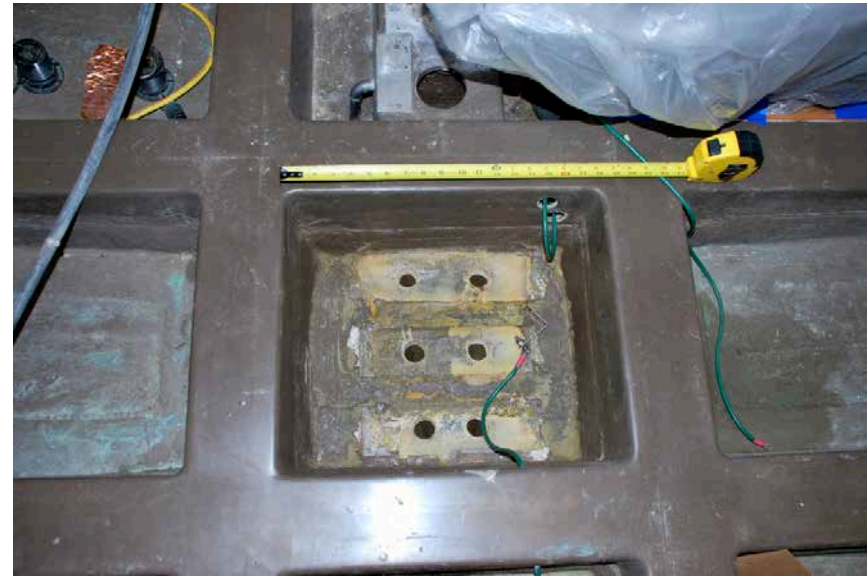
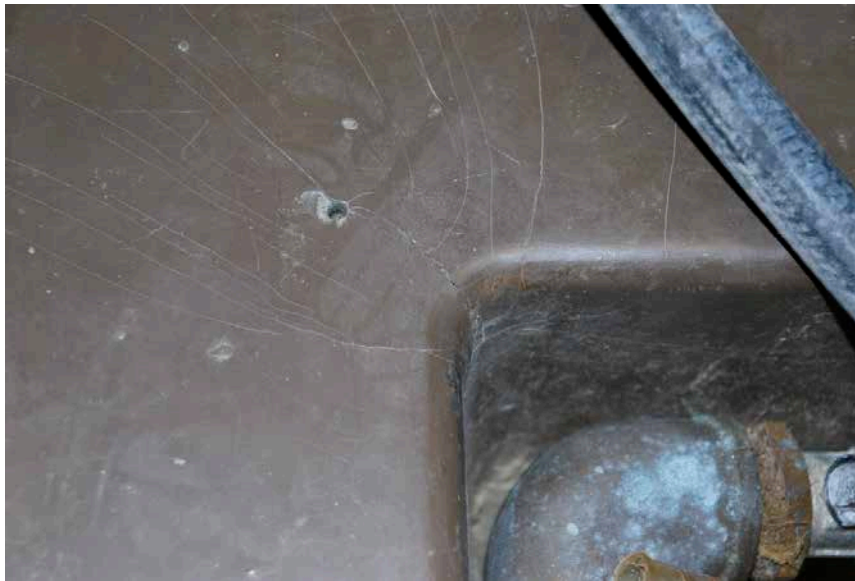
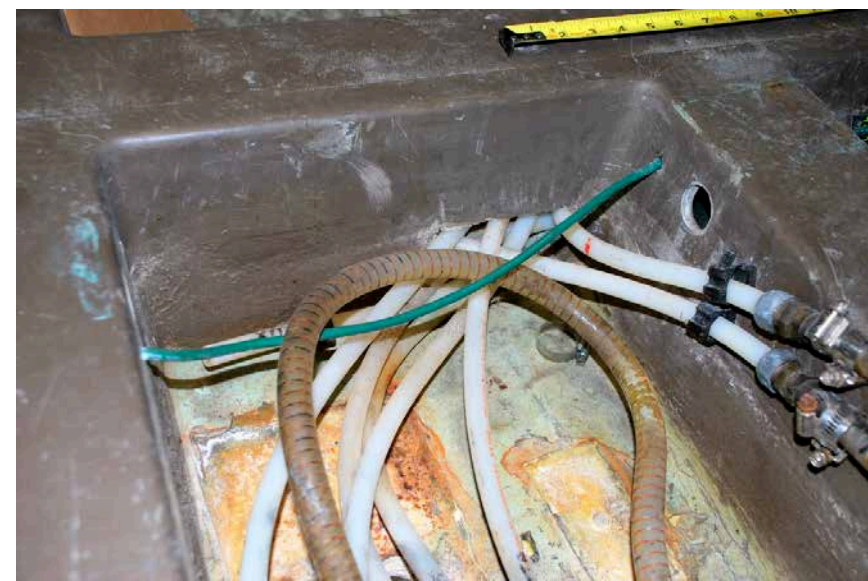
Fractured Keel Stiffeners

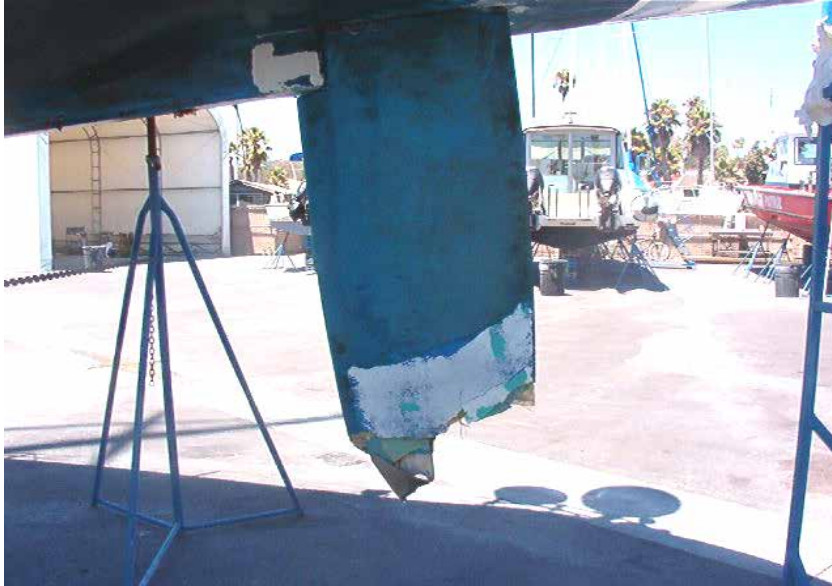
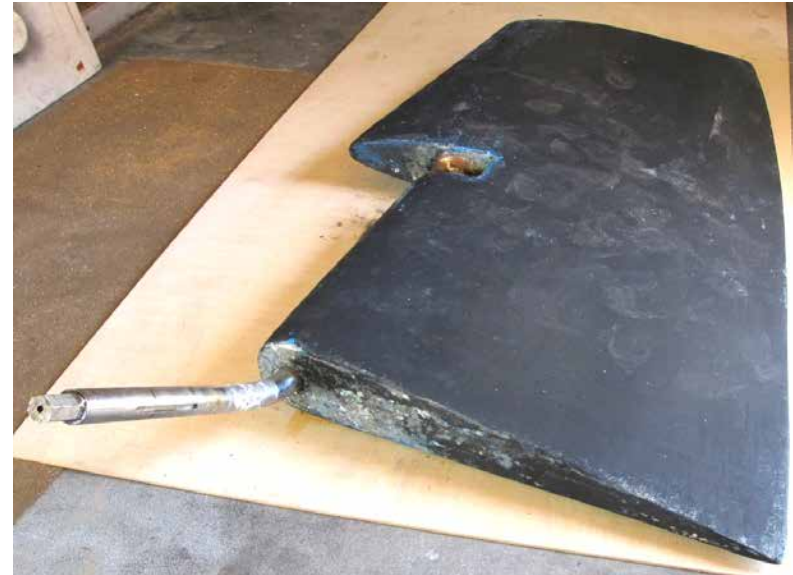
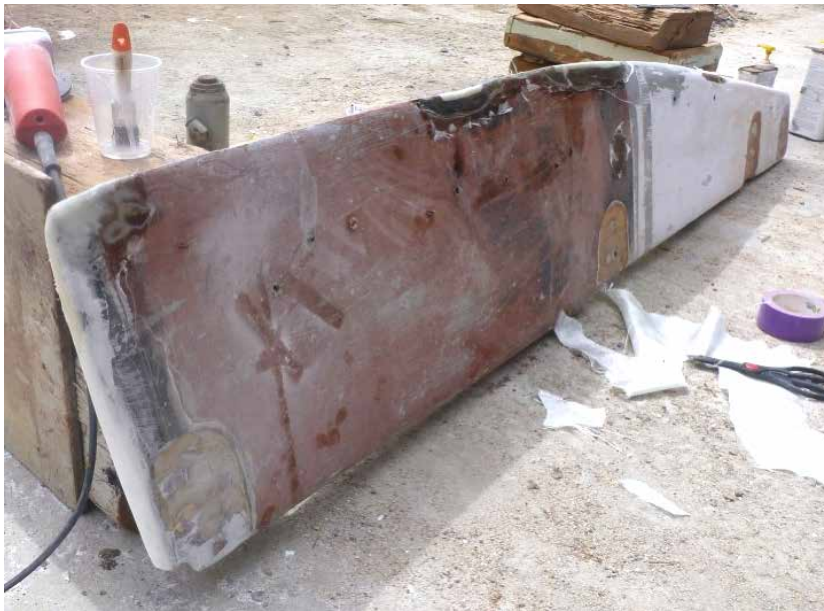
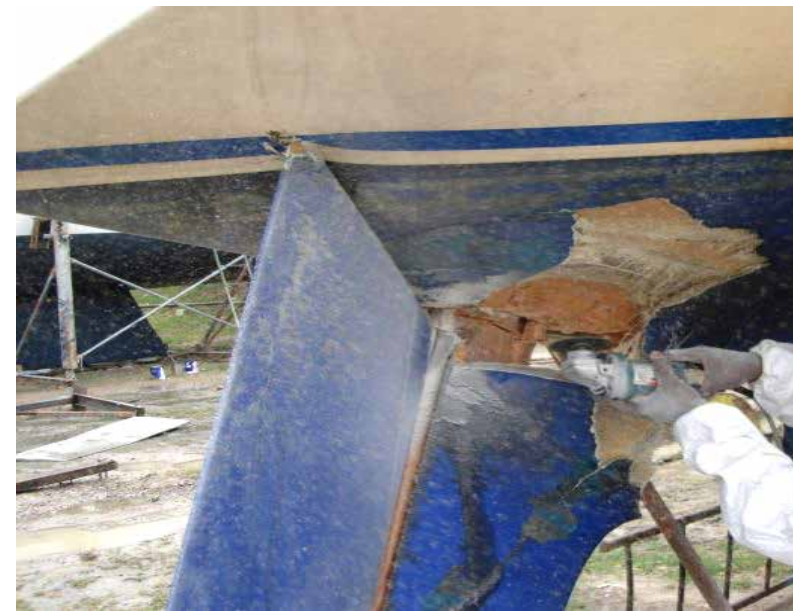
Damaged Rudders
