Marine Composites

Structural Failure Case Histories

Eric Greene, Naval Architect

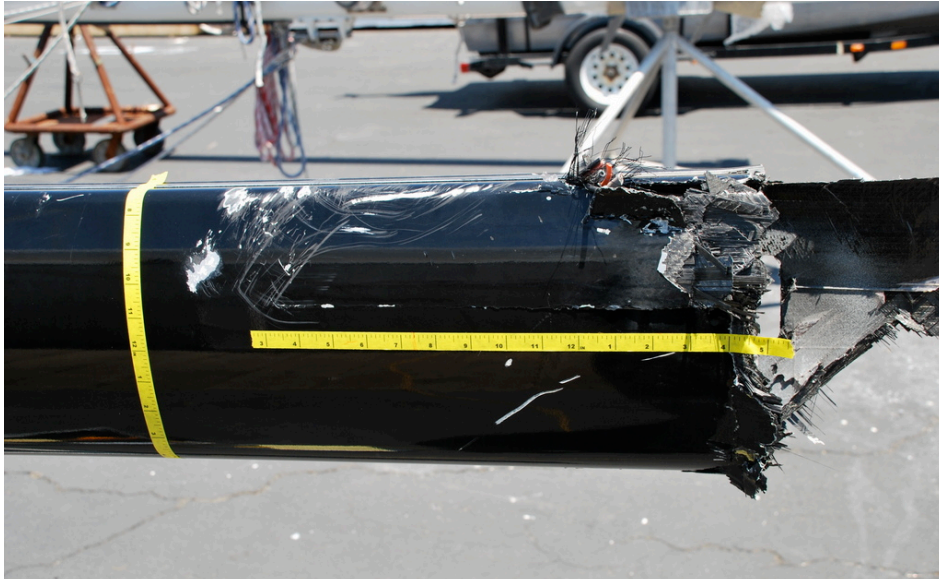
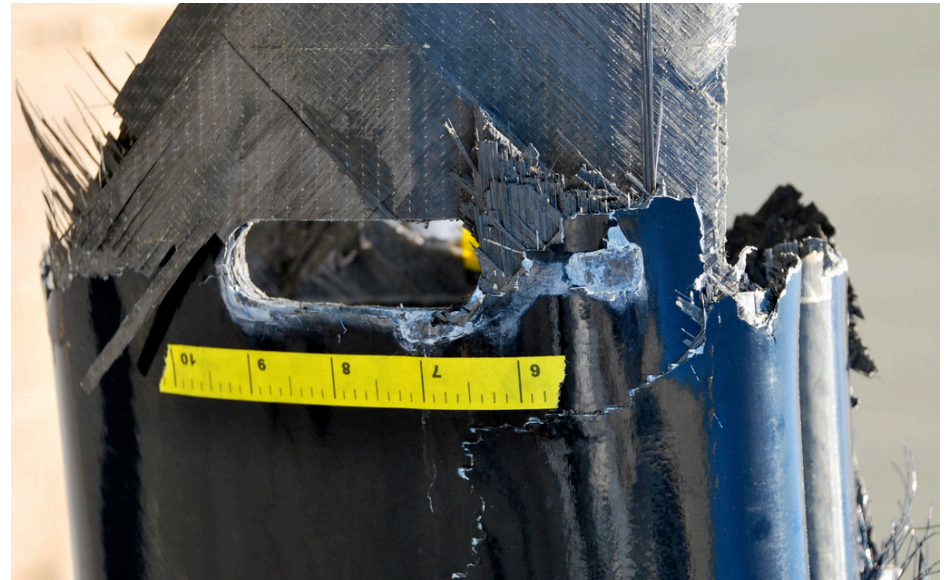
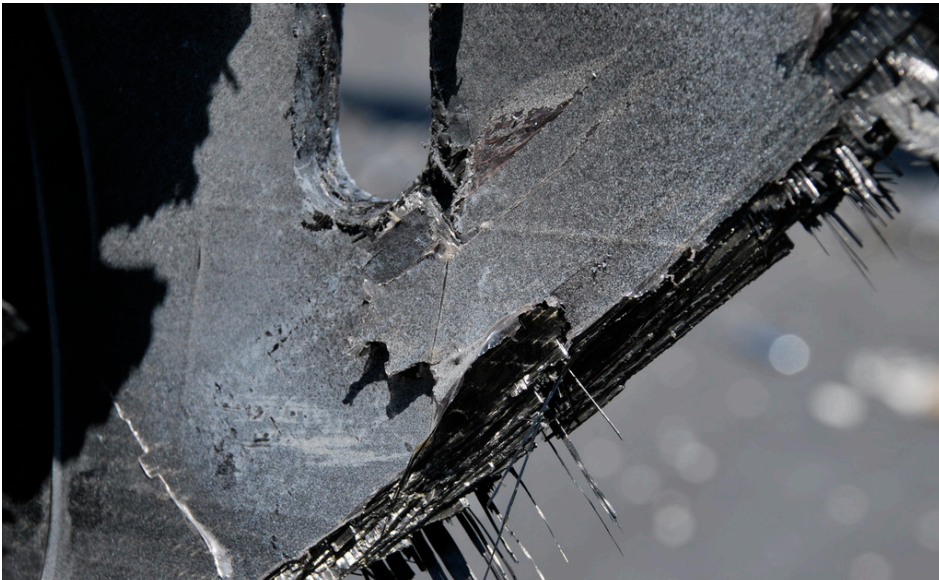
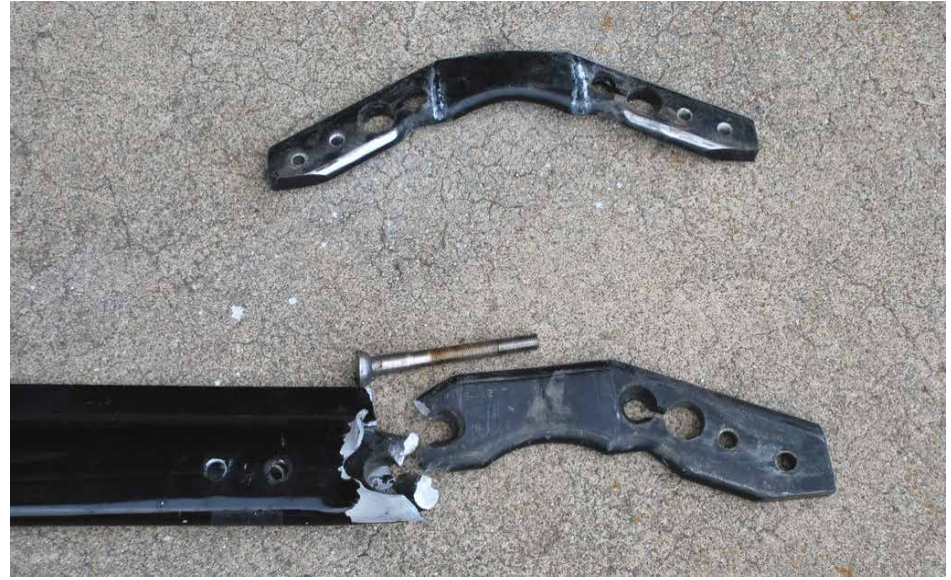
Carbon Fiber Mast Failure

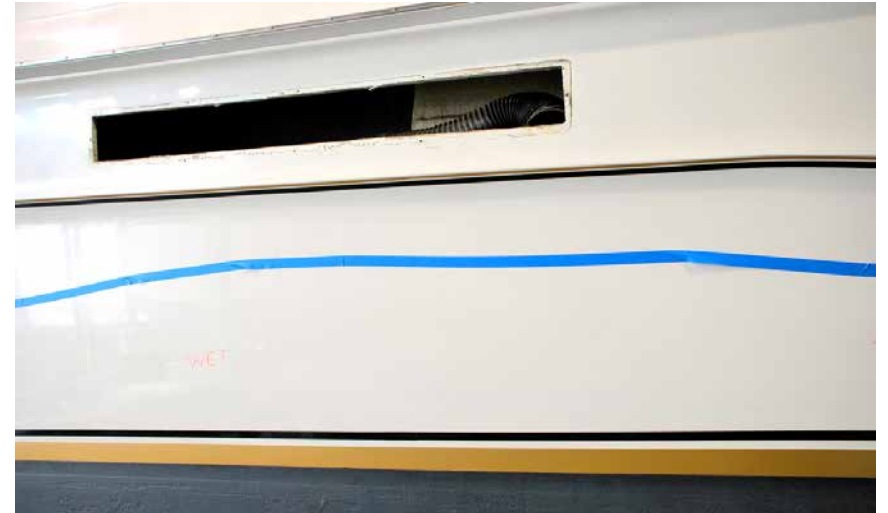
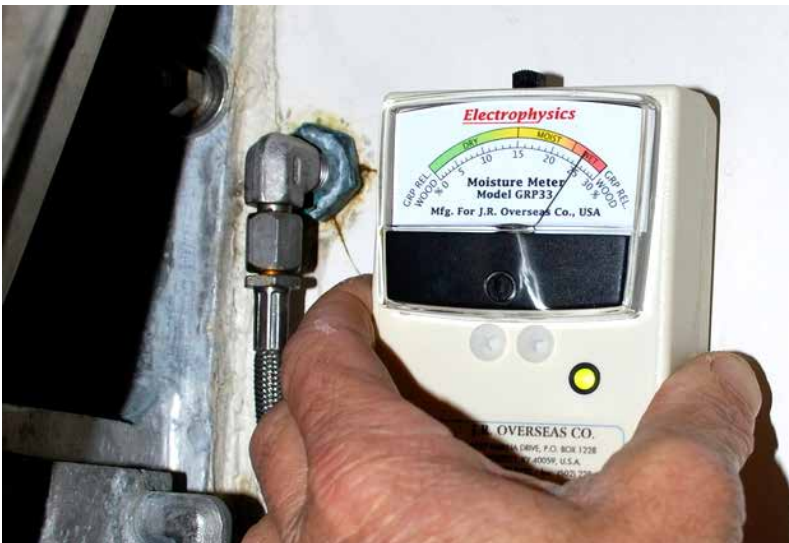
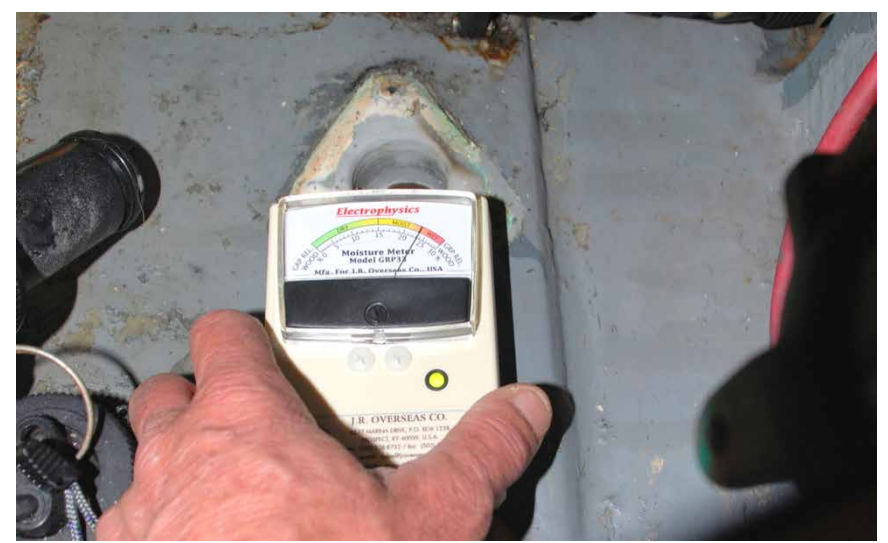
Moisture Ingress

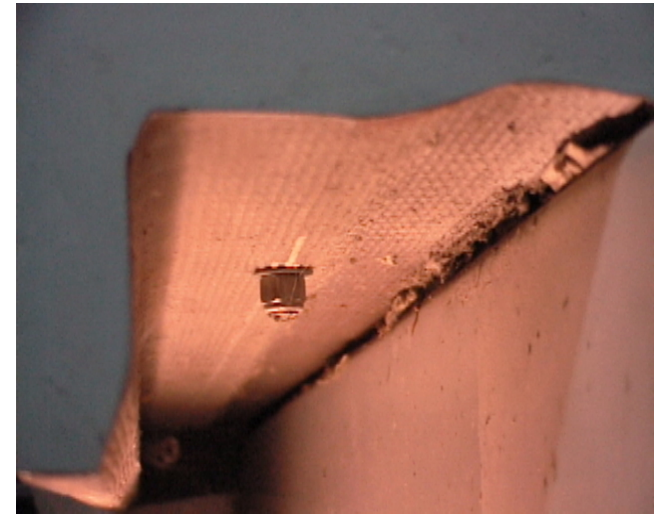
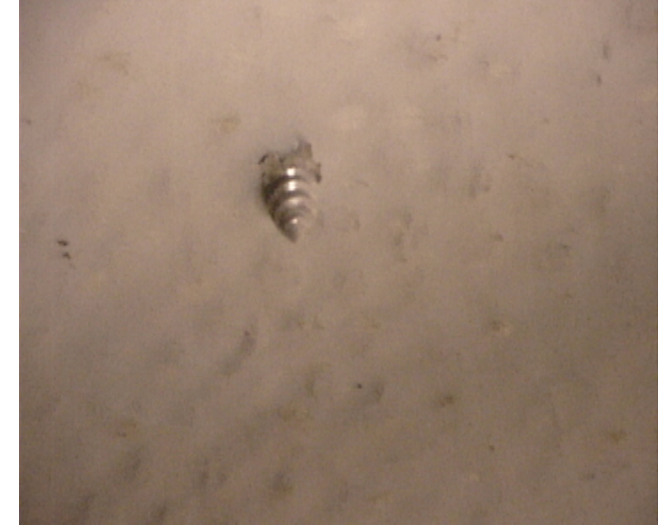
Moisture Ingress

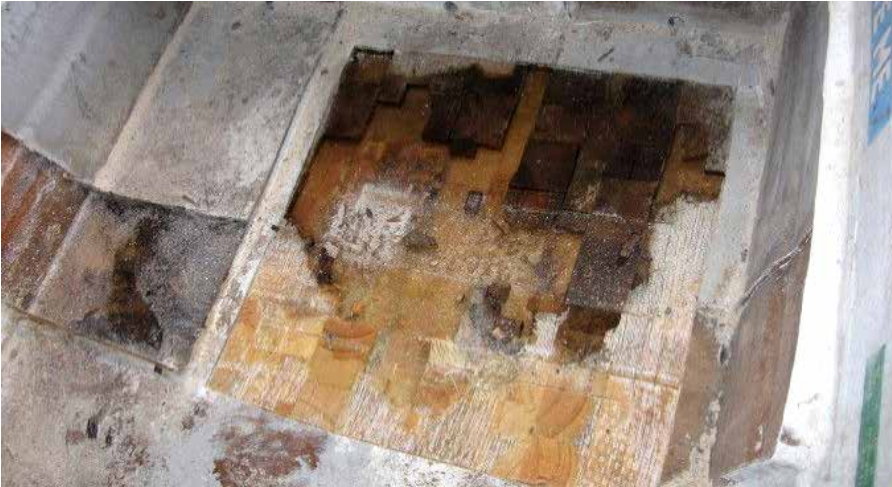
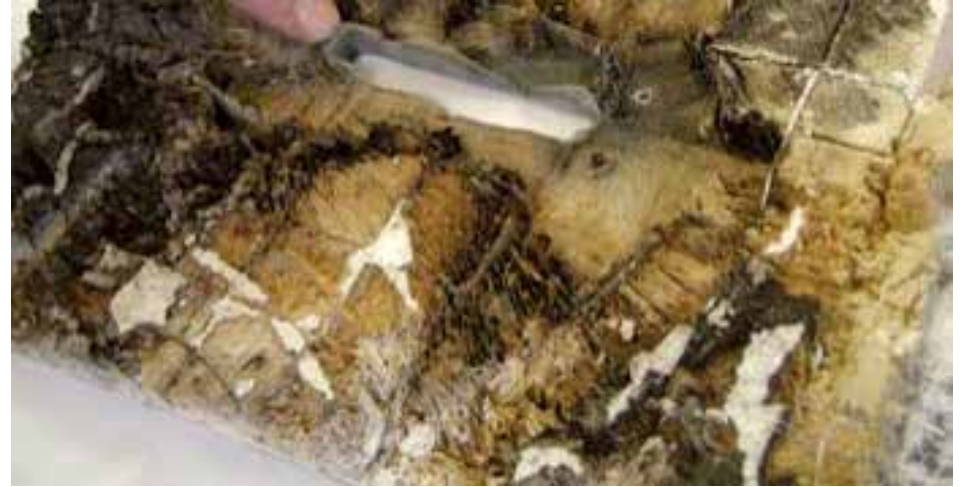
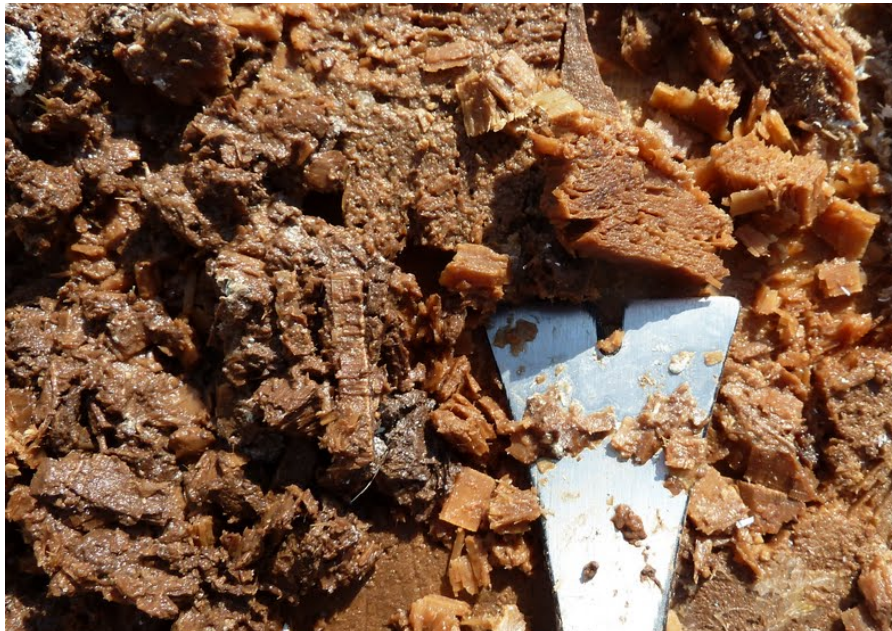
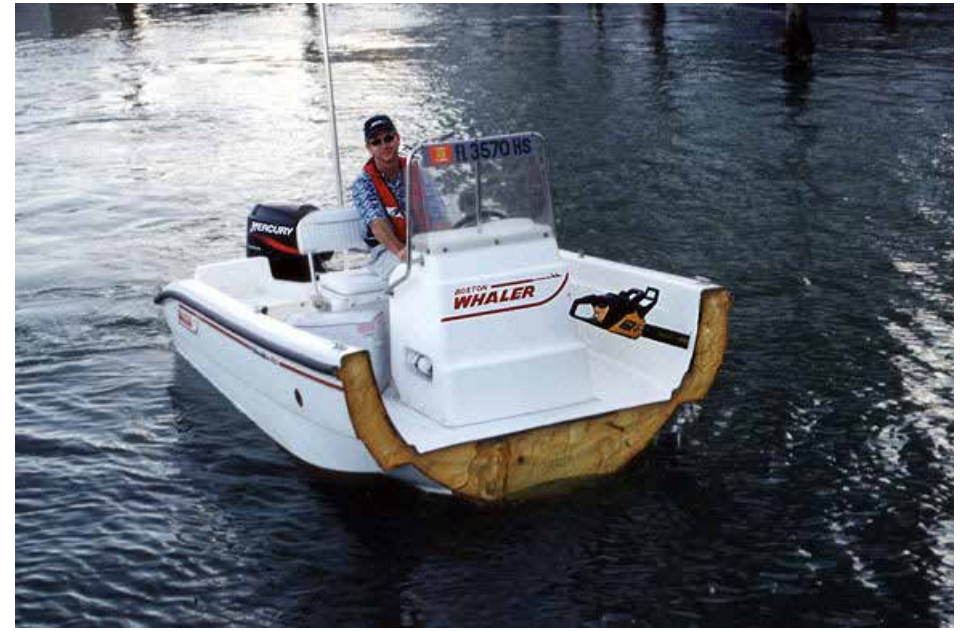
Core Water Damage
