Marine Composites

Webb Institute
Senior Elective

Non-Destructive Evaluation

Eric Greene, Naval Architect

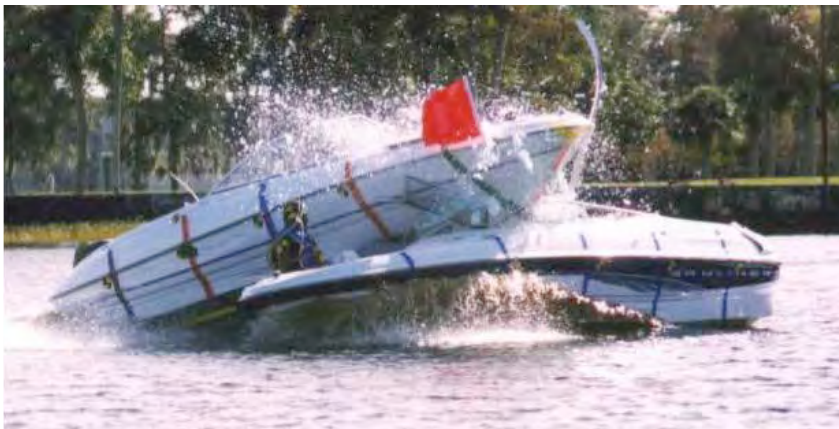
Boat collision reconstructed by Miles Beam funded by the US Coast Guard
[www.boatcrash.com]

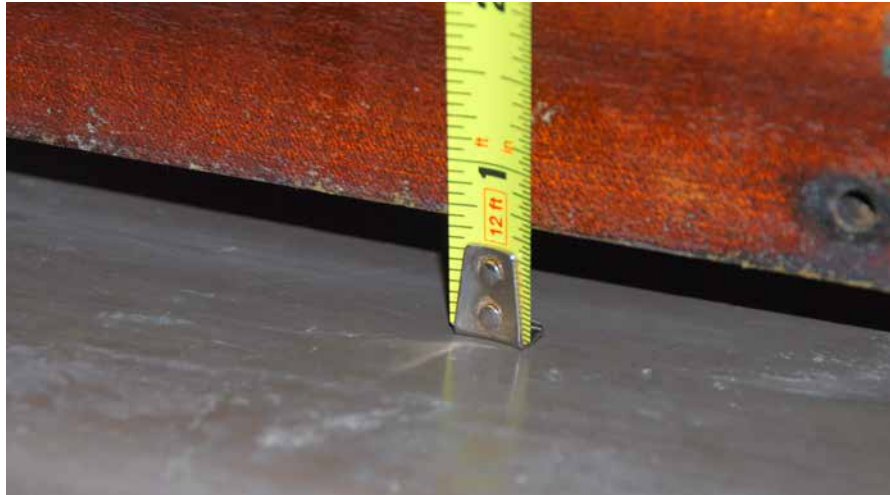
Bulkhead separated from stiffener

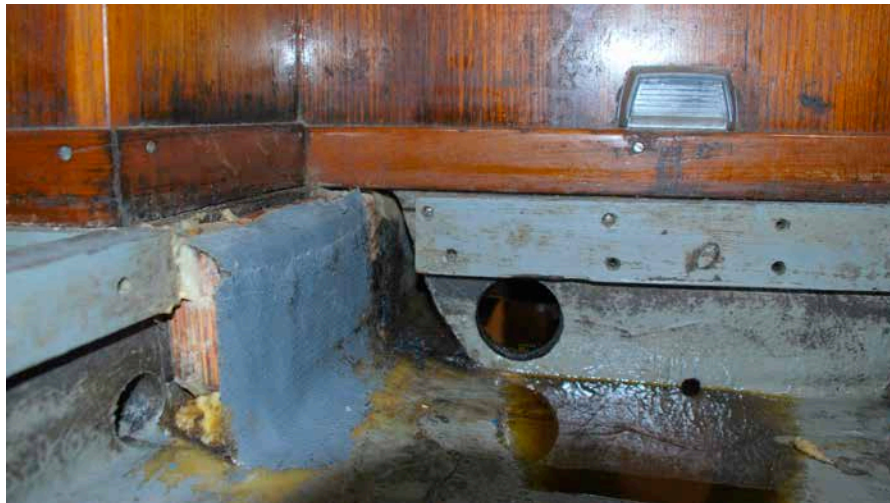
Inadequate tabbing detail

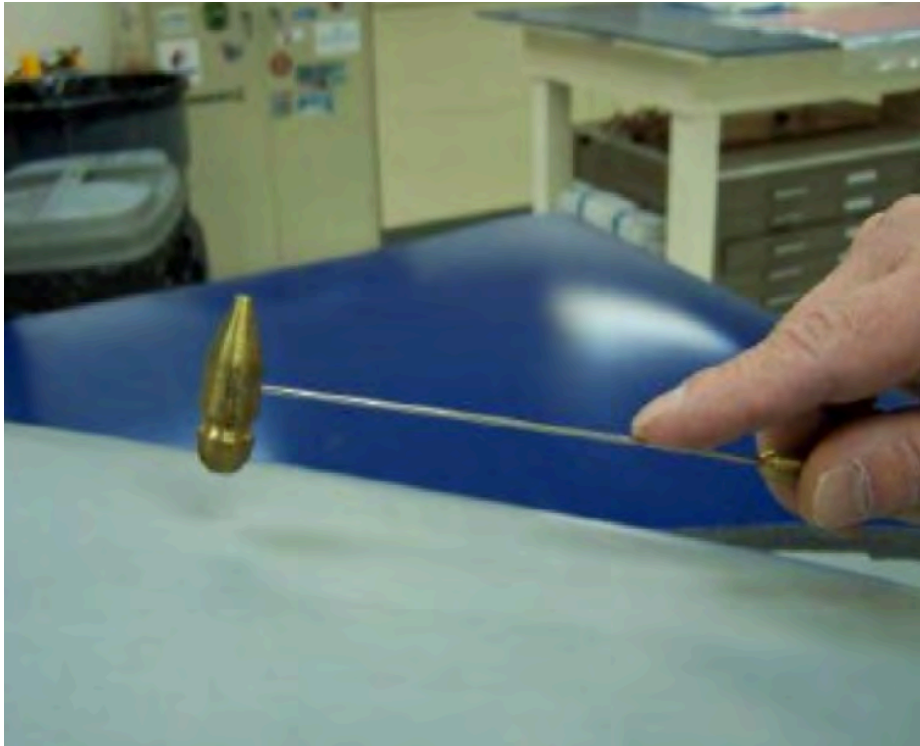
Military specification tap hammer

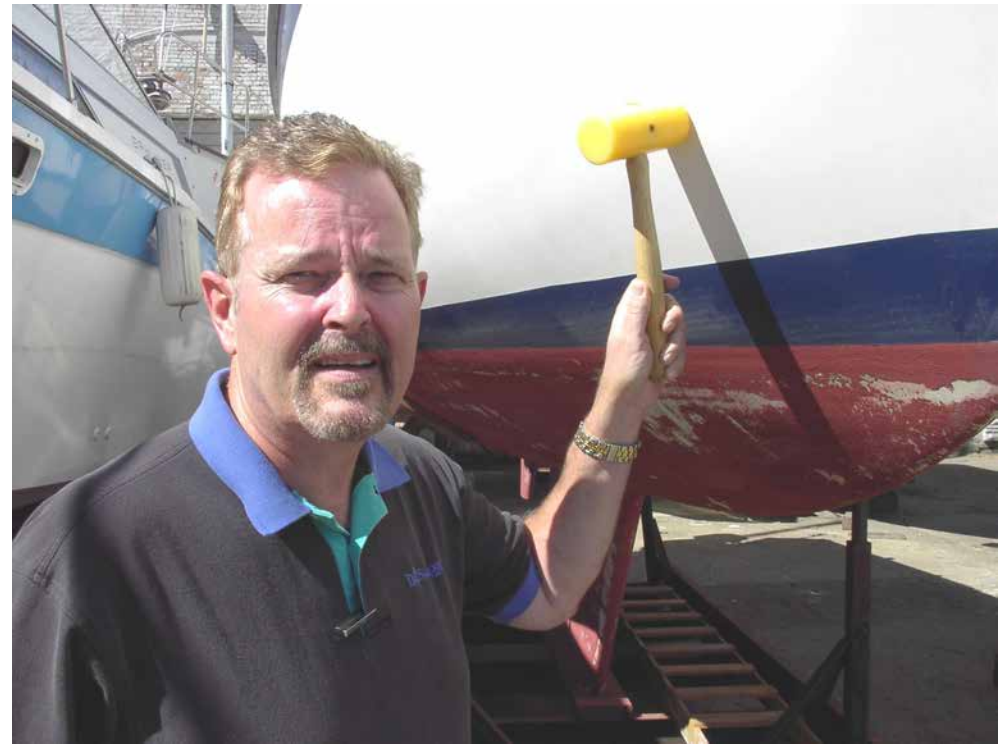
Marine surveyor Greg Davis uses sounding hammer on fiberglass boat hull

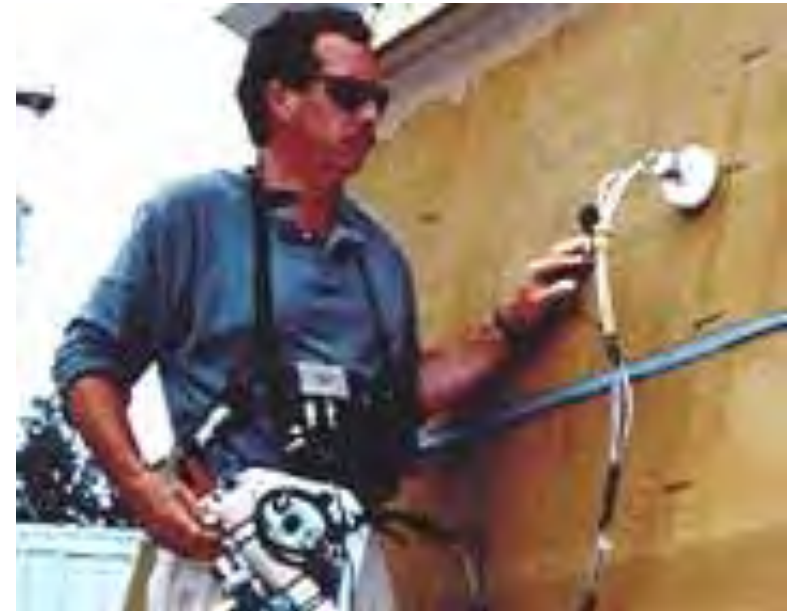
Bruce Pfund shown demonstrating his Smart Hammer system [Bruce Pfund Special Projects]

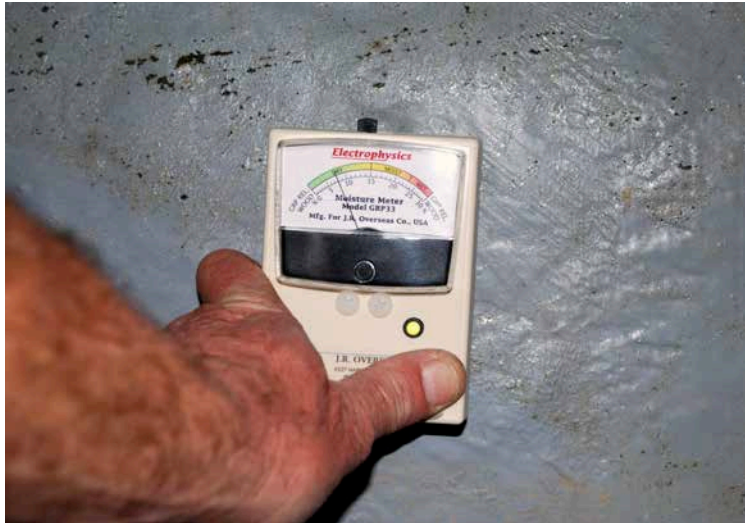
Capacitance moisture meter

- Resistance type devices more accurate than capacitance devices but require surface penetration
- Capacitance devices will not provide readings with laminates that contain carbon fiber or over most copper-based bottom paints
- Ambient conditions such as recent rain or the presence of dew can produce false high reading
- Moisture meters more effective when used in conjunction with other NDE methods, such as hammer sounding to assess structural integrity

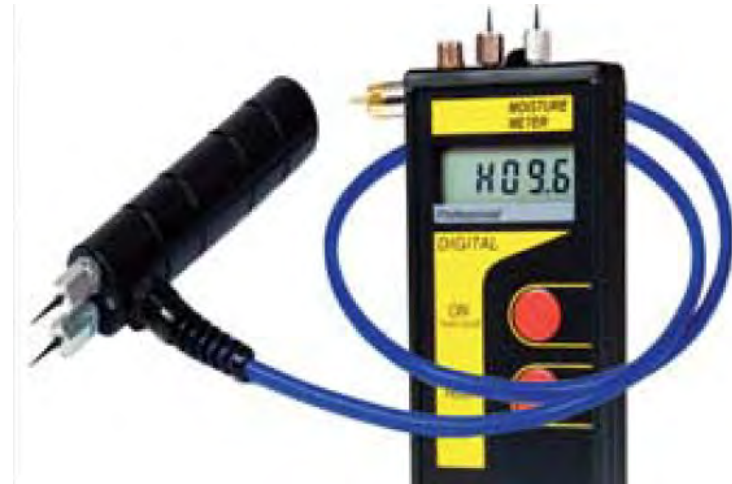
Resistance moisture meter

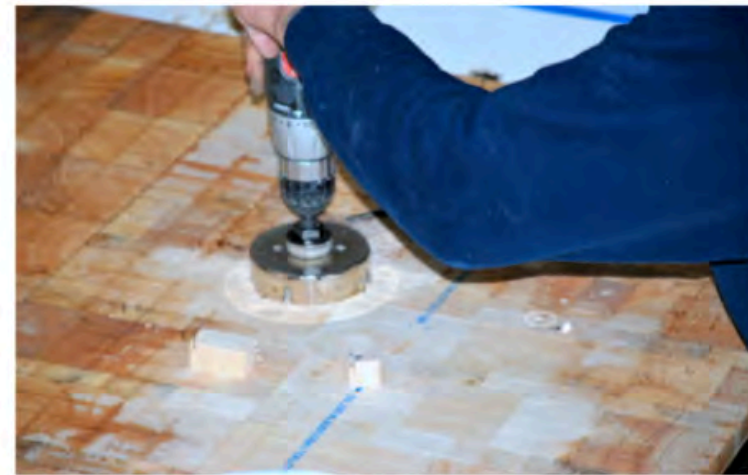
Hole saw is used to create a 1/8 inch deep void for water to be encapsulated

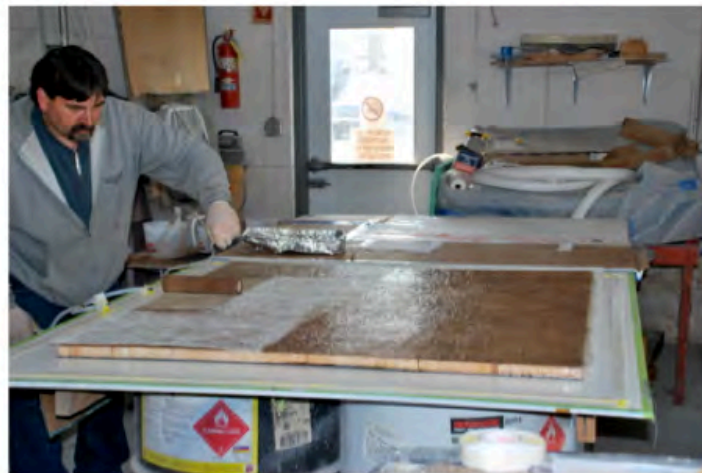
Inner skin is laminated by hand

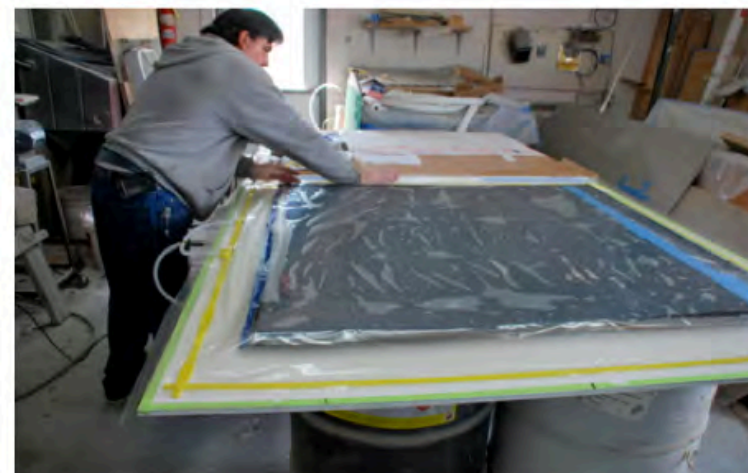
Vacuum bag is used to consolidate hand-laminated inner skin

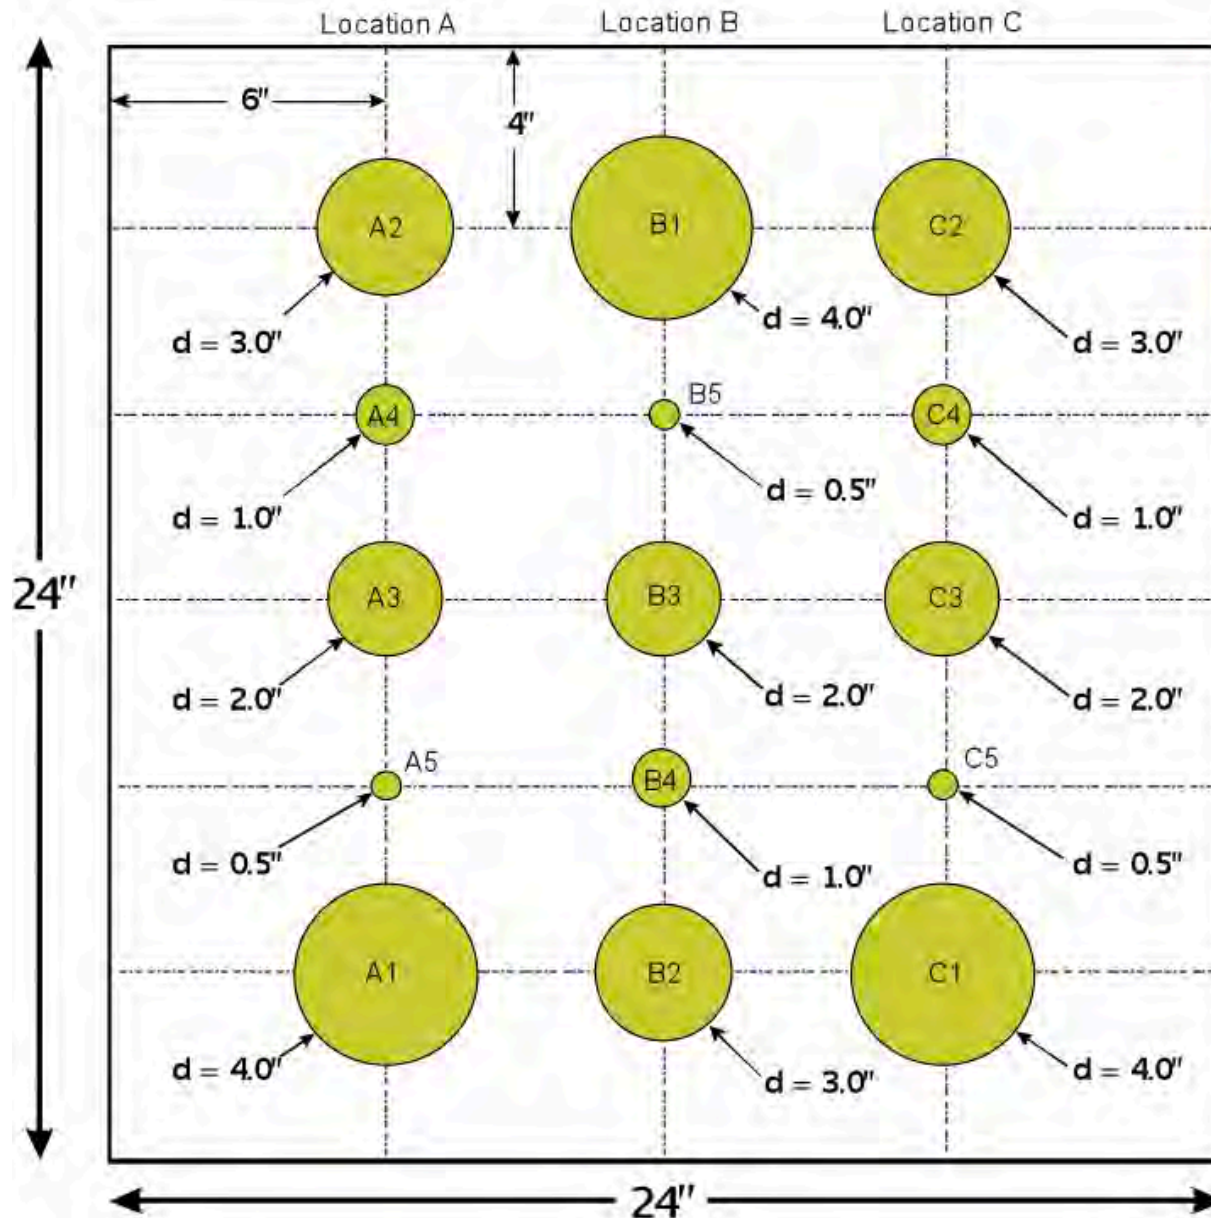
Simulated Delamination for NDE Study

1. Layout delamination disks on "peel ply" material and mark the centers of each circle.
2. Cut delamination disks 0.5" to 4" diameter from "peel ply" material.
3. Using spray-tac adhesive, position Location A disks on core material.
4. Using spray-tac adhesive, position Location B and C disks on reinforcement material.
5. Carefully position reinforcement stack on molding table for single side infusion

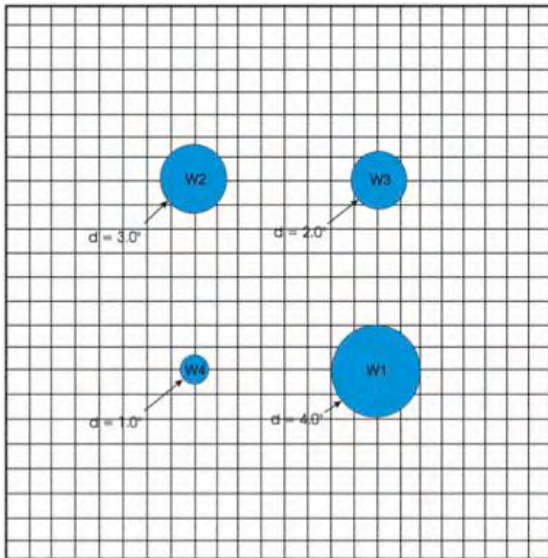
Panel with simulated defects (entrapped water) and IR image

IR image capture

- Heat is uniformly applied to area
- An infrared camera measures the reflected heat
- Defects have thermal properties that vary from the base material – voids may create heat buildup while water ingress will locally cool the area
- Ambient lighting/heating conditions can strongly influence infrared image – beware of surface reflections
- Analysis of heat rate-of-change can provide more detailed information about potential defects

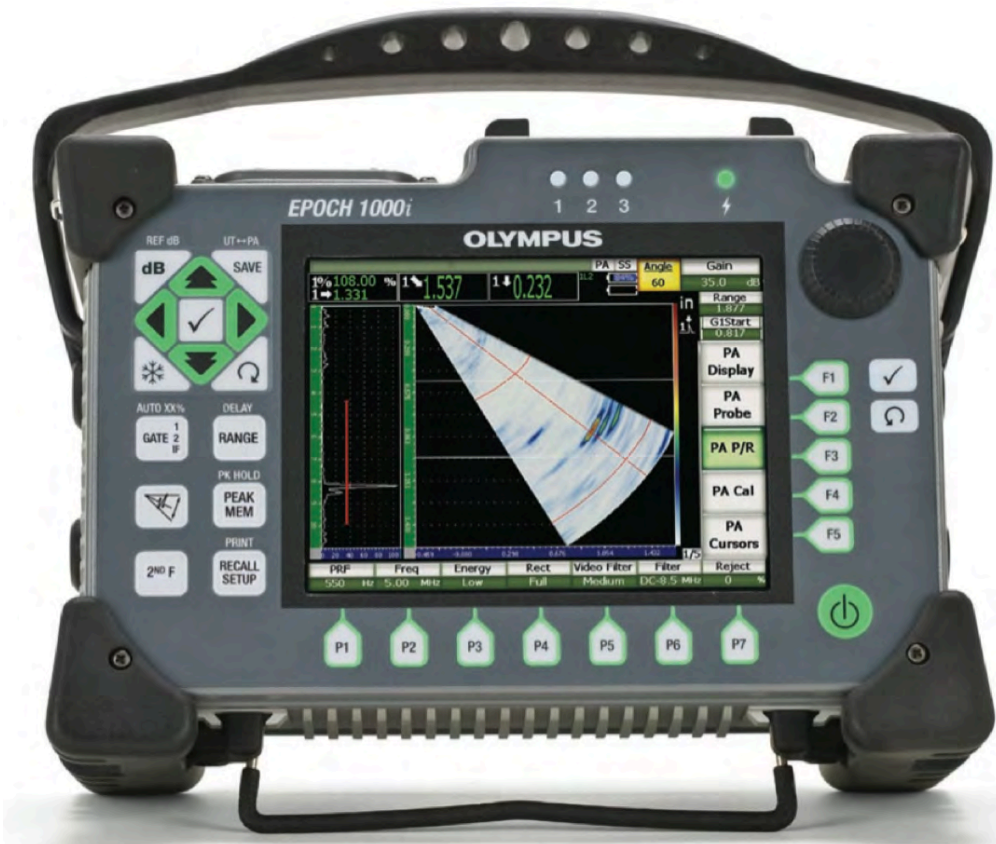
Olympus ultrasonic phased array flaw detector with simultaneous A-scan and S-scan display

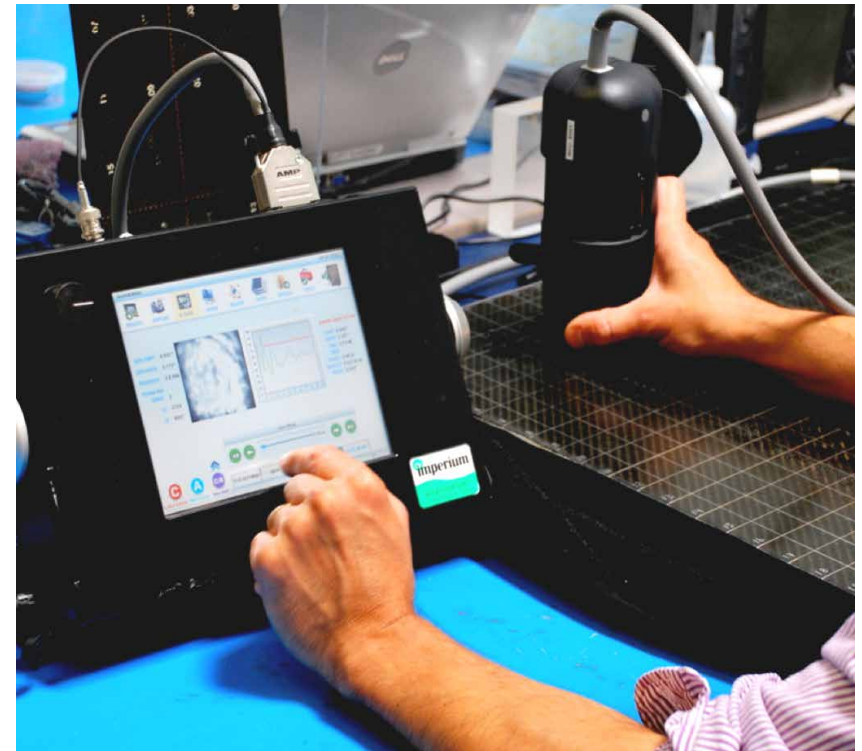
Imperium Acoustocam used to inspect test panel with simulated defects

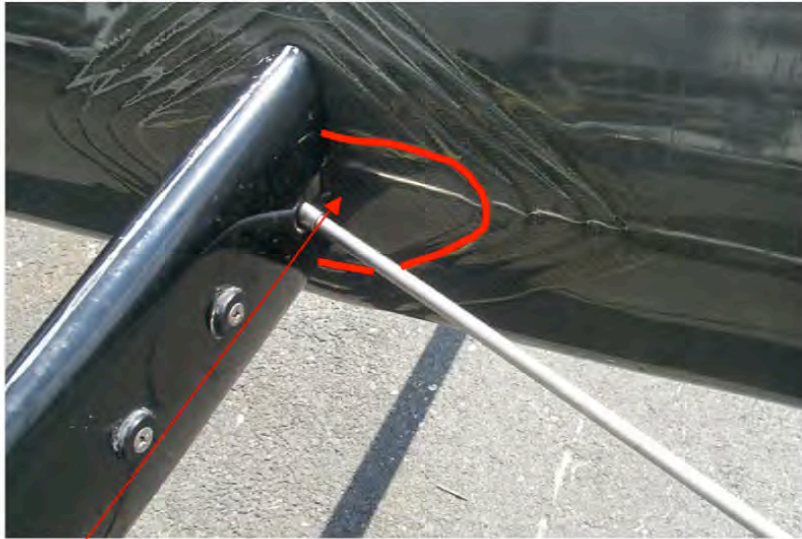
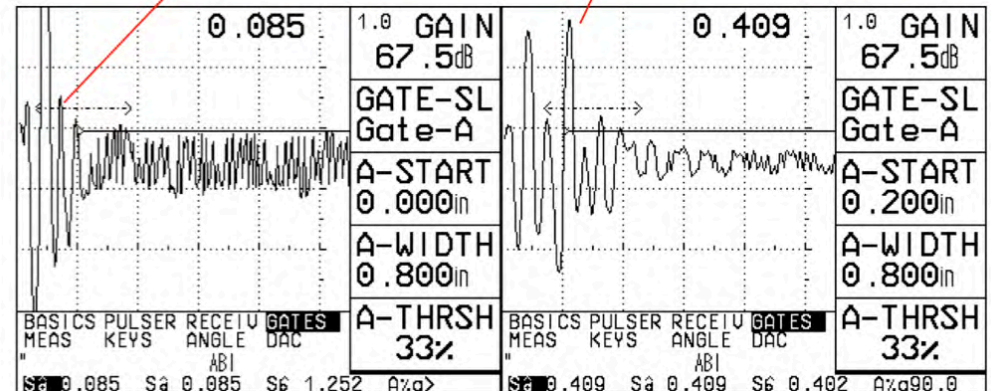
Ultrasonic Case Study

Carbon fiber mast struck by lightning examined with ultrasonic to find delamination below spreader (left) and delamination under first ply near masthead (right) [Bruce Bandos, 2002]

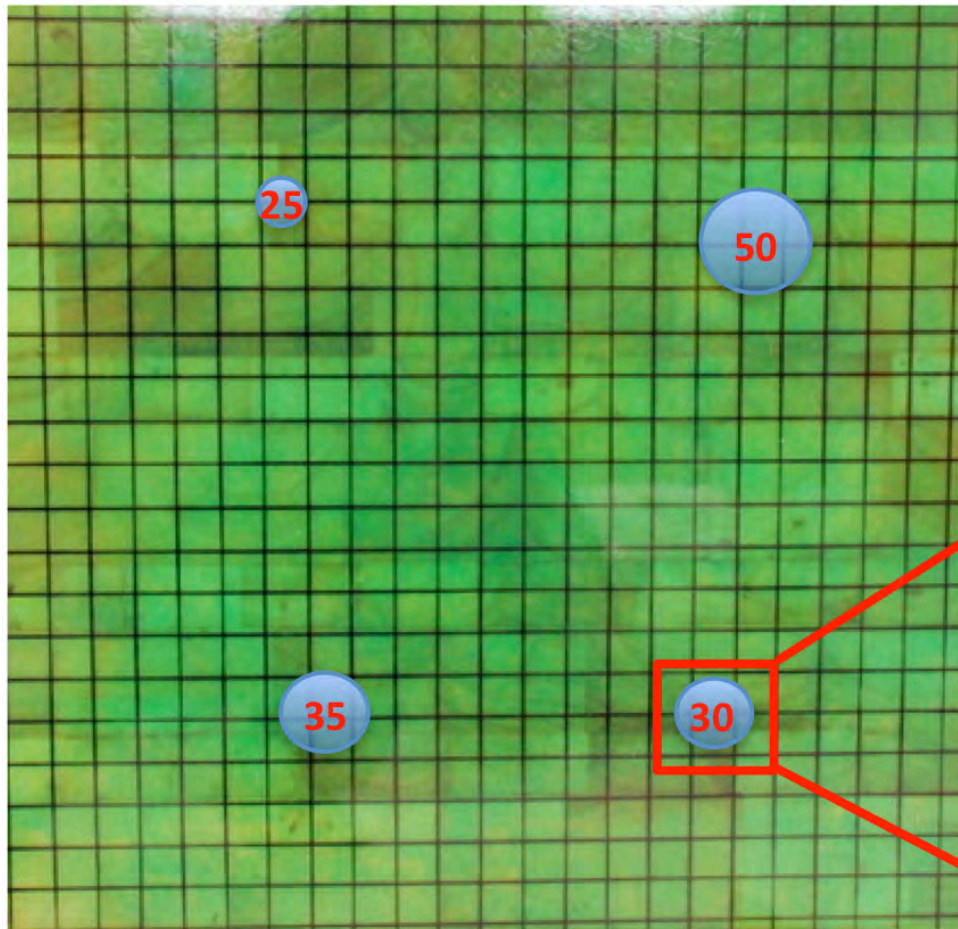
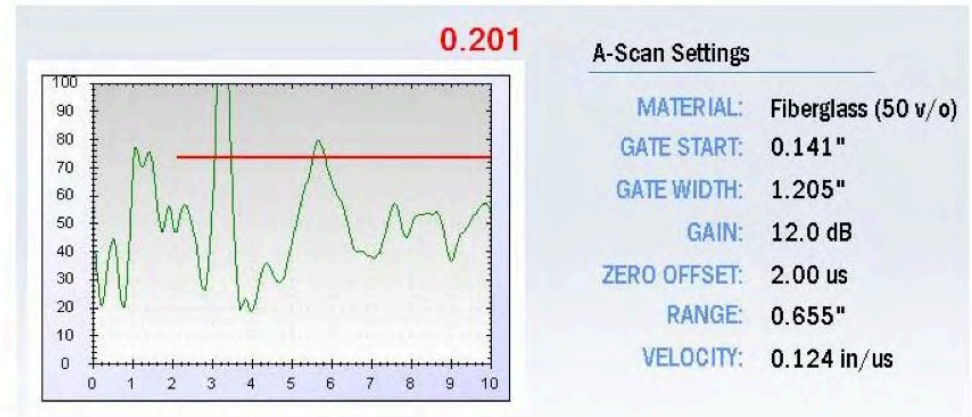
NDE Study Ultrasonic Test Results

Impact energies on E-glass laminate (left) and corresponding ultrasonic NDE data (right) [data courtesy of Imperium, Inc.]

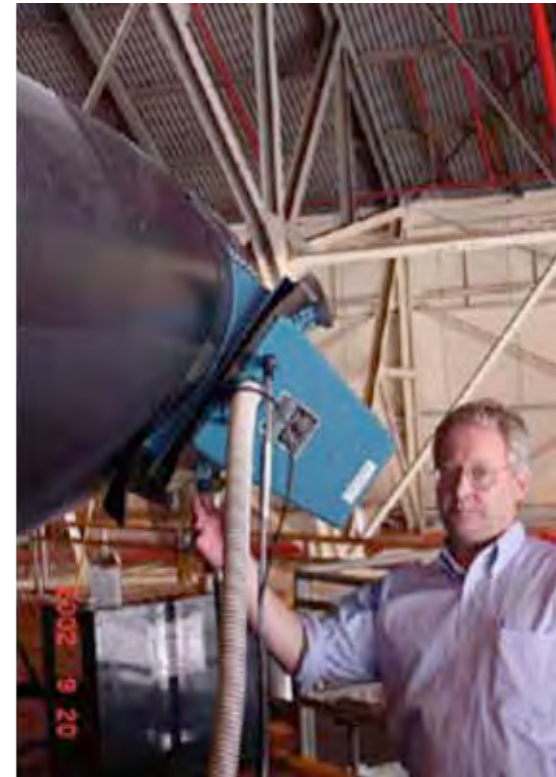
Laser Shearography

Shearography principal [Collrep 2006] and portable shearography device [Newman 2009]

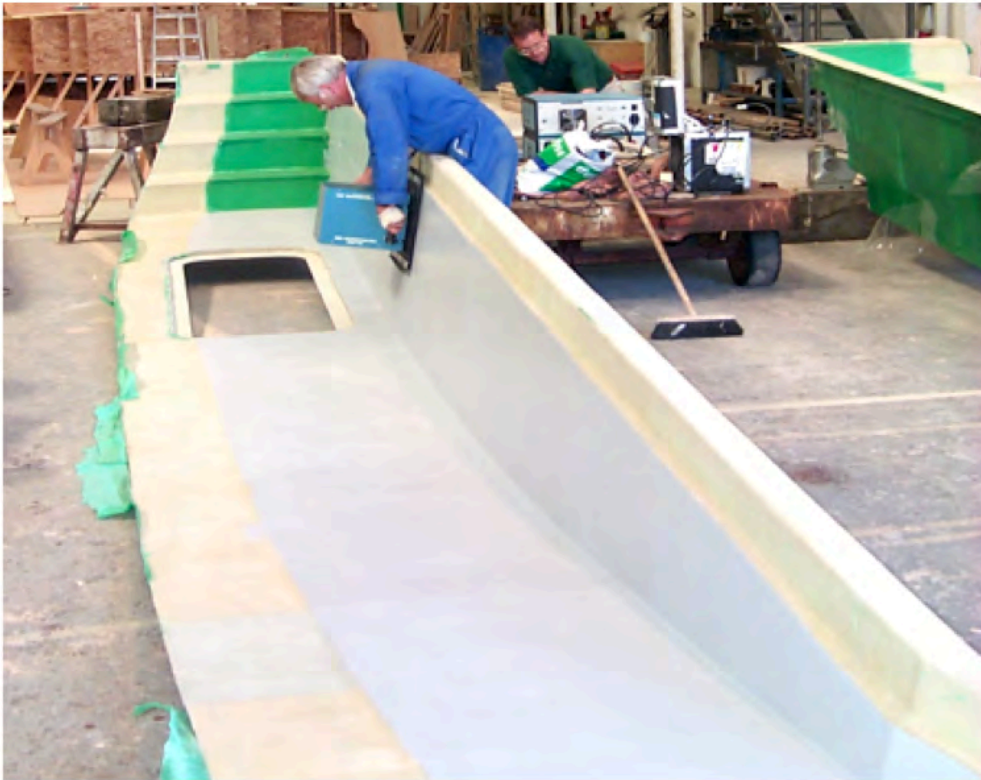
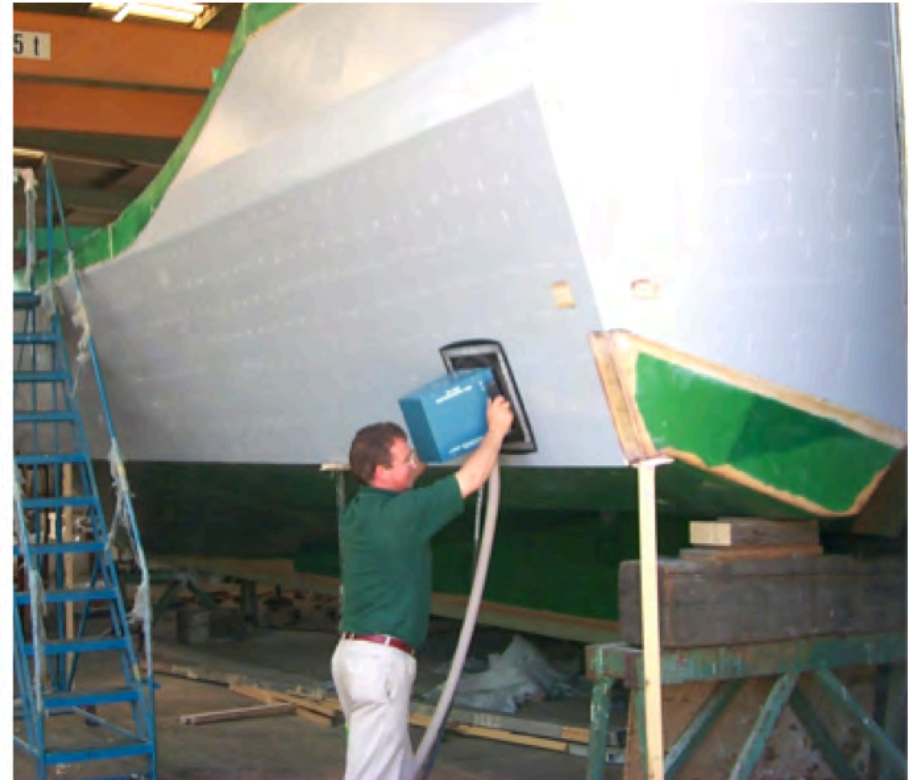
Laser Shearography

Laser shearography used to examine RNLI lifeboats [Laser Technology]

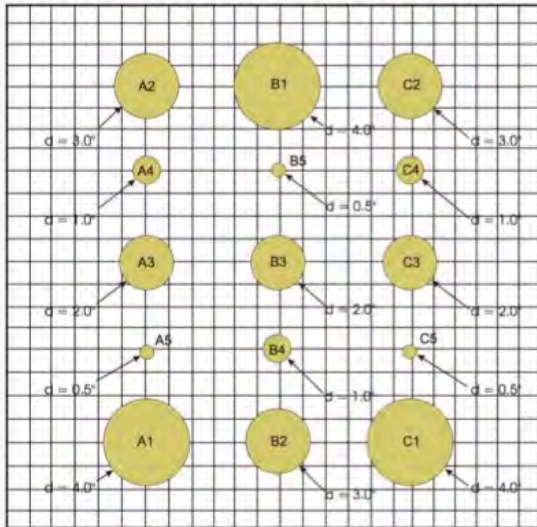
Simulated Defects

**Simulated
delamination (top)
and core shear
failure (bottom)**

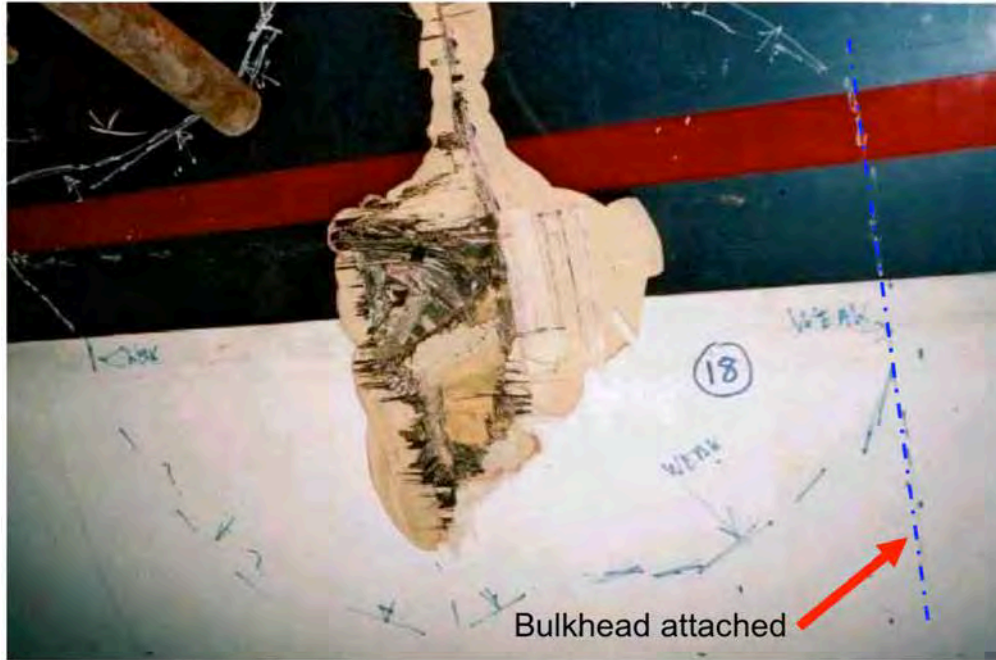
Full extent of impact damage
to hull sandwich construction
[Laser Technology, Inc.]

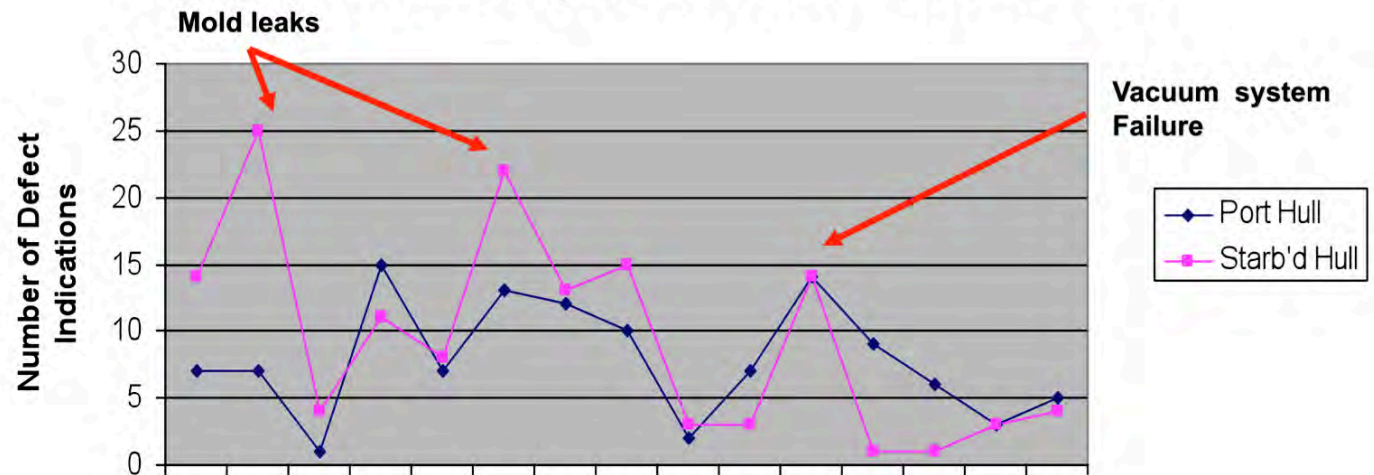
Number of defects per Hull Half - 1997 to 2001

RNLI Severn class detected
hull defects over time
highlights systematic process
failures during fabrication
[Laser Technology, Inc.]

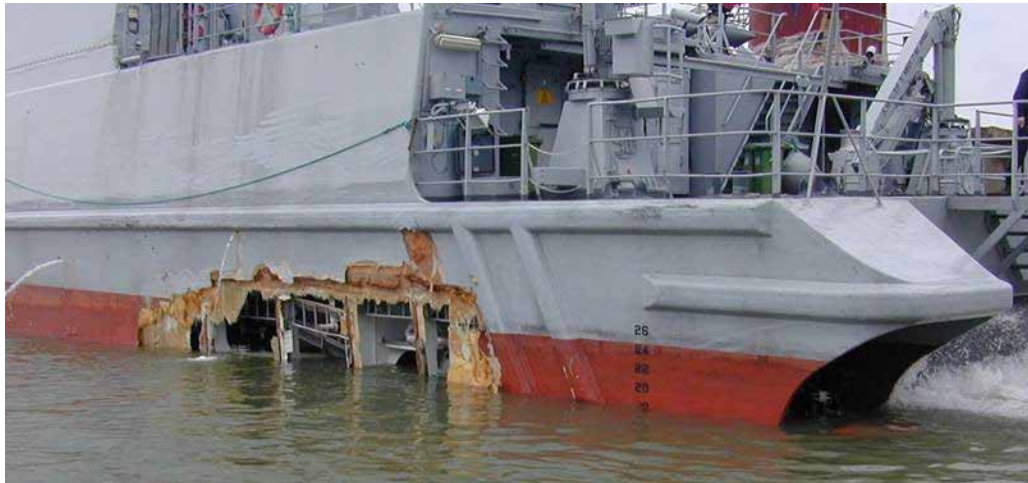
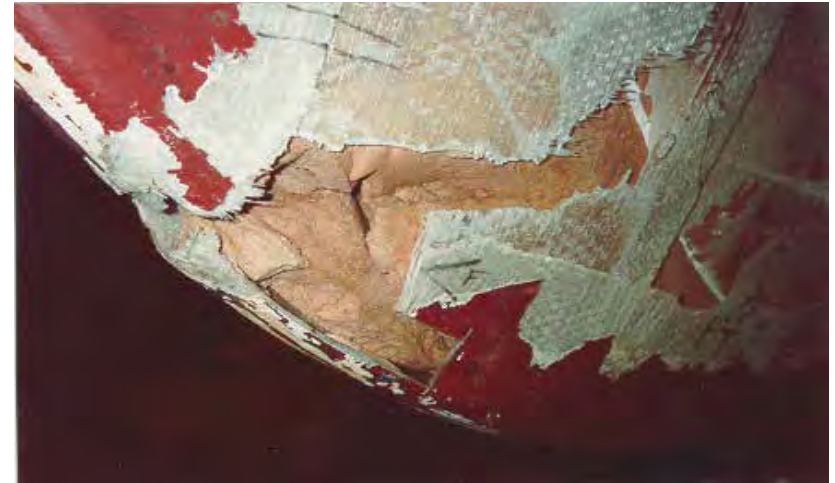
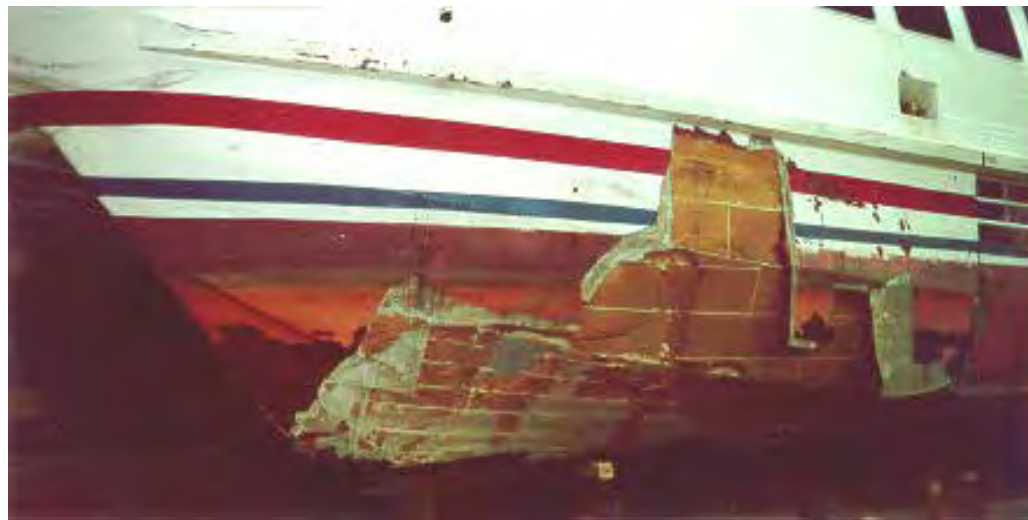
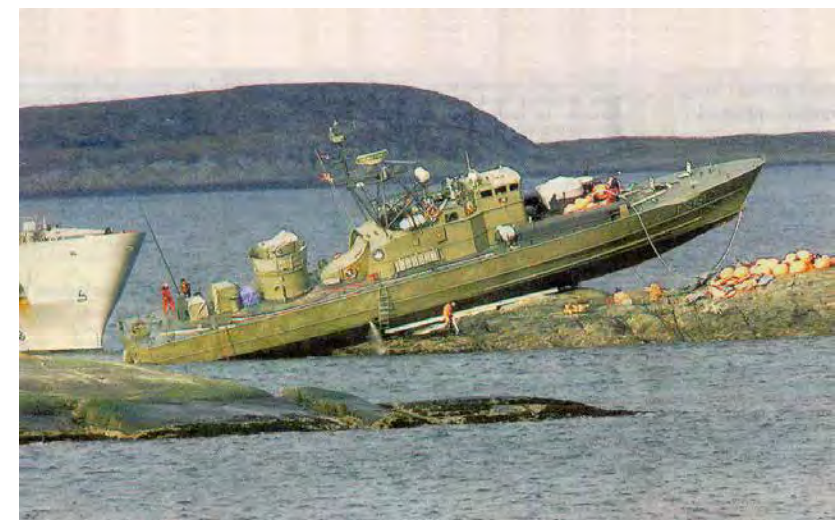
Mine Counter Measure Ship Collision with Dock

Christian Berggreen, Technical University of Denmark, 2008

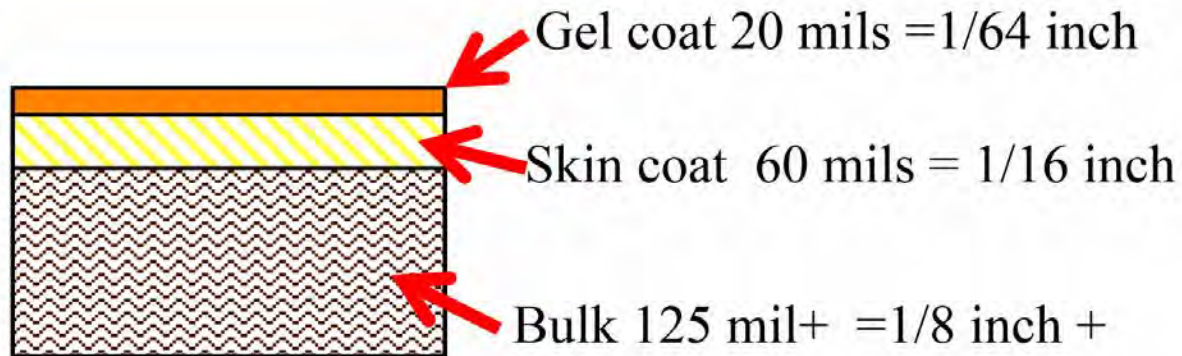
Recreational Boat Repair Guidelines

Depth of defect	Repair
Less than 1/32 inch	gel repair
Less than 1/16 inch	putty
Greater the 1/16 inch	laminare

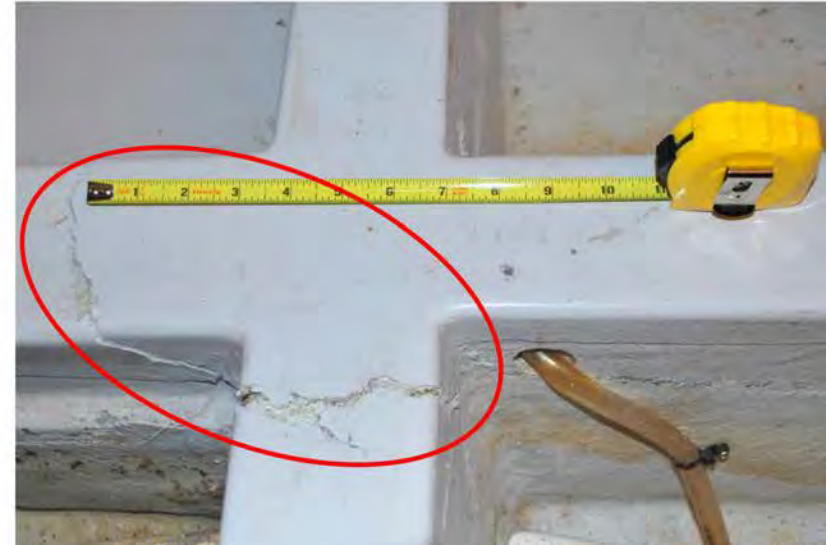
2

1. Grind laminate 9" beyond detected damage
2. Repair with structural laminate up to 16 layers for full thickness

Framing Repairs

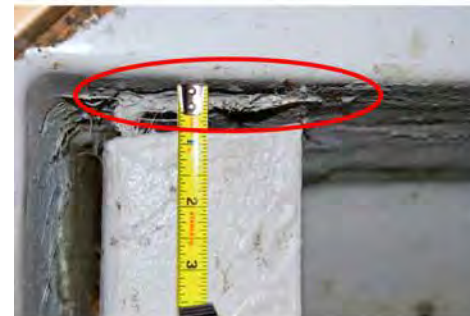
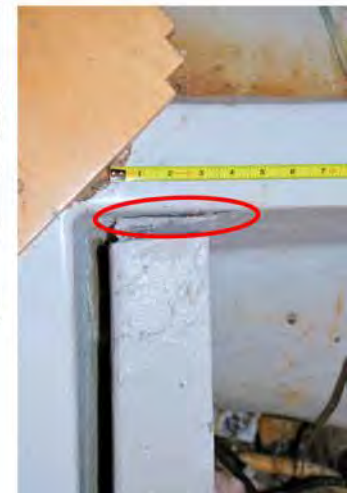
5

1. Grind laminate 4" beyond detected damage
2. Create corner radius with structural putty
3. Repair tabbing with E-BXM 1708/E-LTM 1808/E-BXM 1708 with 1" taper (smallest first)

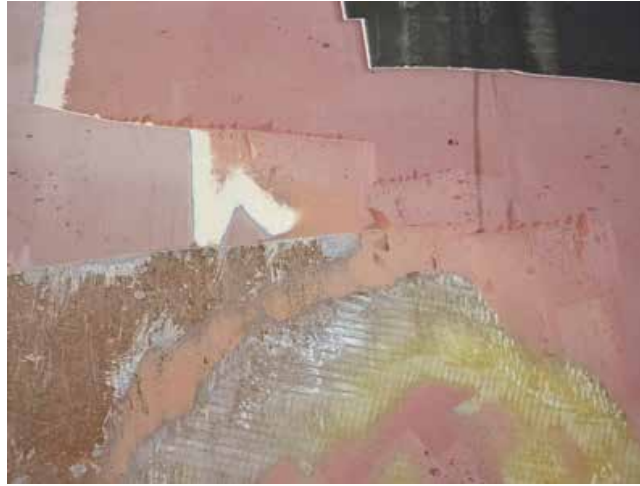
Multiple layers of existing fairing

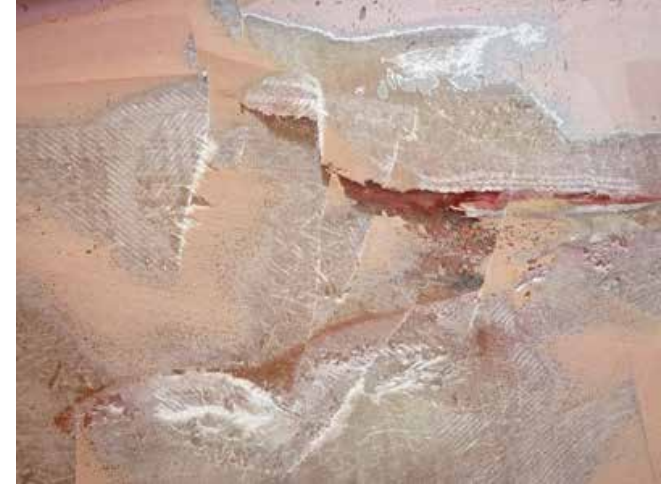
Delamination

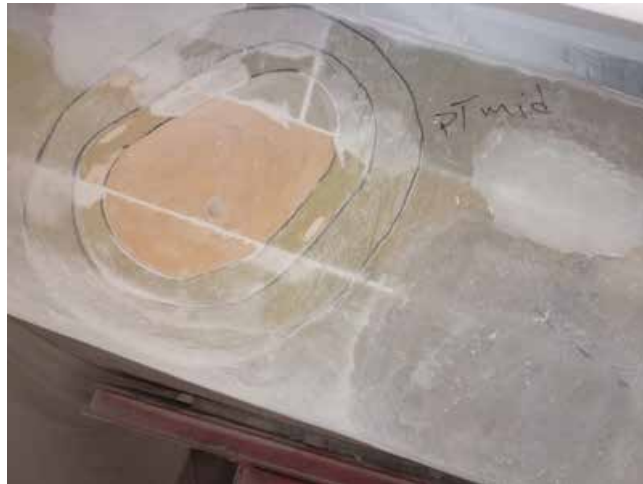
Mark area for repair reinforcements

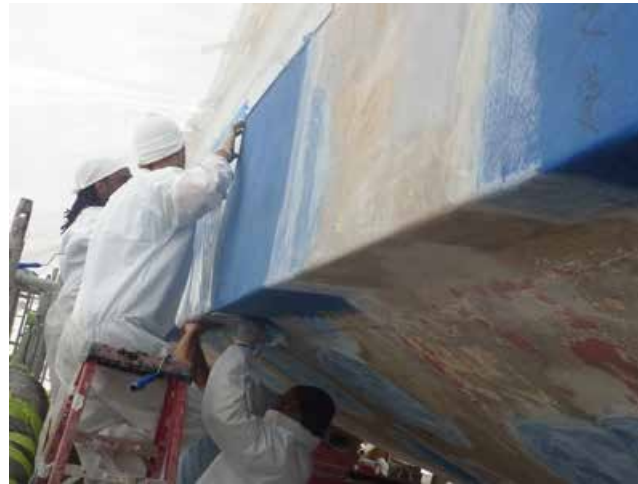
Waterline lamination in progress

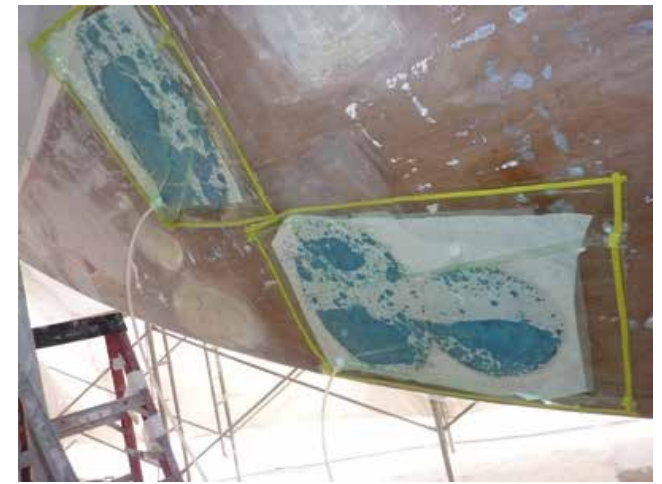
Using vacuum bags to consolidate repairs

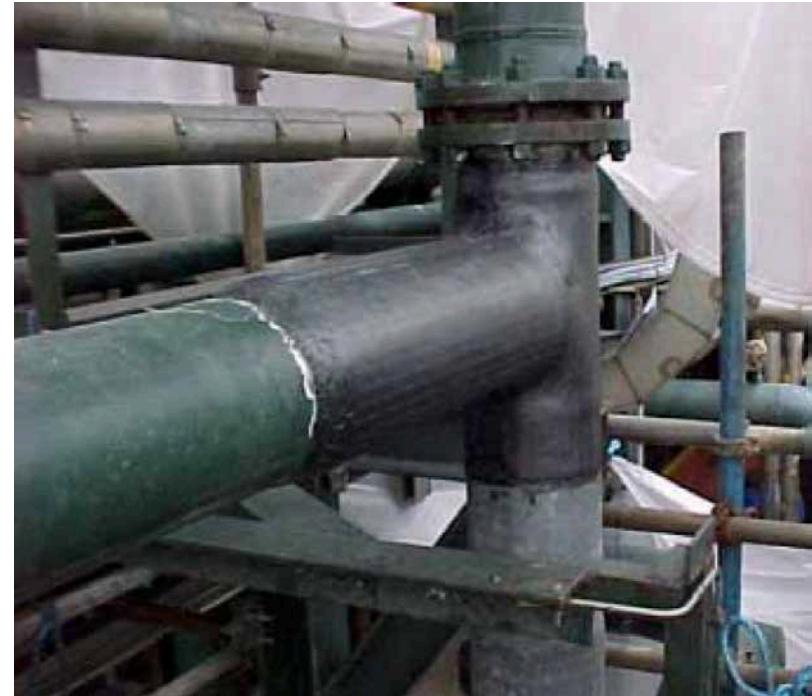
Carbon fiber repair of 14 inch tee joint on a seawater return header
