# Marine Composites

Webb Institute  
Senior Elective

## Environmental Degradation

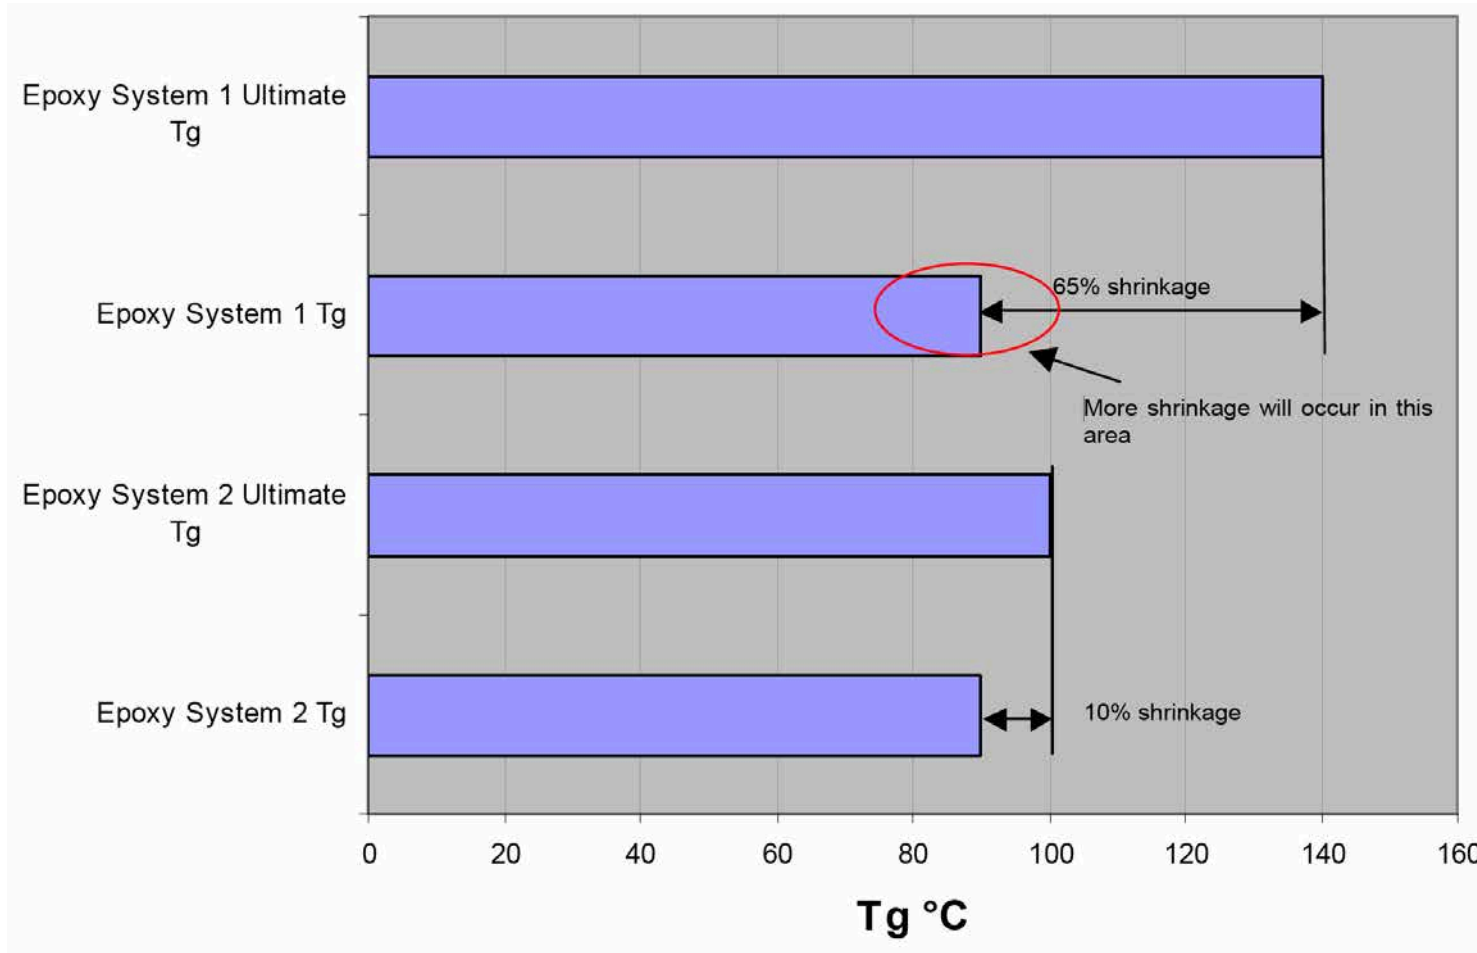
If epoxy system 1 is exposed to temperatures just over 90°C a higher level of shrinkage will occur compared to epoxy system 2. This is because 90% of the cure has taken place, as cure has an exponential relationship less physical shrinkage will occur in the last 10% of cure.

Epoxy system 1 has an ultimate Tg 140°C and epoxy system 2 has an ultimate Tg 100°C, both systems have been post cured to gain a Tg of 90°C.

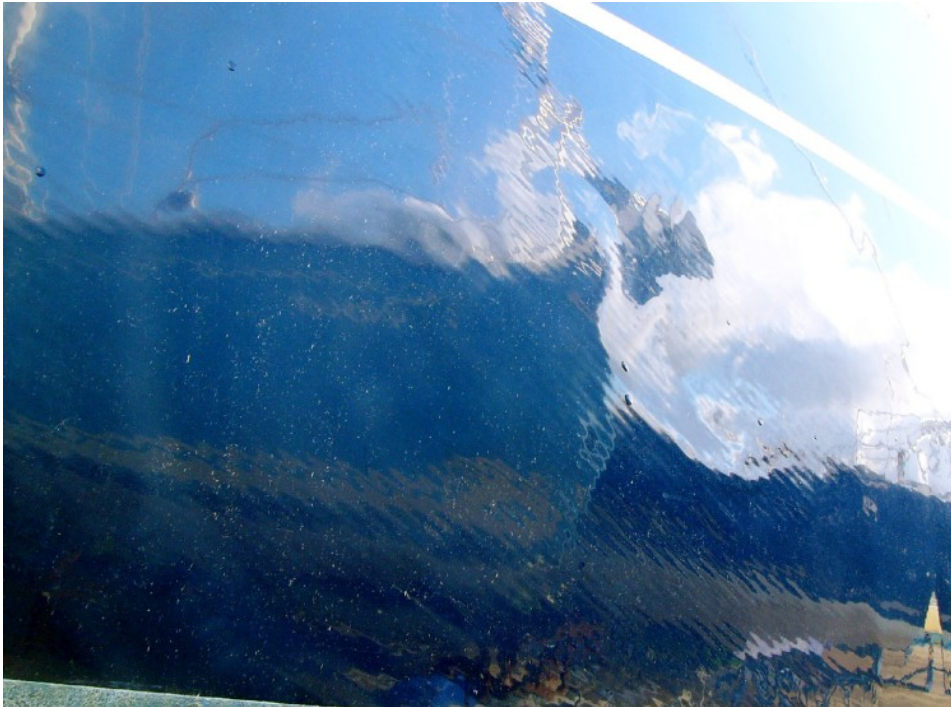
Typical reinforcement print-through problem when dark laminate “post cures”

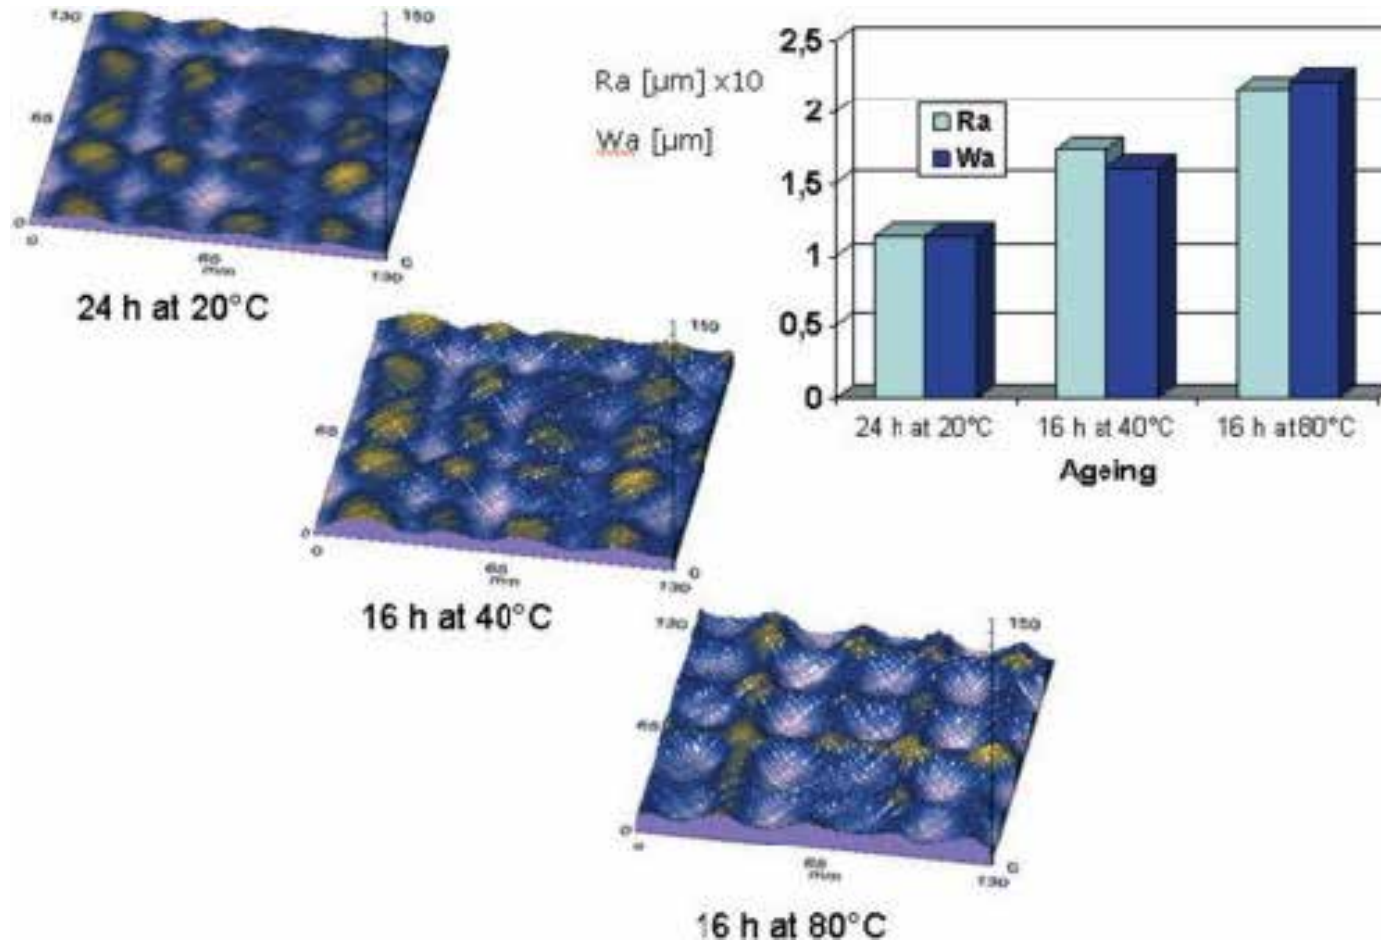
Exaggerated 3D-views from the same surface area after different ageing steps. Corresponding Ra (roughness average) and Wa (waviness average) values are displayed on the right. The size of the measured area was 130 by 130 mm.

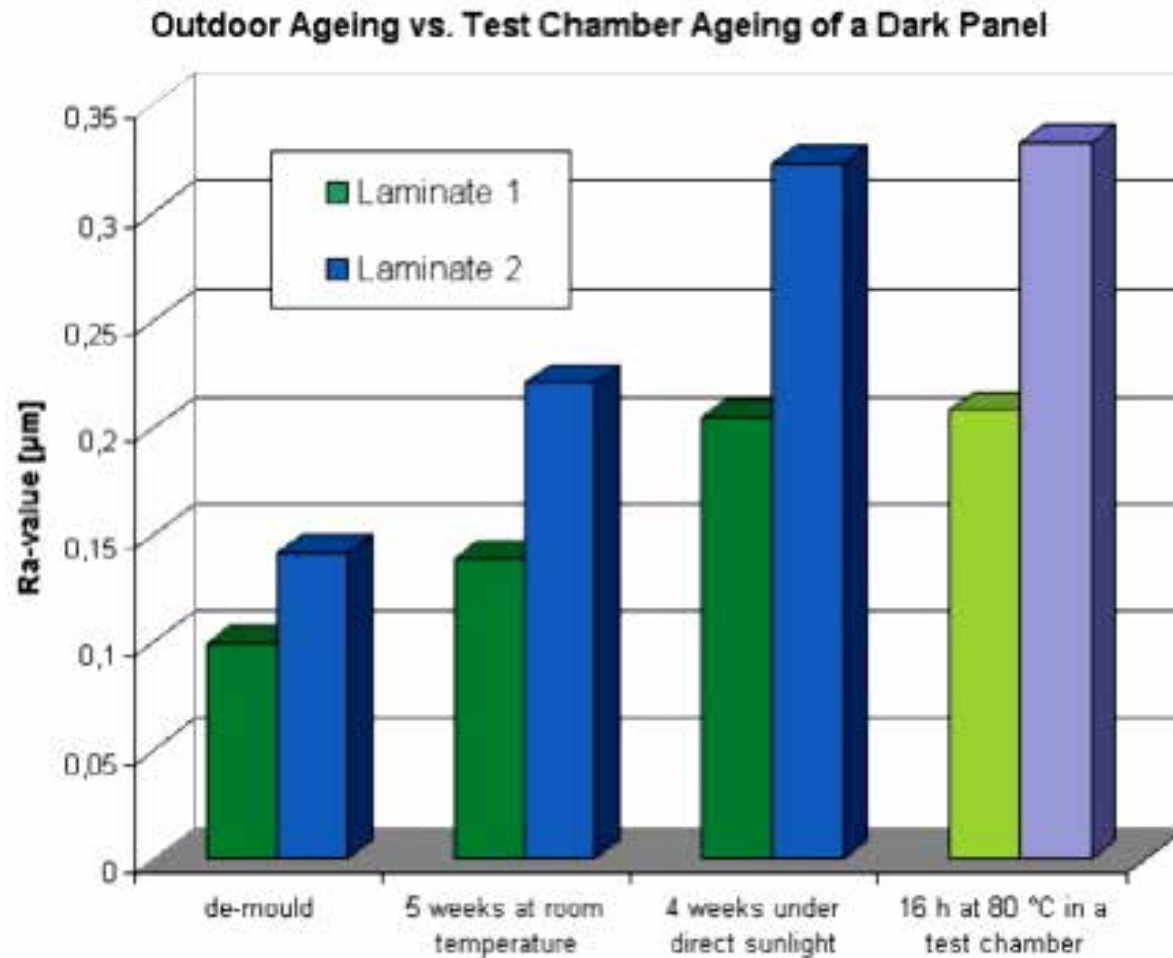
Comparison between outdoor and test chamber ageing. Two different laminates showed similar change in Ra-value with both ageing methods.

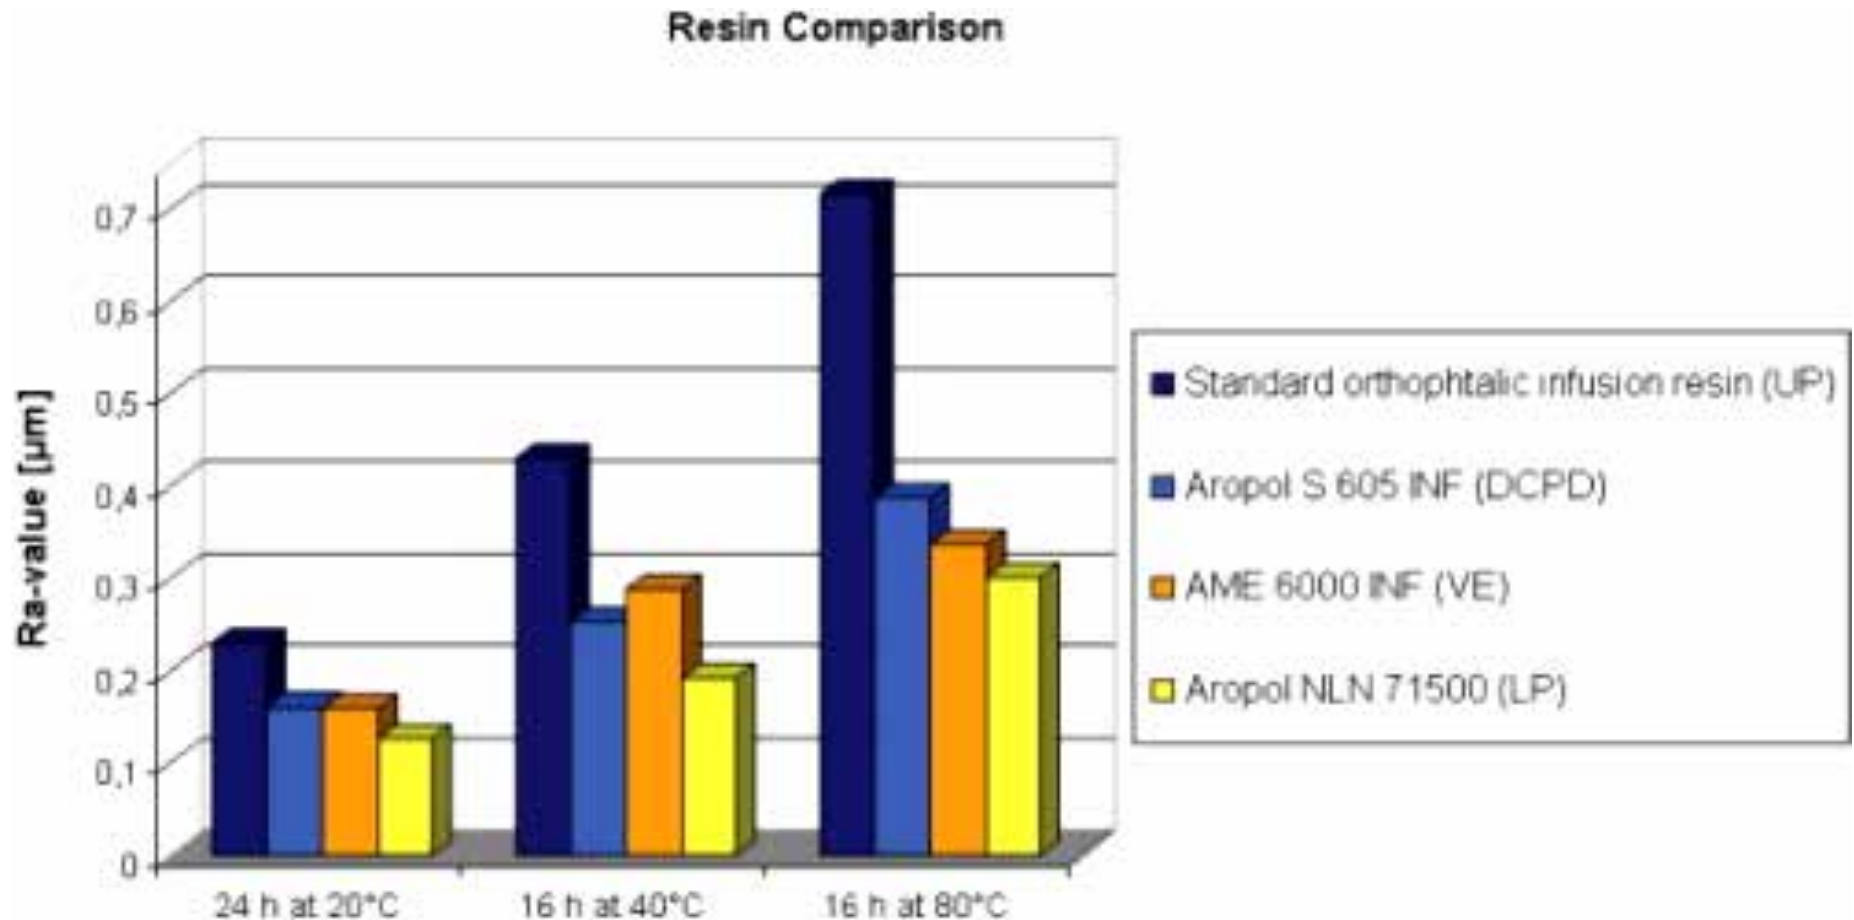
Different resins showed different surface quality properties. Note, in resin comparison all laminates were made without using a surface improving layer (skin or barrier coat).

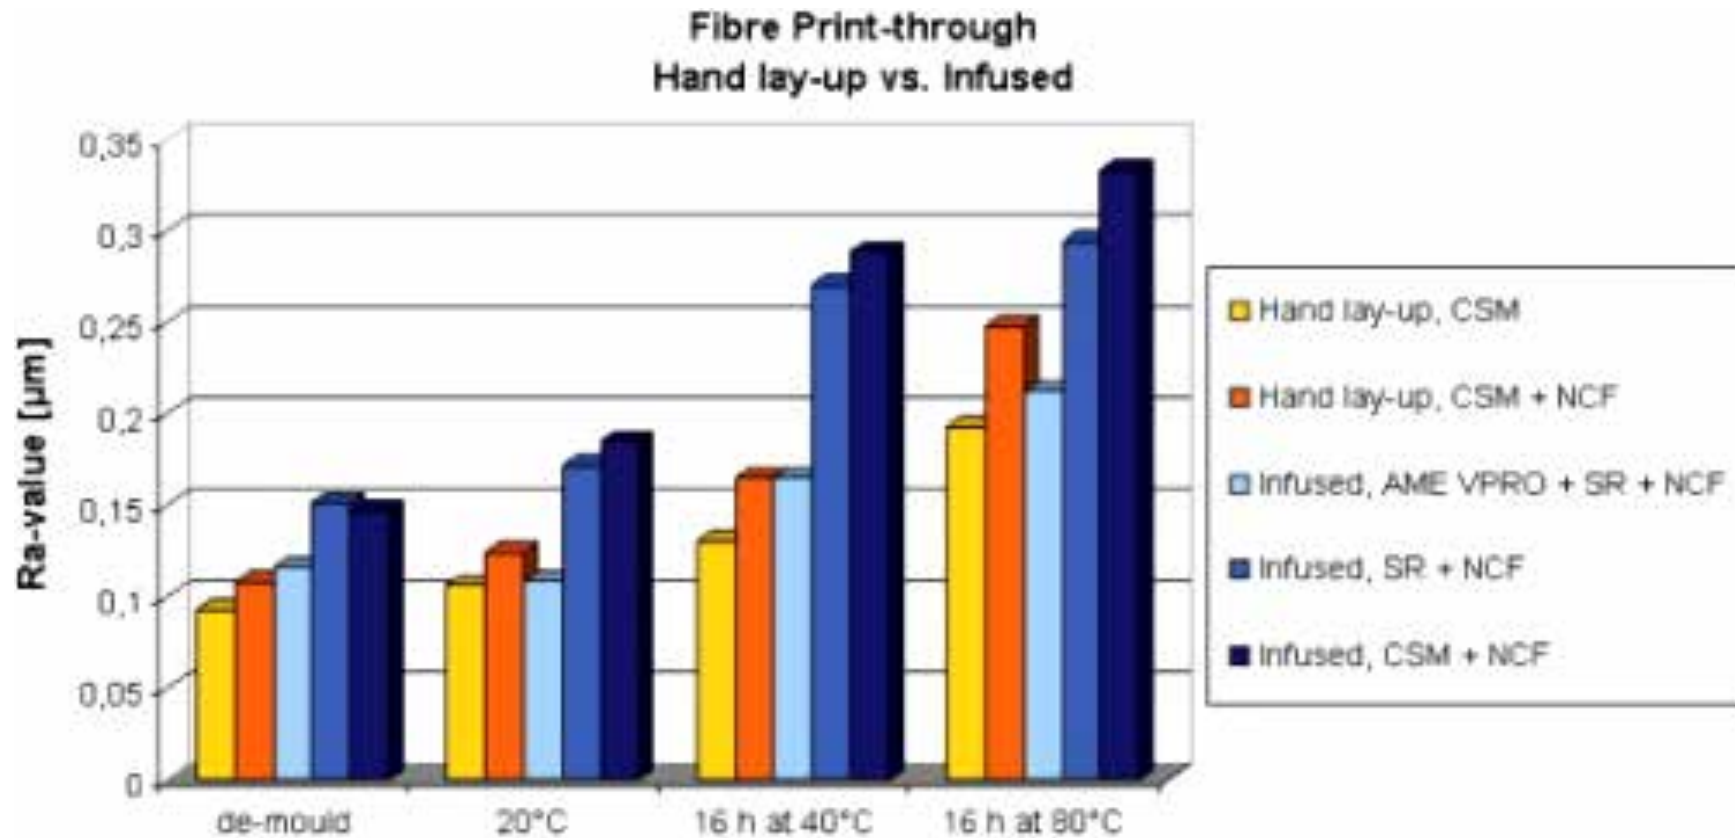
Influence of various reinforcement types and lamination methods on surface quality. Note that 2nd and 5th column consist of similar reinforcements.

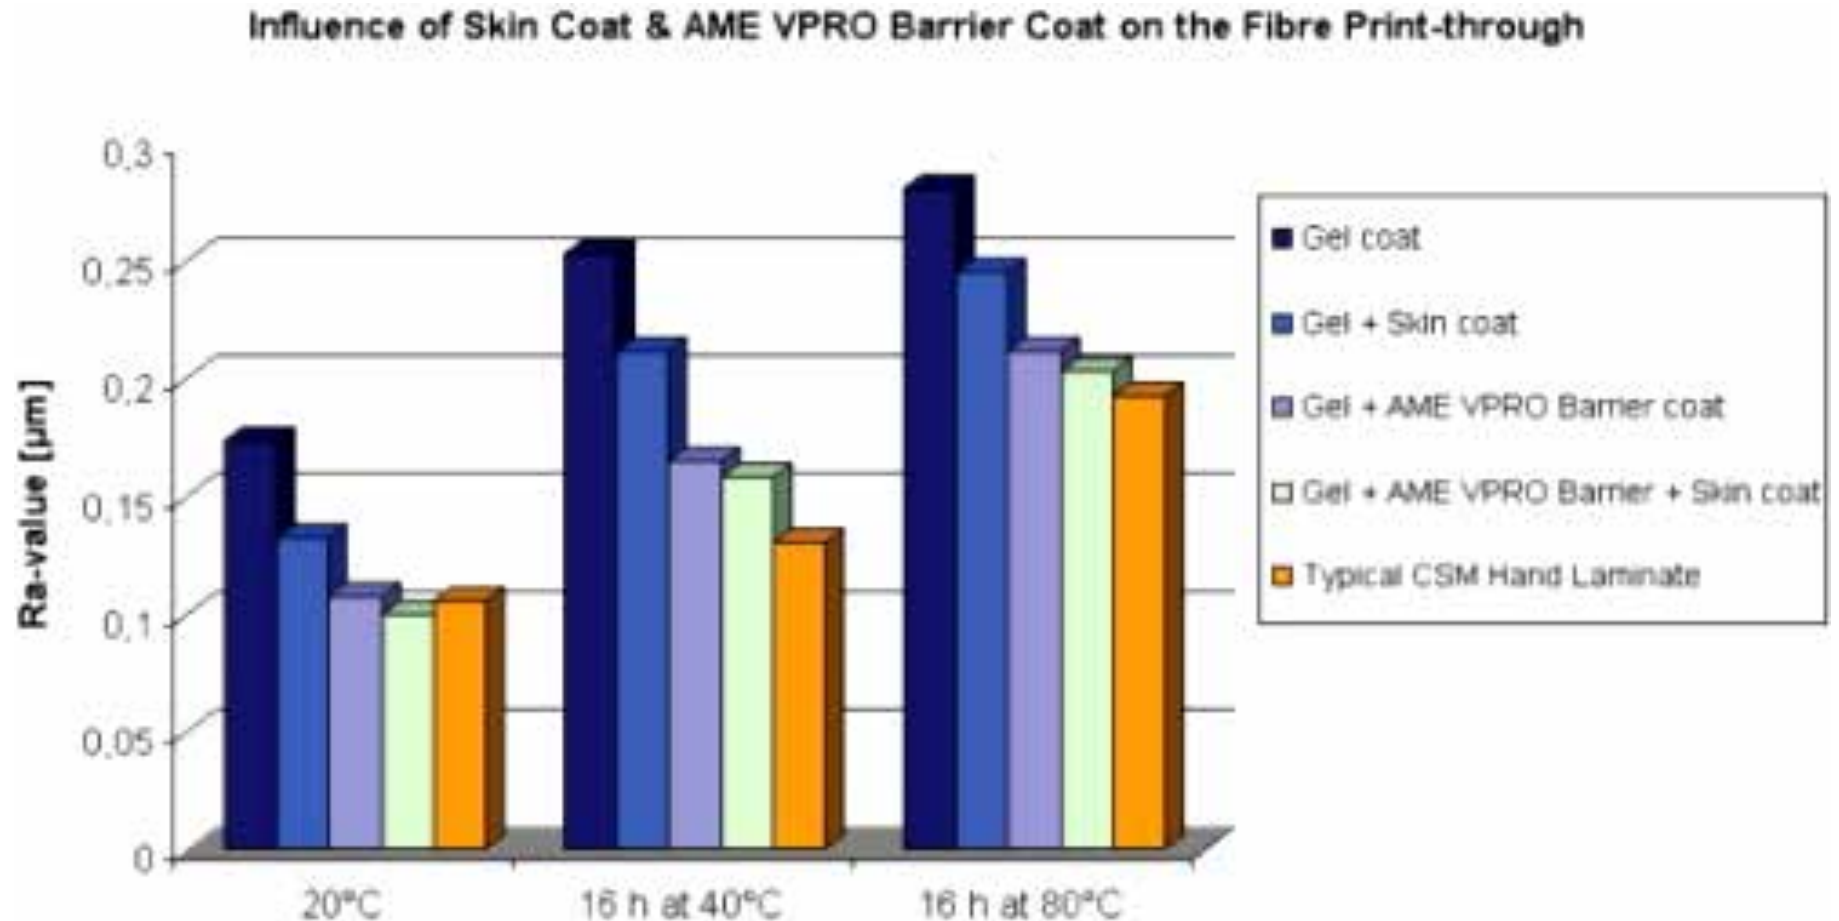
Both skin and barrier coats lowered the fiber print-through. The surface quality of AME VPRO barrier laminate was eventually close to a typical CSM hand laminate level.

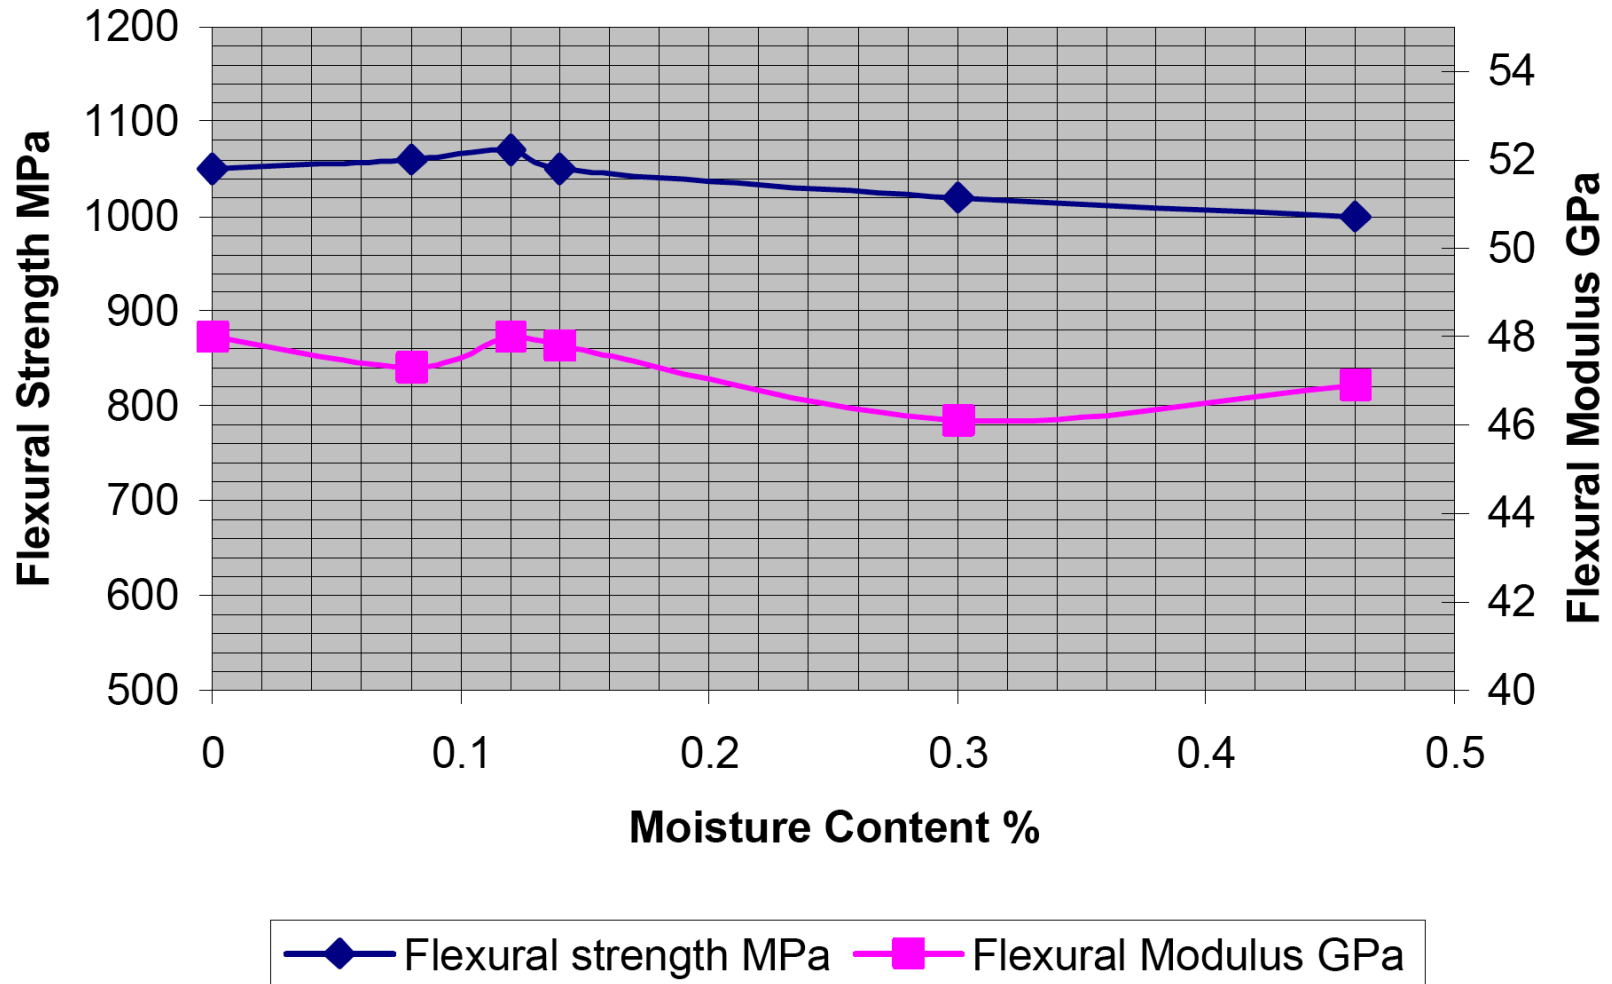
## Effect of Moisture Content on Flexural Strength and Modulus

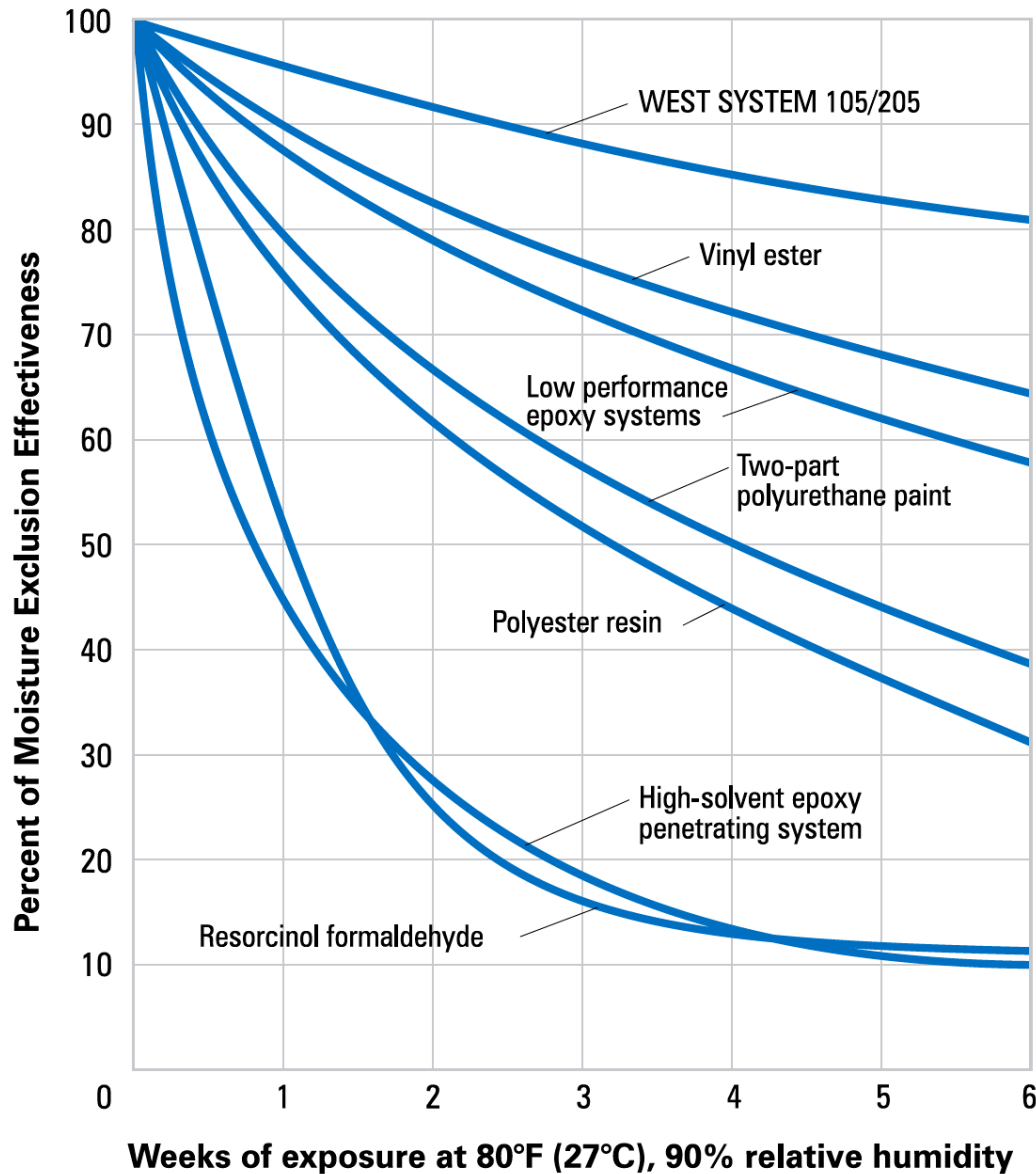
**Moisture exclusion effectiveness (MEE) of various marine materials. Comparison of three coats of each material.**

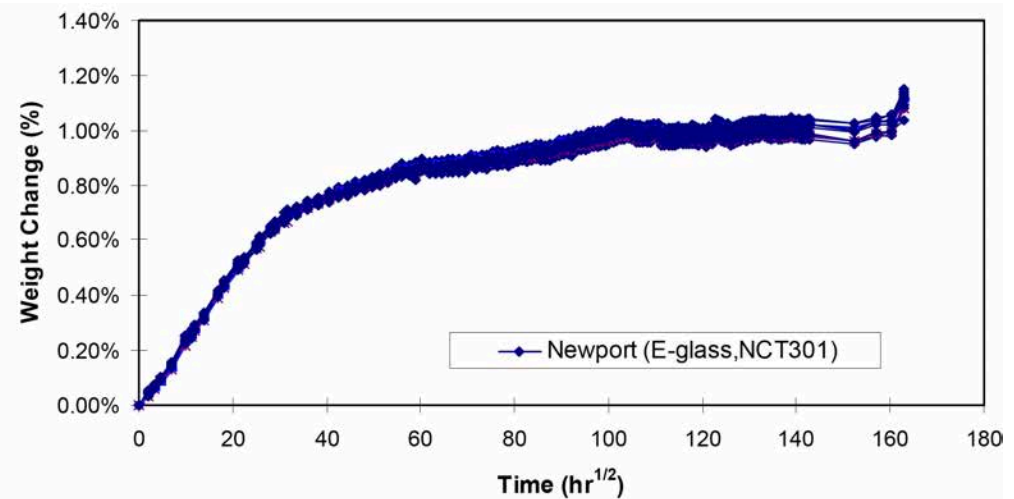
Four years weight-gain data for E-glass/NCT301 coupons immersed in simulated seawater

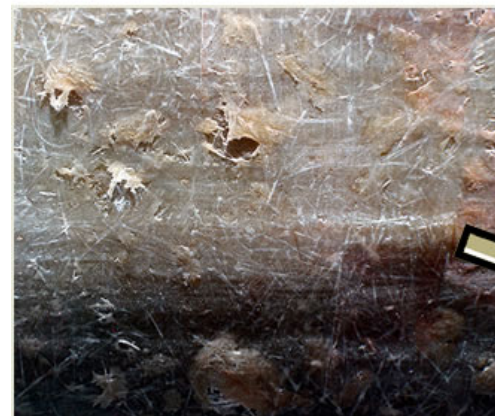
**Formation of blisters**

- ① Air blisters
- ② Water take up
- ③ Formation of blisters
- ④ Increase of blisters
- ⑤ Cracking of Gel Coat

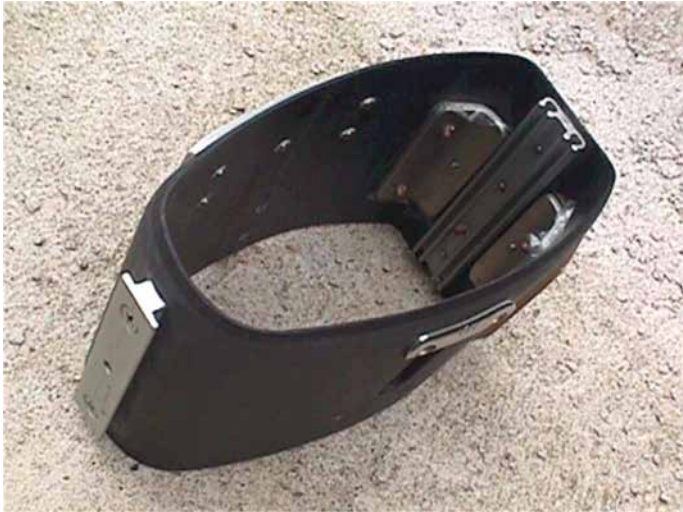
A portion of a carbon fiber mast is shown with metal couplings attached to it

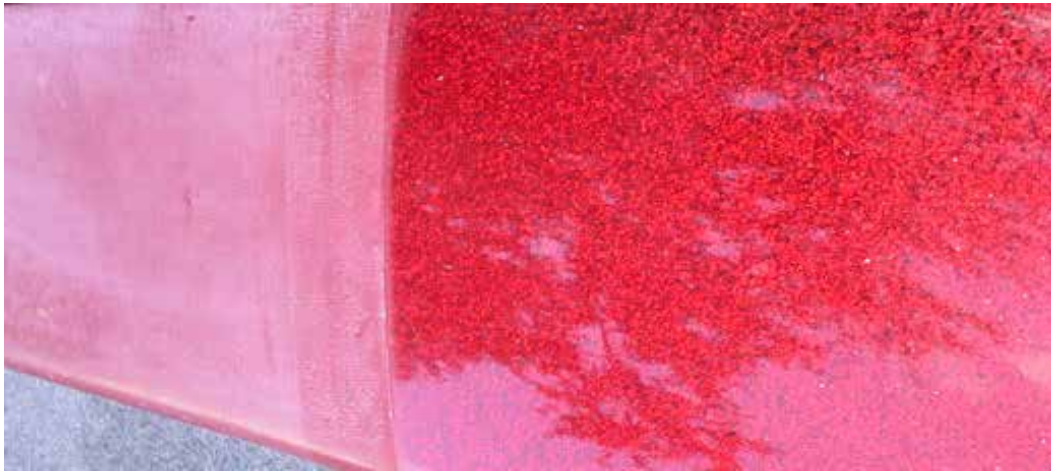
UV damaged (left) and restored gel coat (right)

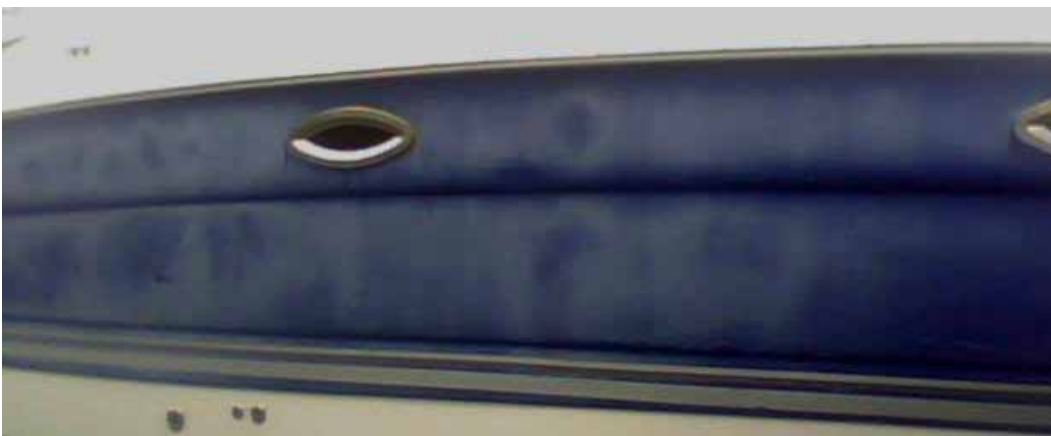
Typical whitening of colored gel coat

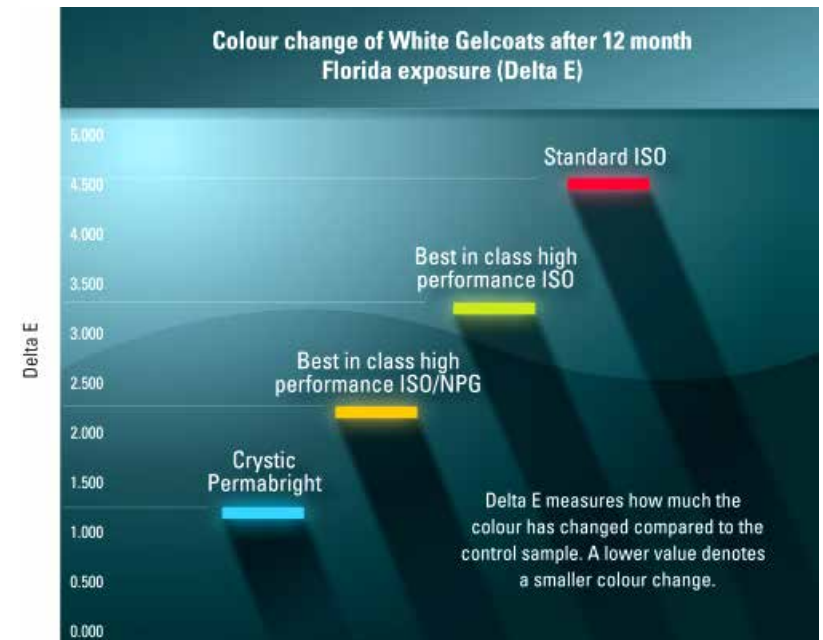
Scott Bader Crystic marine gel-coat claims improved color stability and UV weather resistance

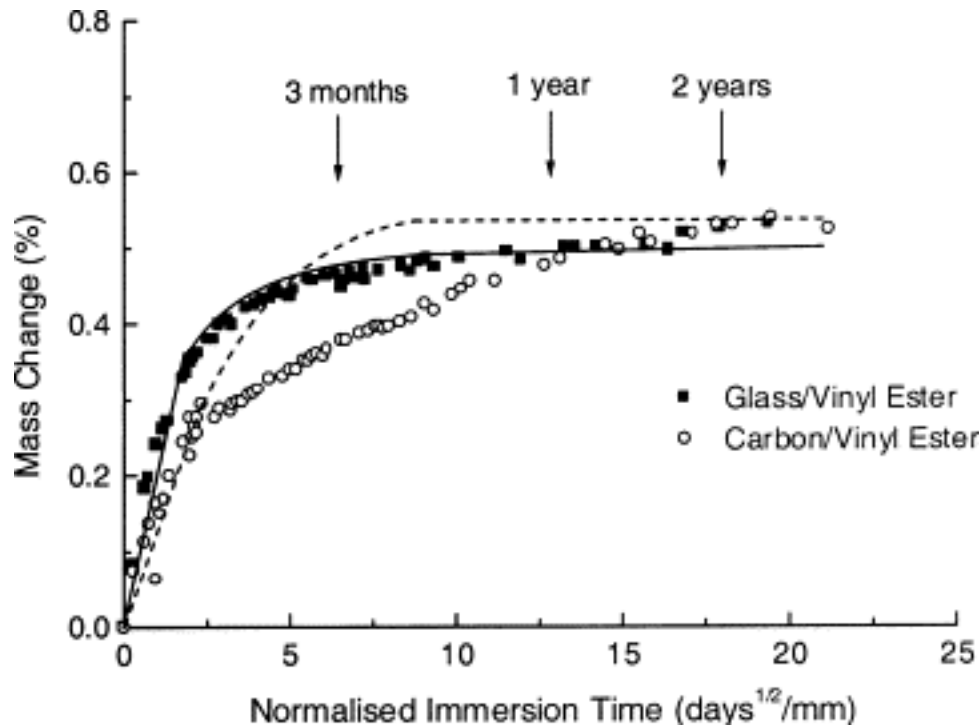
Water uptake curves for the vinyl ester-based composites

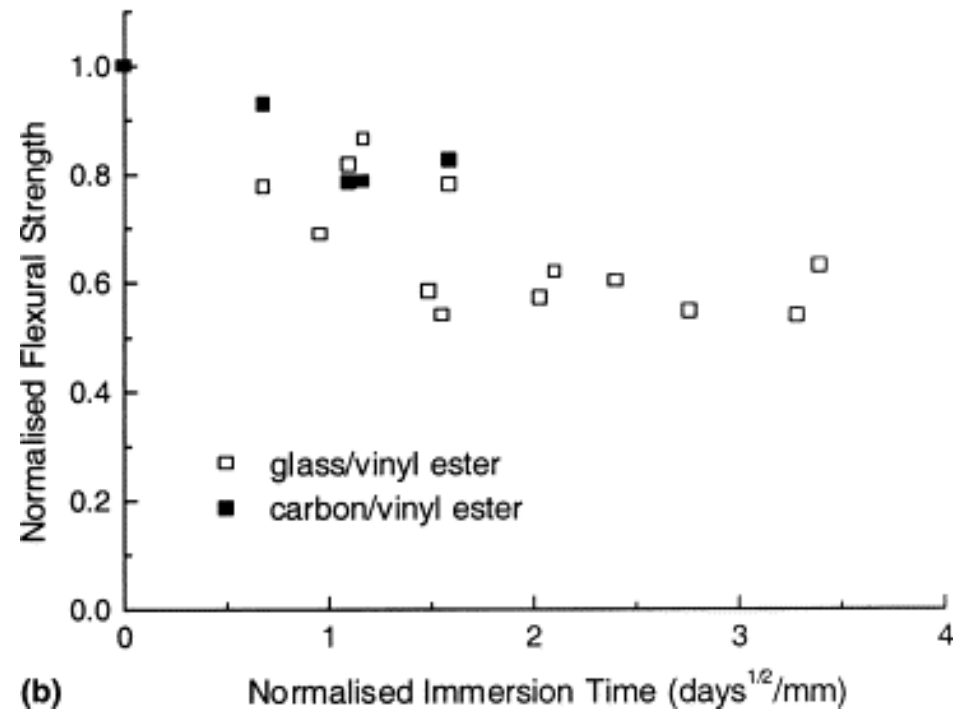
Effect of seawater immersion time on the normalized on flexural strength of the vinyl ester-based composites

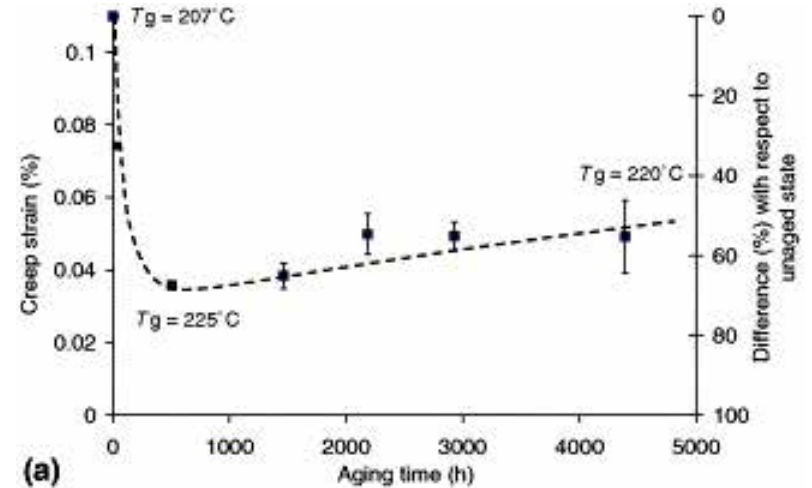
Creep tests on  $[\pm 45]_{4s}$  laminate: creep strain after 1000 s versus aging time at 180°C: (a) creep tests at 40 MPa; (b) creep tests at 60 MPa.

*Viscoelastic behavior, thermo-mechanical damage and degrading resulting from physical and chemical aging can be analyzed in a multi-scale model.*

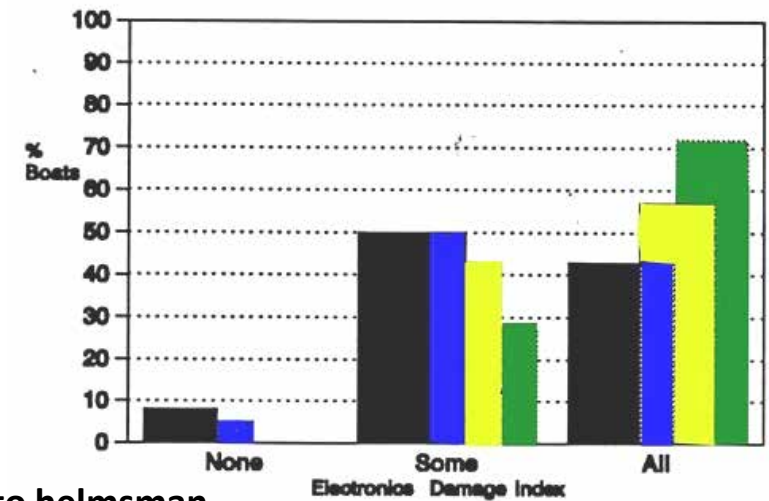
Proportion of boats struck by lightning suffering electronics damage of varying degrees
