Marine Composites

Webb Institute
Senior Elective

Impact Damage

Eric Greene, Naval Architect

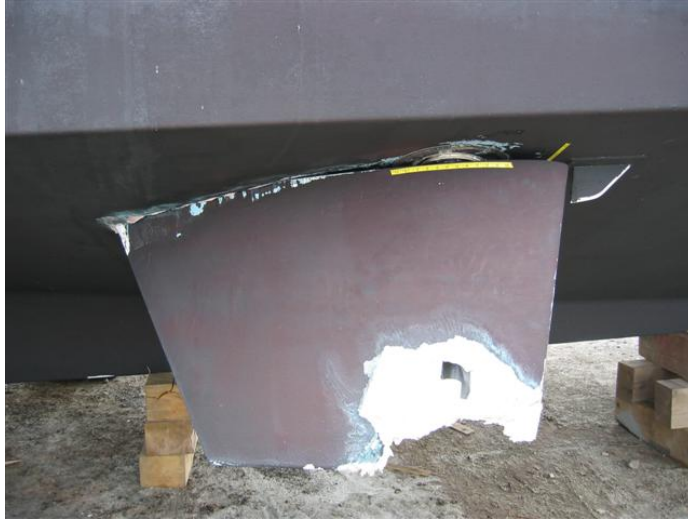
Roll stabilizer damaged after grounding (top) and resulting hull damage (below)

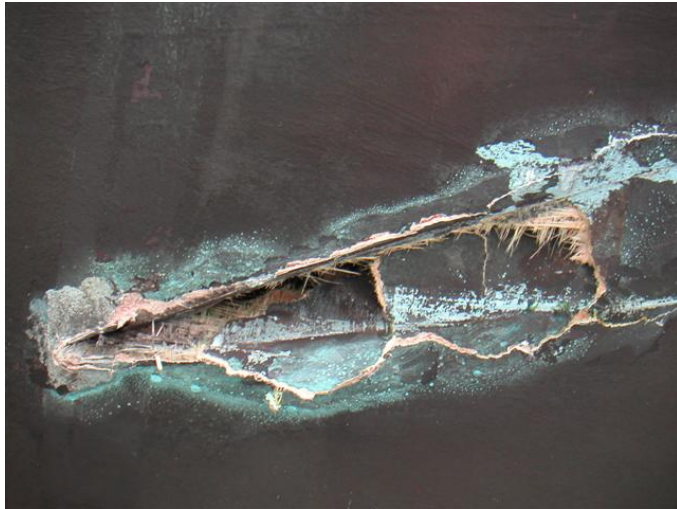
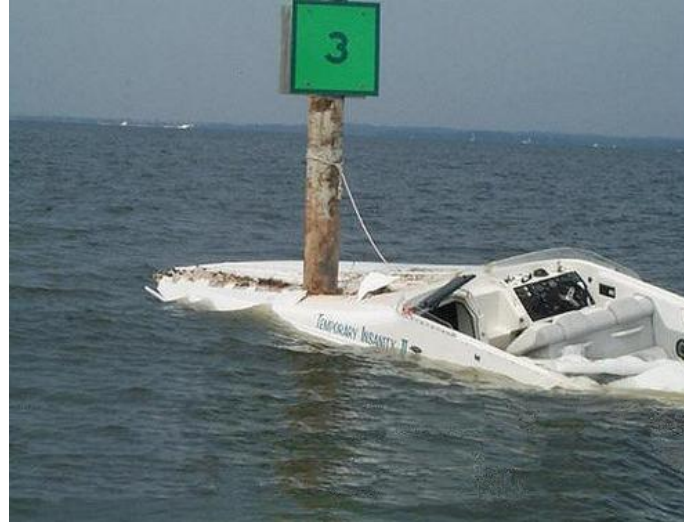
Just before 2 a.m., a 1992, 38-ft. Fountain power boat slammed into a fixed, channel marker, ripping a 17-ft. gash in the forward hull & becoming impaled on the steel piling holding the channel marker.

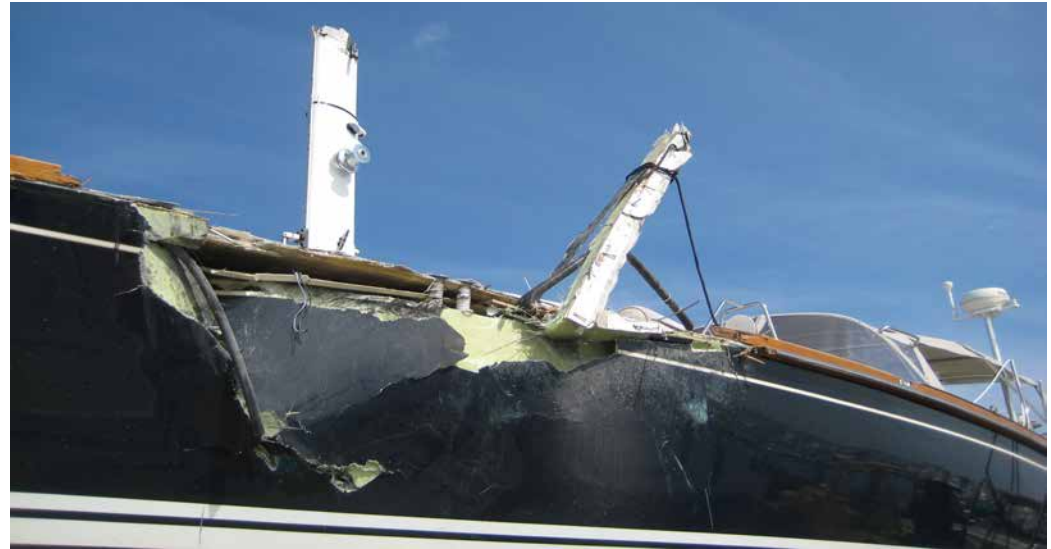
Sailboat hit by powerboat on autopilot in the open ocean

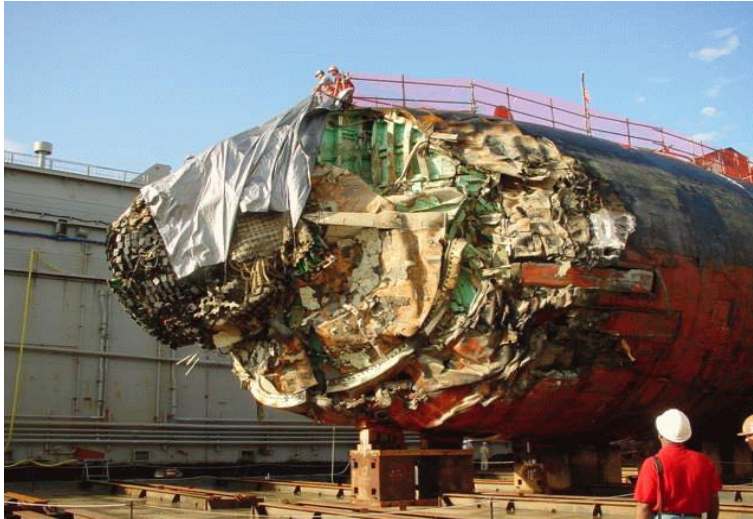
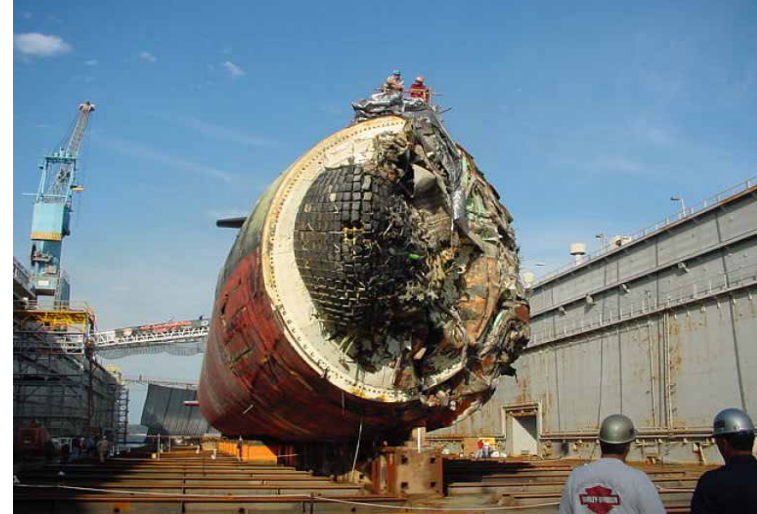
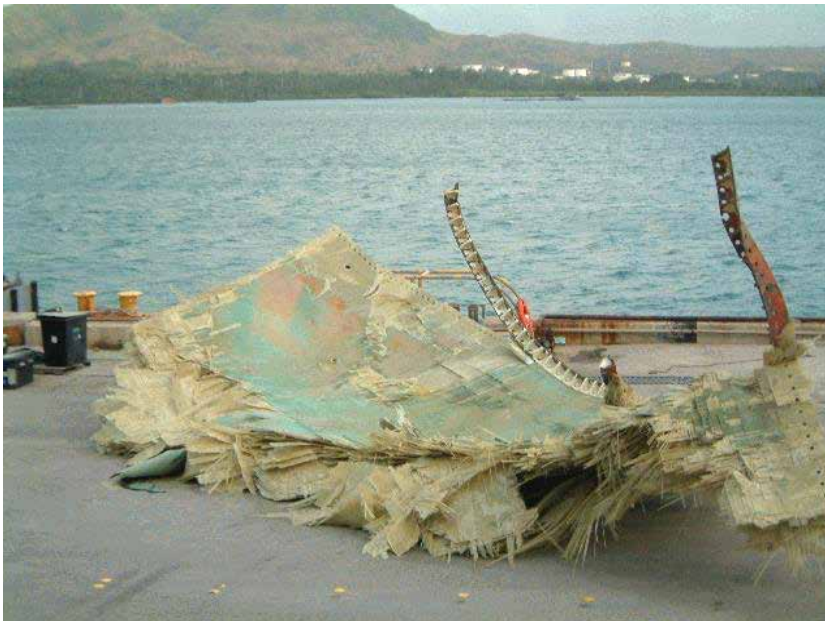
Submarine Impact Damage

SSN 711 *San Francisco* hit an uncharted seamount in Jan 2005

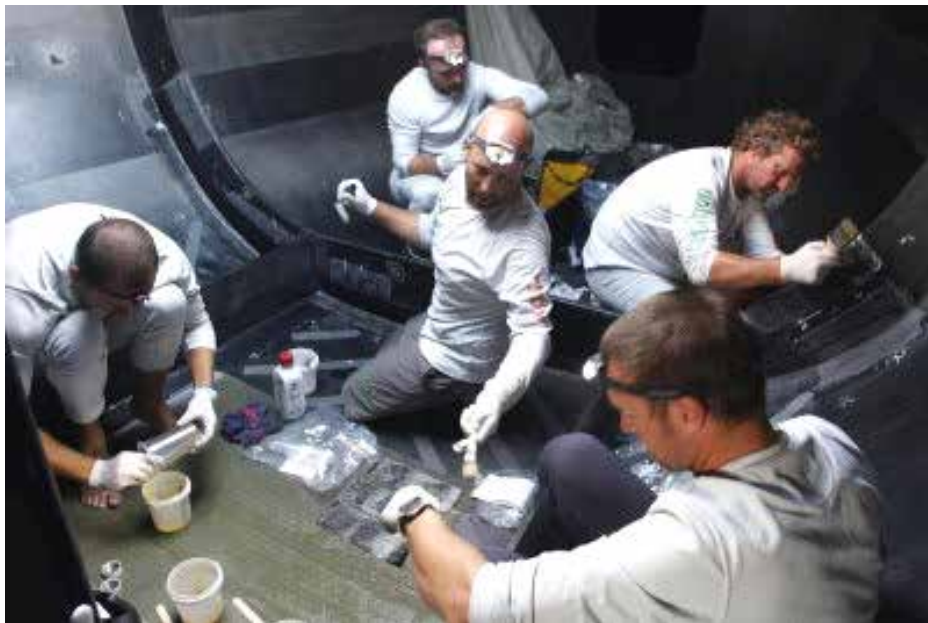
Crew repairs damage to ring frame sustained in 50 knot winds on Irish entry in the 2011-12 edition of the Volvo Ocean Race

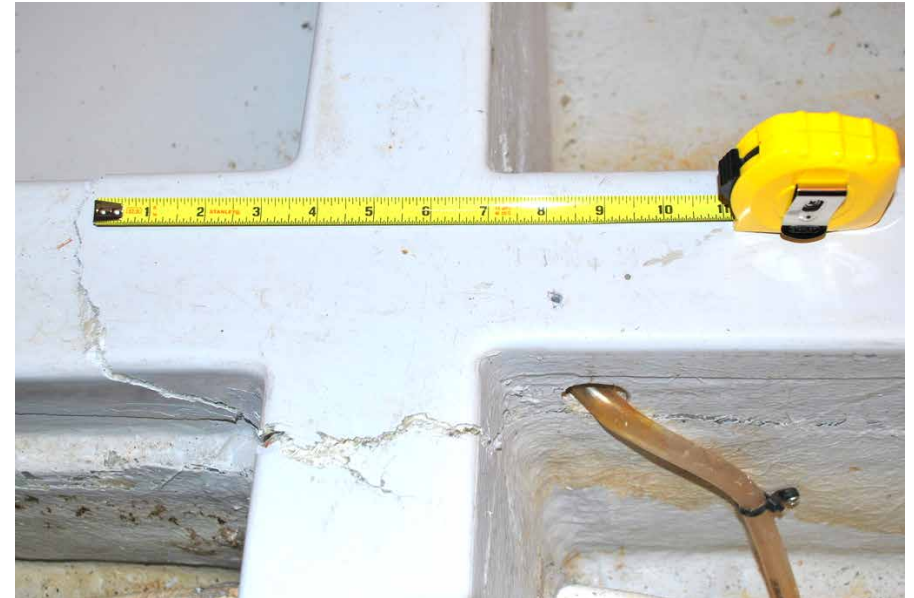
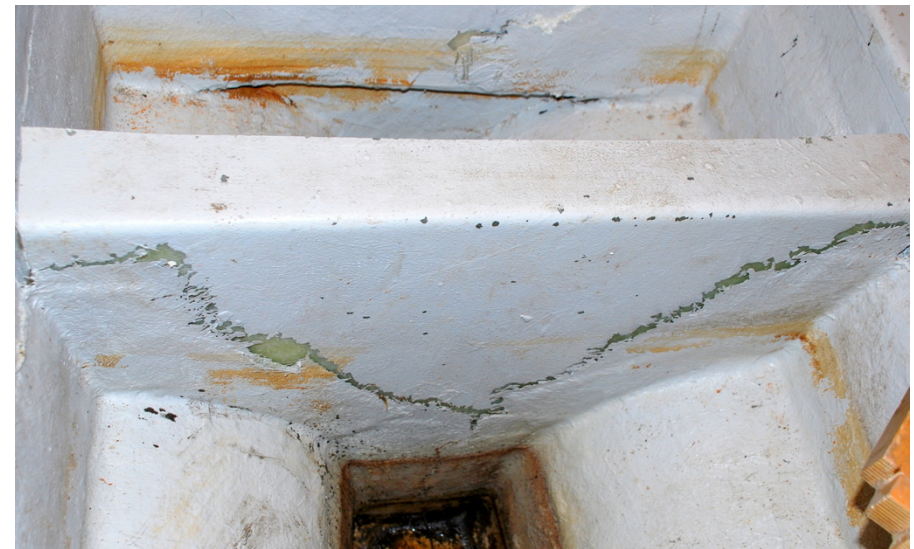
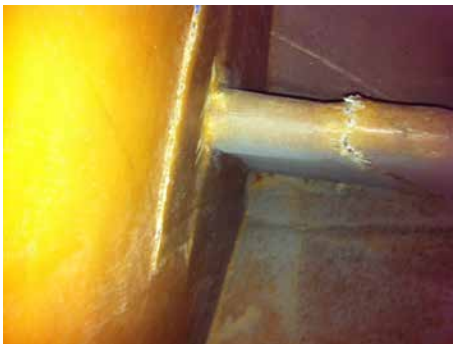
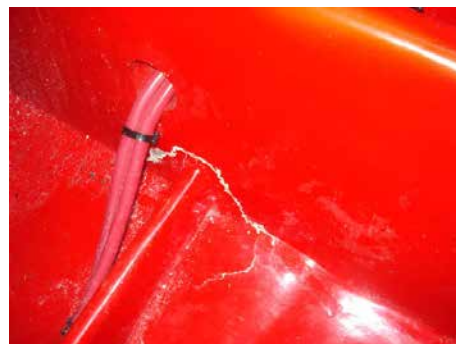
Stringer damaged from grounding event

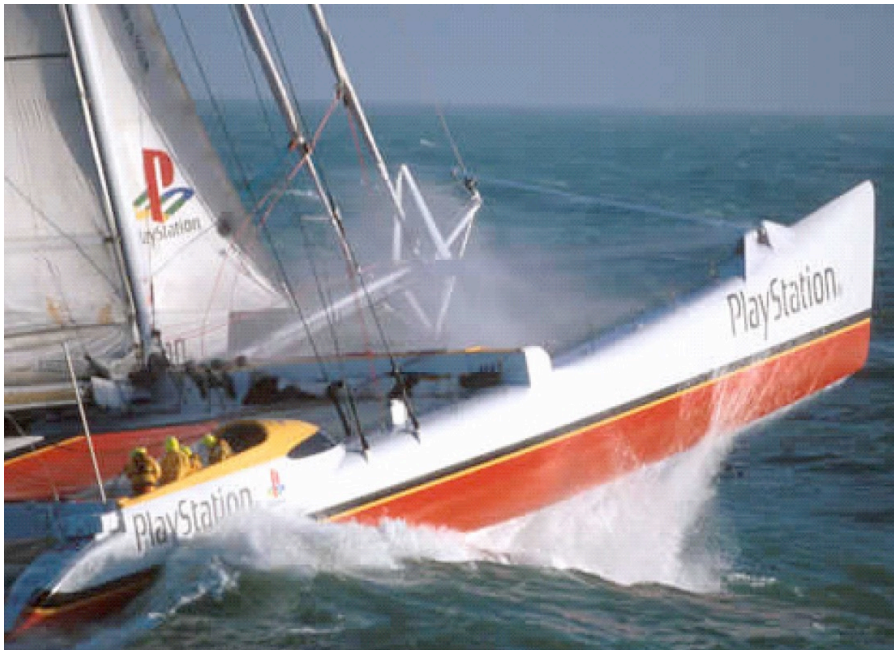
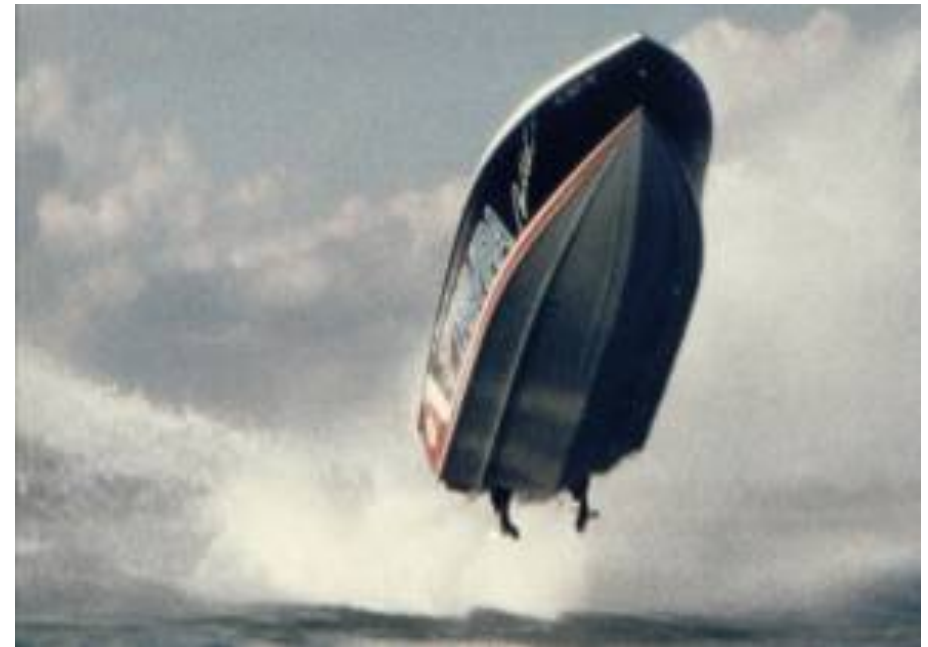
Illustrations of Sail, left [High Modulus] and Power, right [Structural Composites] High-Speed Vessel Slamming Events

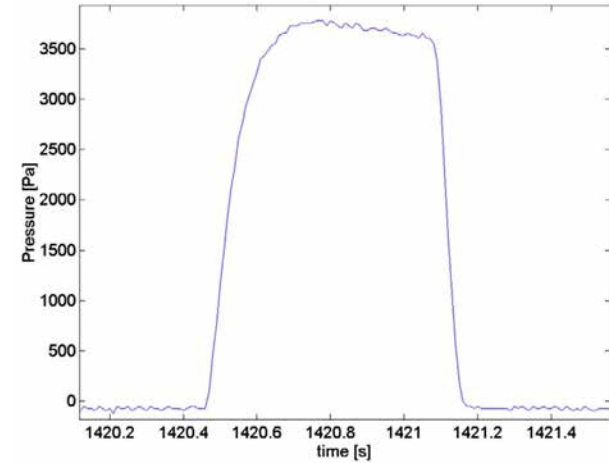
Typical Slam Impact Pressure

Transverse distribution of
Crowther 318 pod slamming
pressure for 4 m/s impact

Longitudinal distribution of
Austal H 63 slamming pressure
for 4 m/s impact

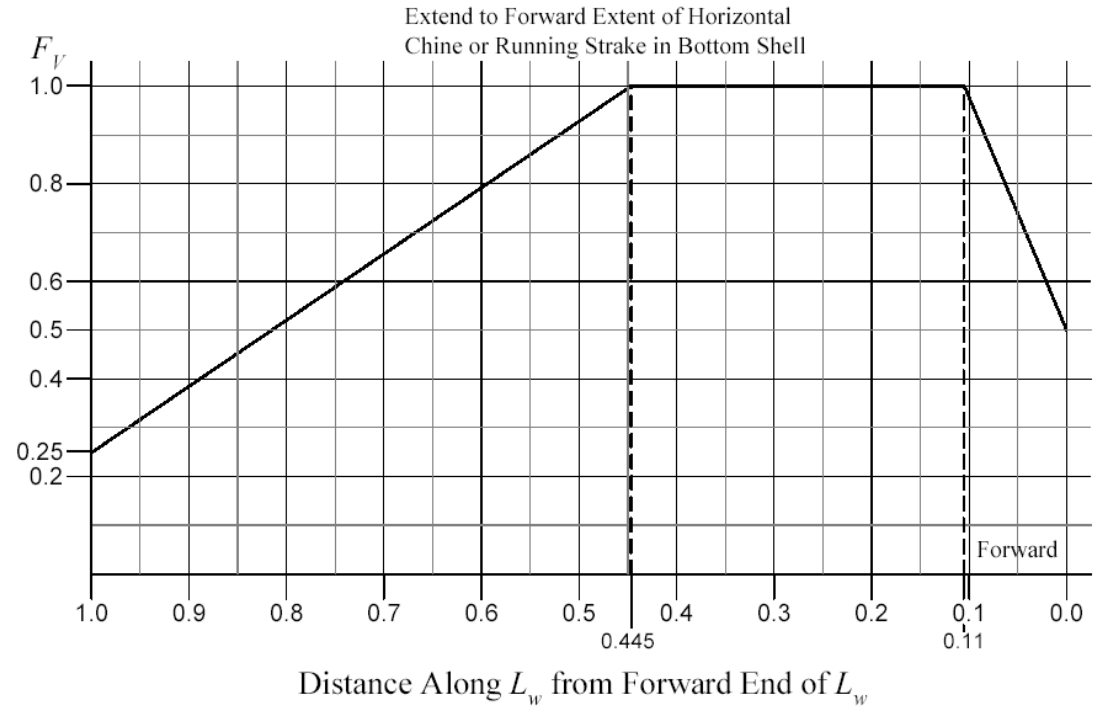
Vertical Acceleration Distribution Factor F_V

n_{cg} = the vertical acceleration of the craft as determined by a model test, theoretical computation, or service experience

$$P_{bxx} = \frac{N_1 \Delta}{L_w B_w} [1 + n_{cg}] F_D F_v$$

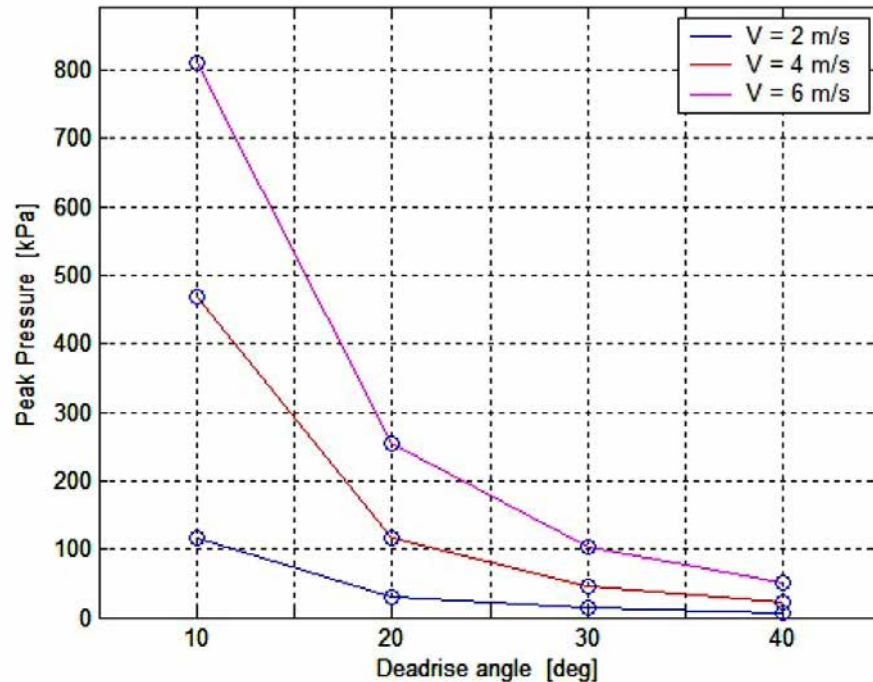
Peak pressures plotted against deadrise angle for 3 different velocities.

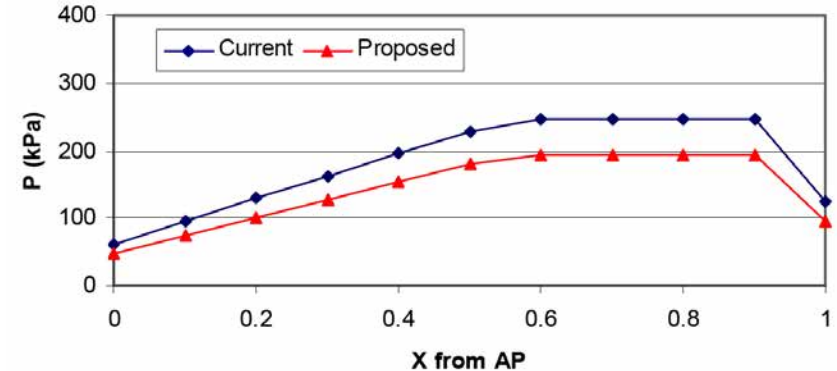
Bottom slamming design pressure

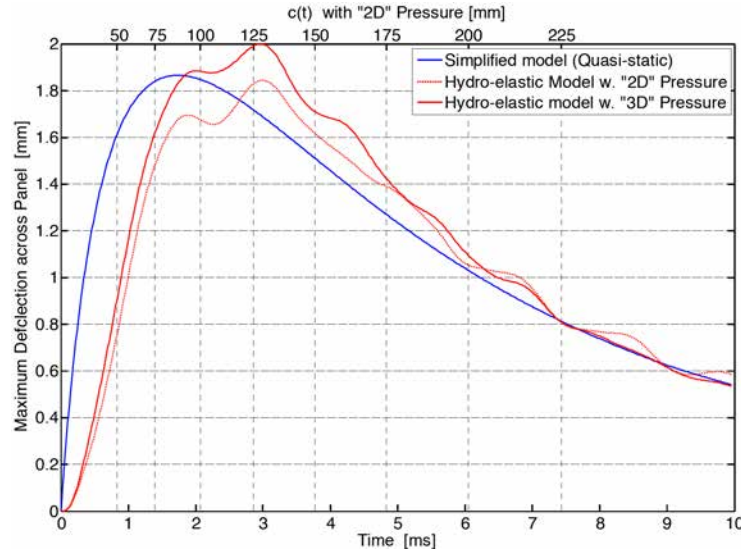
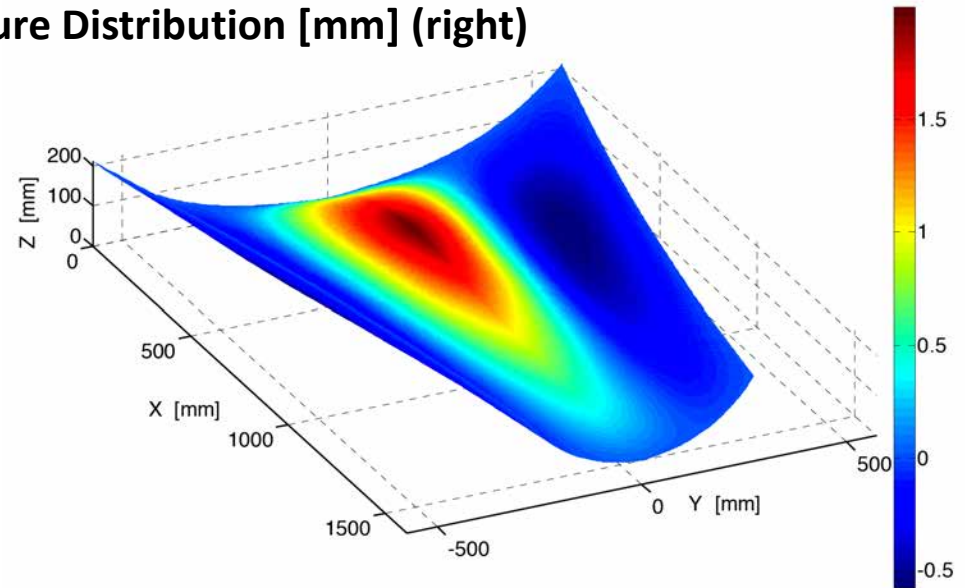
Time History of Panel Deflection (left) and Deflection at time of maximum deflection for "3D" Pressure Distribution [mm] (right)

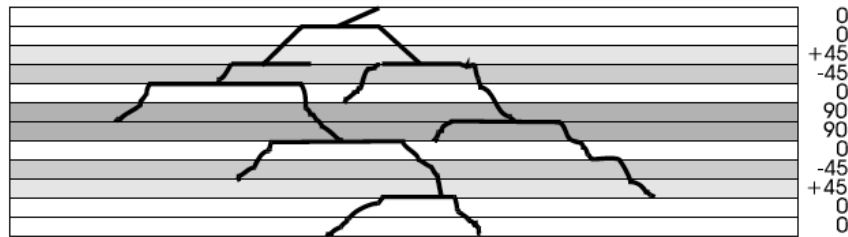
Low-Energy Impact

Pyramid Pattern Matrix Crack from impact.

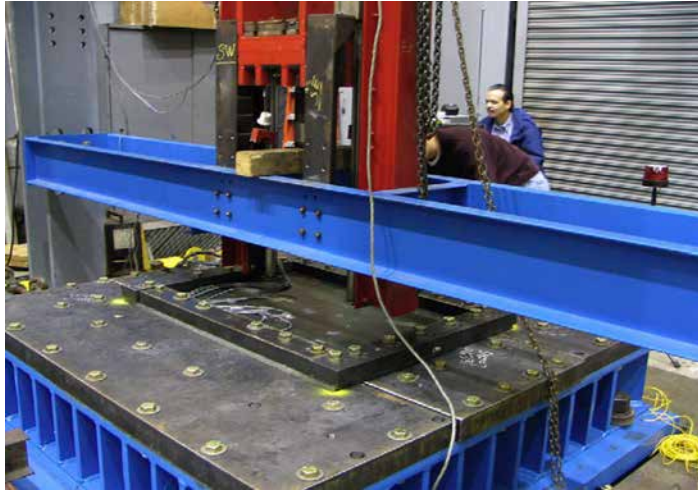
Impact rig for the large-scale plate tests

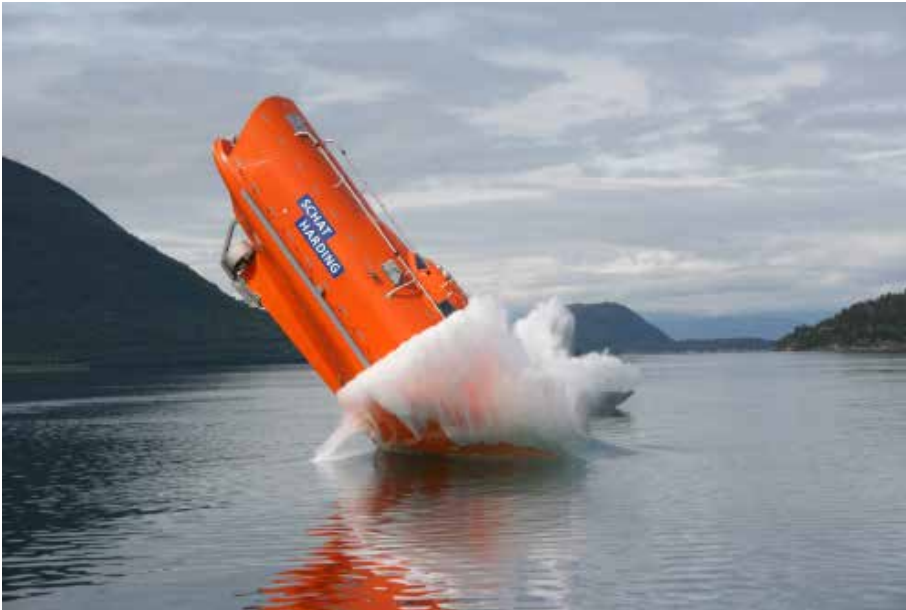
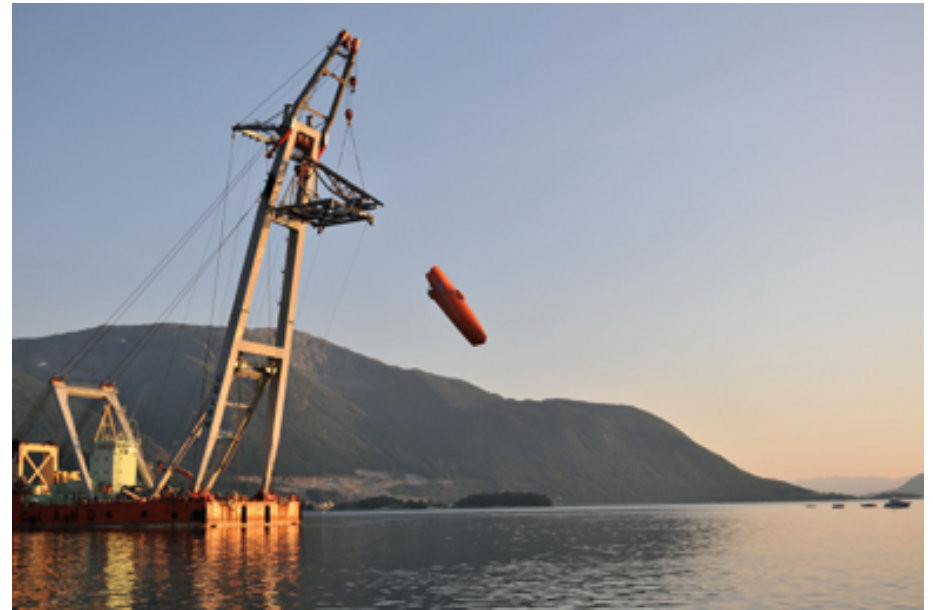
Schat-Harding freefall lifeboat

55 meter freefall test

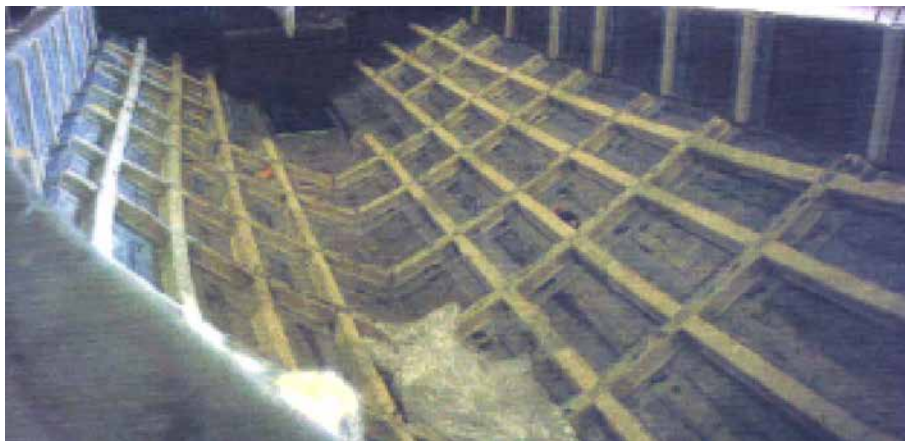
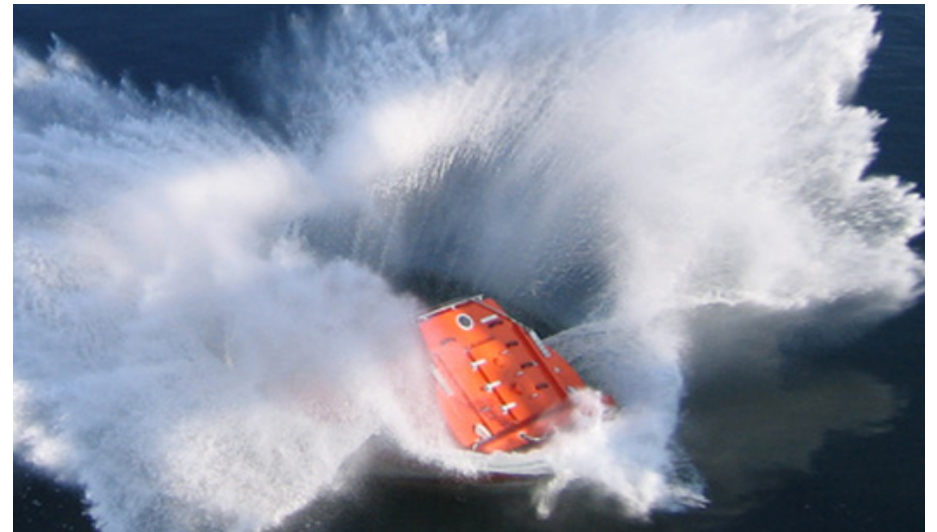
Norsafe lifeboat structural grid

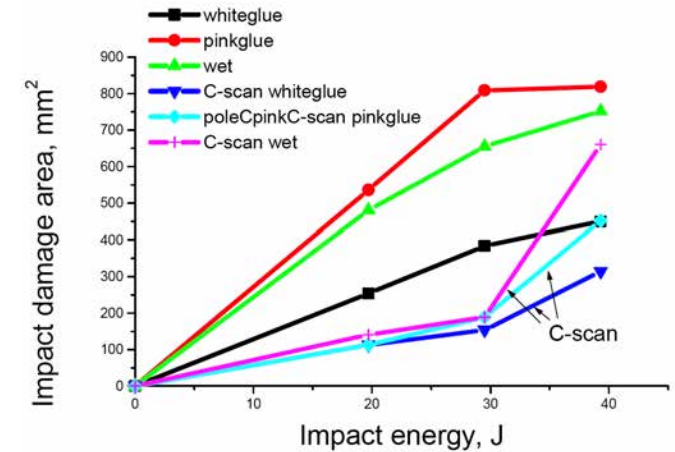
Schematic diagram of the instrumented impact test (left) and “high-density” sample following impact 39.3 J (right)

Impact damage area as a function of impact energy for sandwich structures: visual inspection and C-scan results

In terms of impact damage size, in each case the size of C-scan damage area was significantly smaller than in visual inspection of the sample.

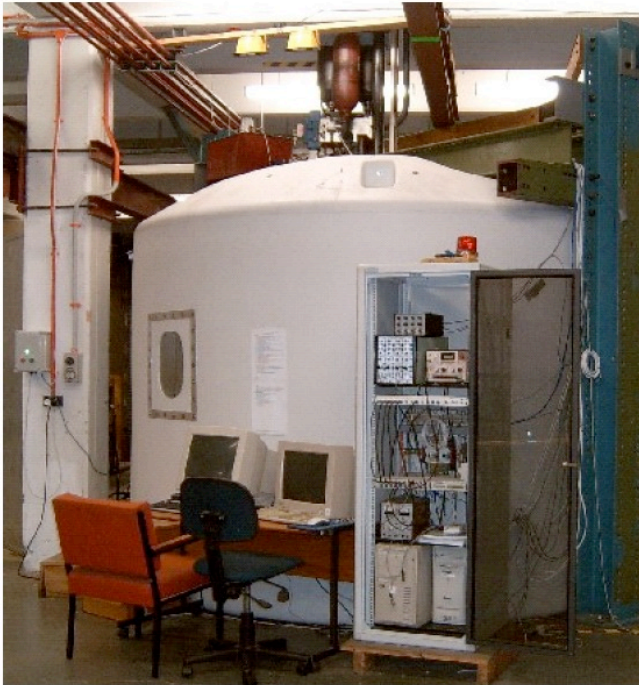
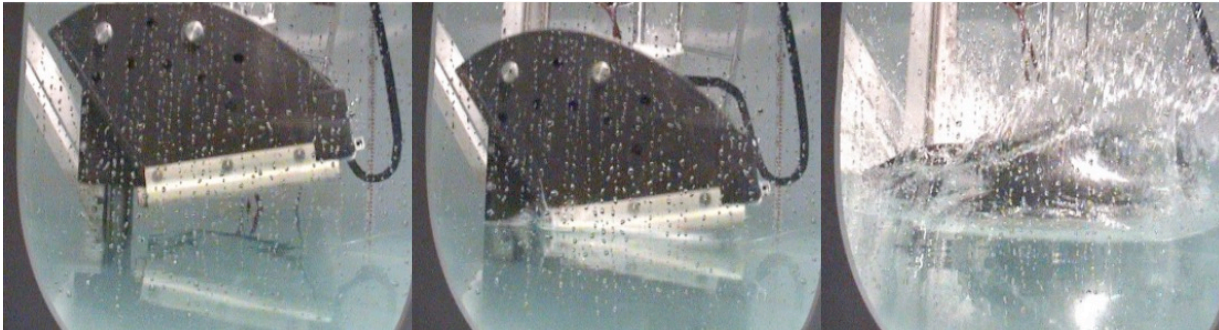
Elements of the Servo-hydraulic Slam Testing System (SSTS) including Ram (1), Load Cell (2), Specimen Fixture (3), Test Panel (4), Side Plates (5), and Back Plate (6).

Top left is Overall Equipment Setup with Computer Control and bottom Sequence is of Slam Test Event [Mark Battley, University of Auckland & Susan Lake, High Modulus]

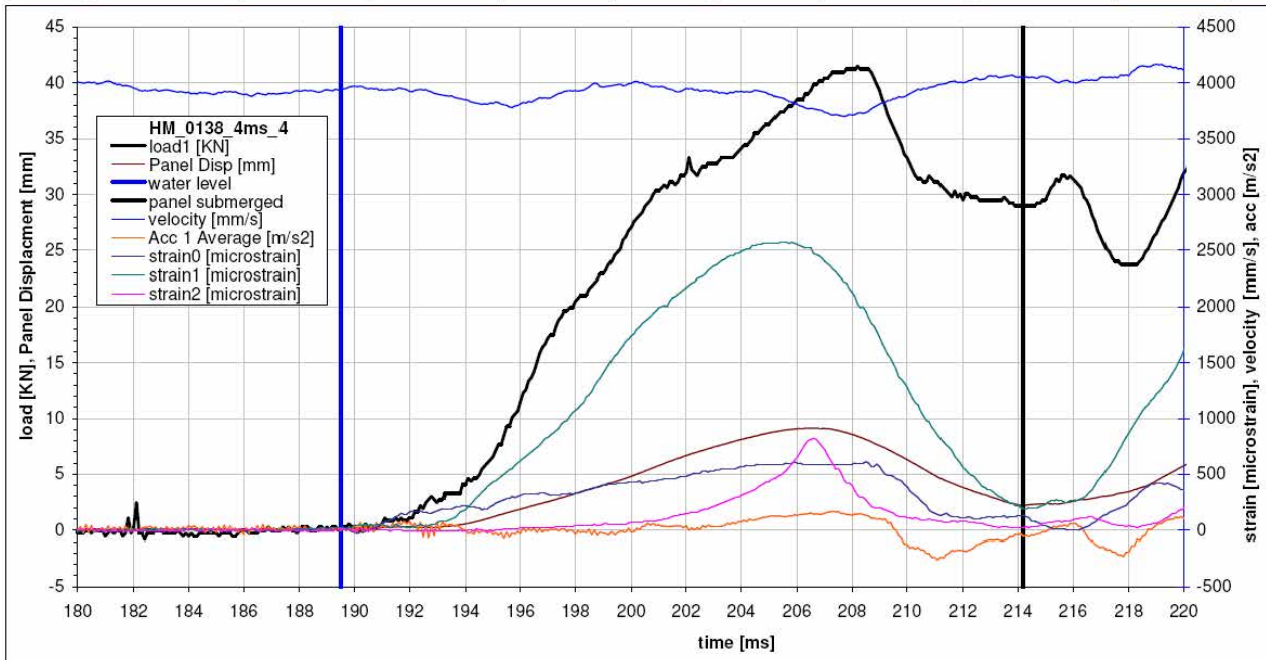
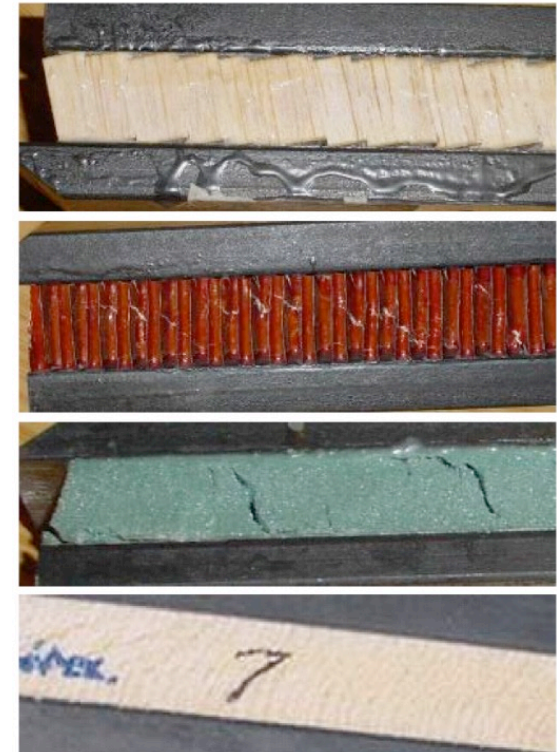
Slam Testing Results

Typical Results from Slam Testing in the SSTs [High Modulus]

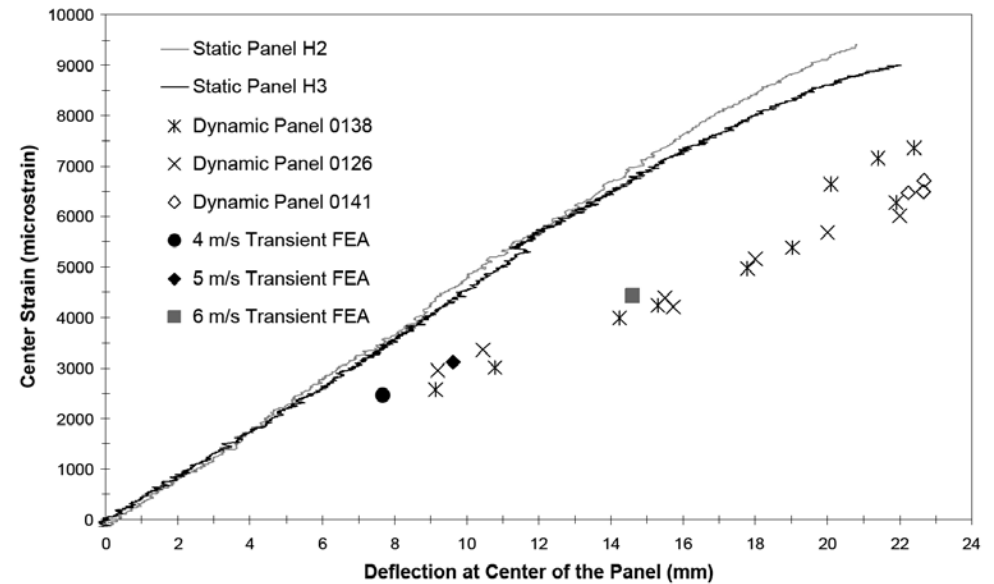
Deflection vs. panel center strain

The dynamic panels have higher deflections relative to bending strains, confirming that the load distribution is not well represented by a uniformly distributed pressure. Under dynamic loading the transverse shear is more significant than bending compared to a uniformly loaded panel.

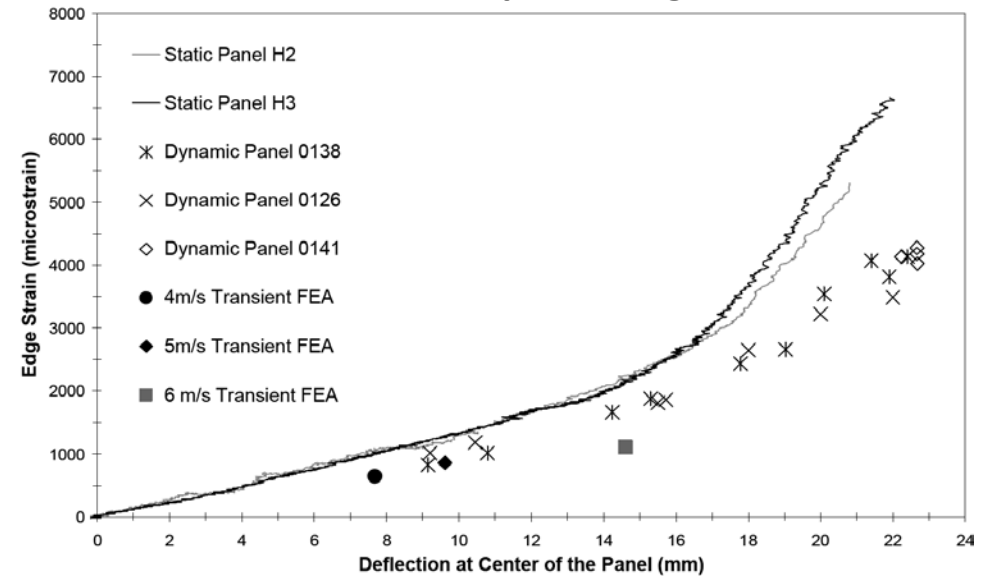
Deflection vs. panel edge strain

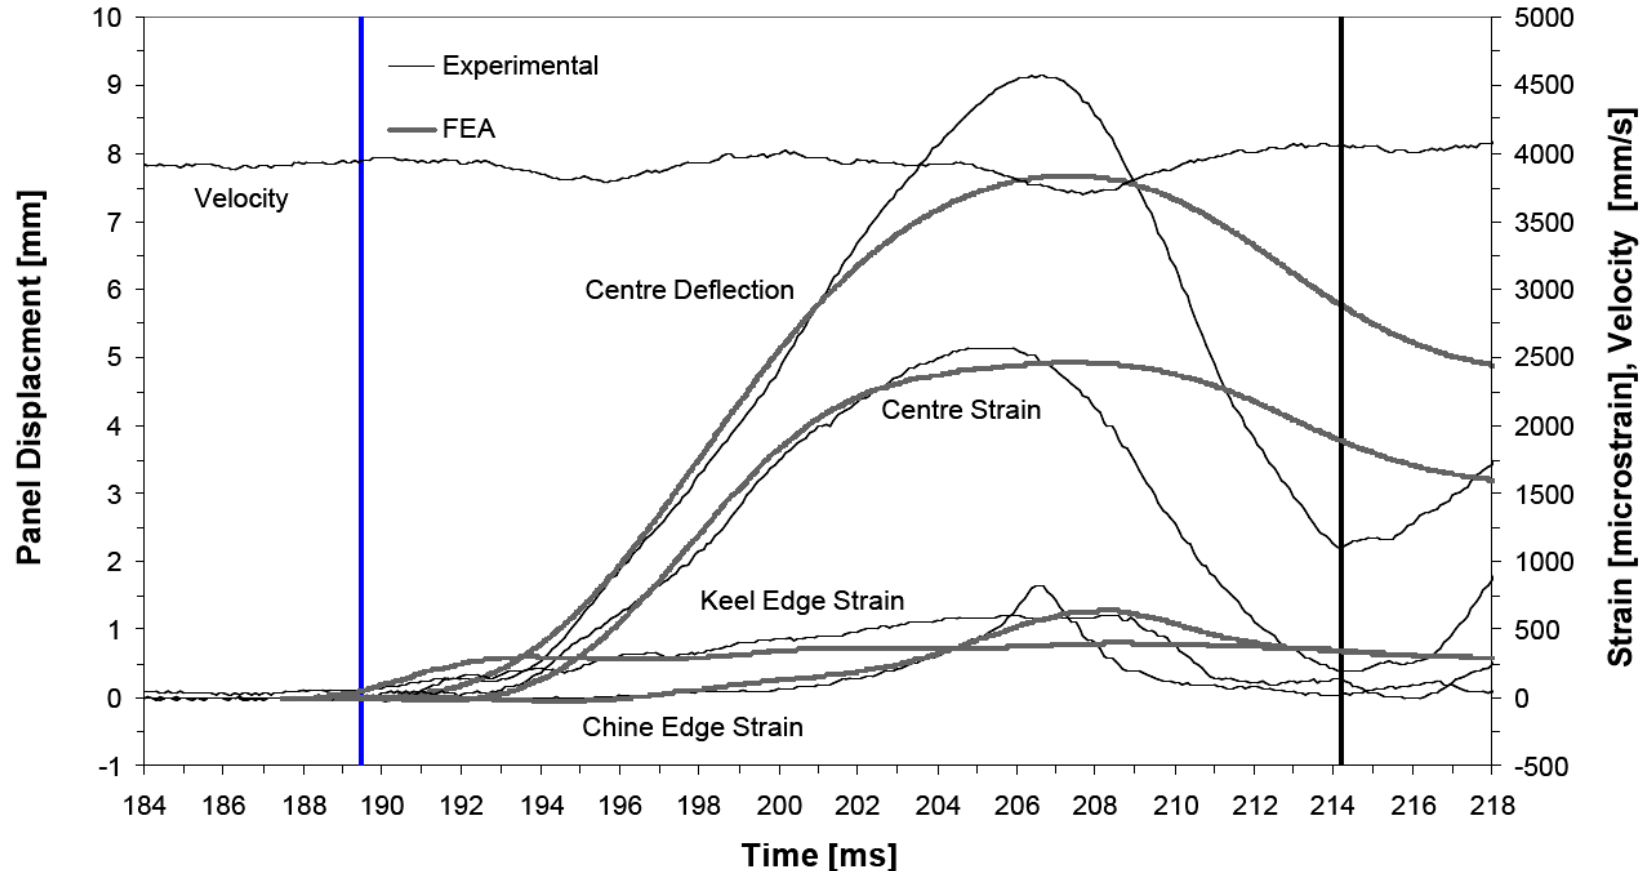
Slam event of 10° panel at 4m/s with transient FEA predictions. The blue vertical line represents the water surface, and the black line full immersion of the panel

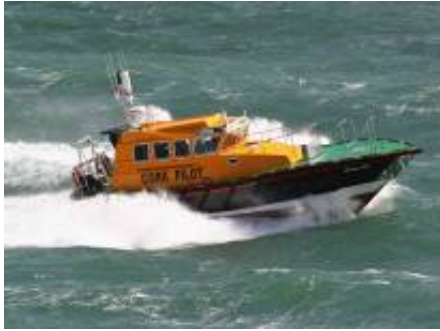
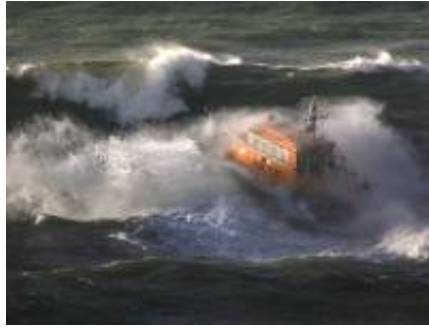
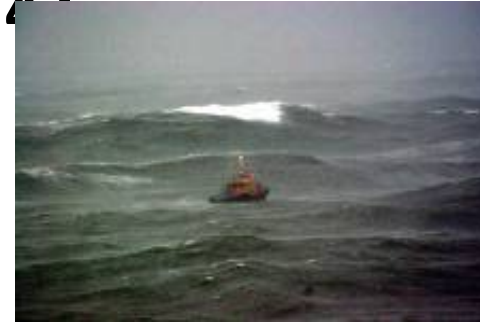
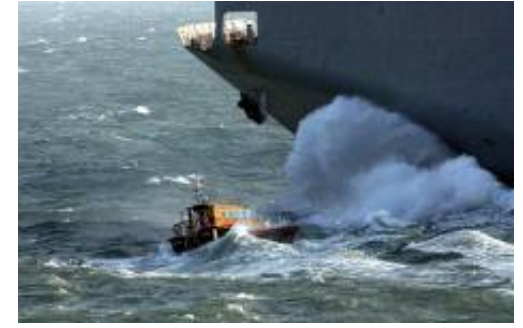
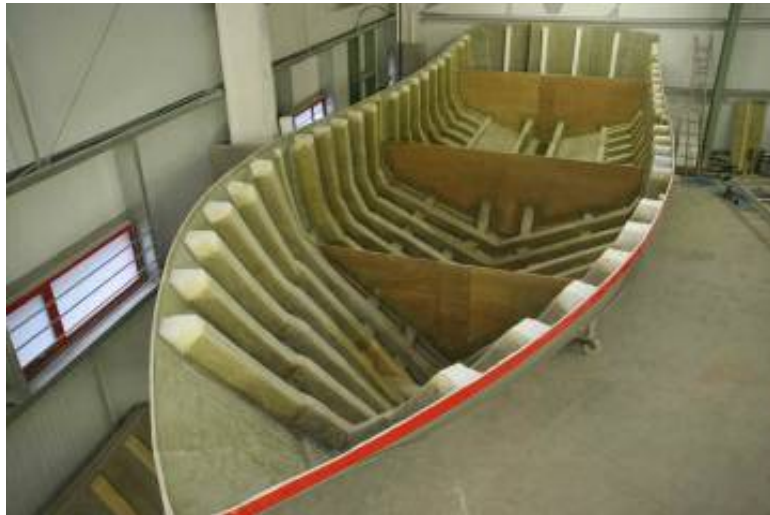
Safe Haven Marine's Interceptor

Photographs showing Pilot Boat operating conditions, including storm with 100-knot wind gust and 10 m waves [www.safehavenmarine.com]

The hulls scantlings are very closely spaced @ 500mm centers giving a 4300mm panel width, the frames themselves are a huge 150 x 150mm resulting in a massively strong structure

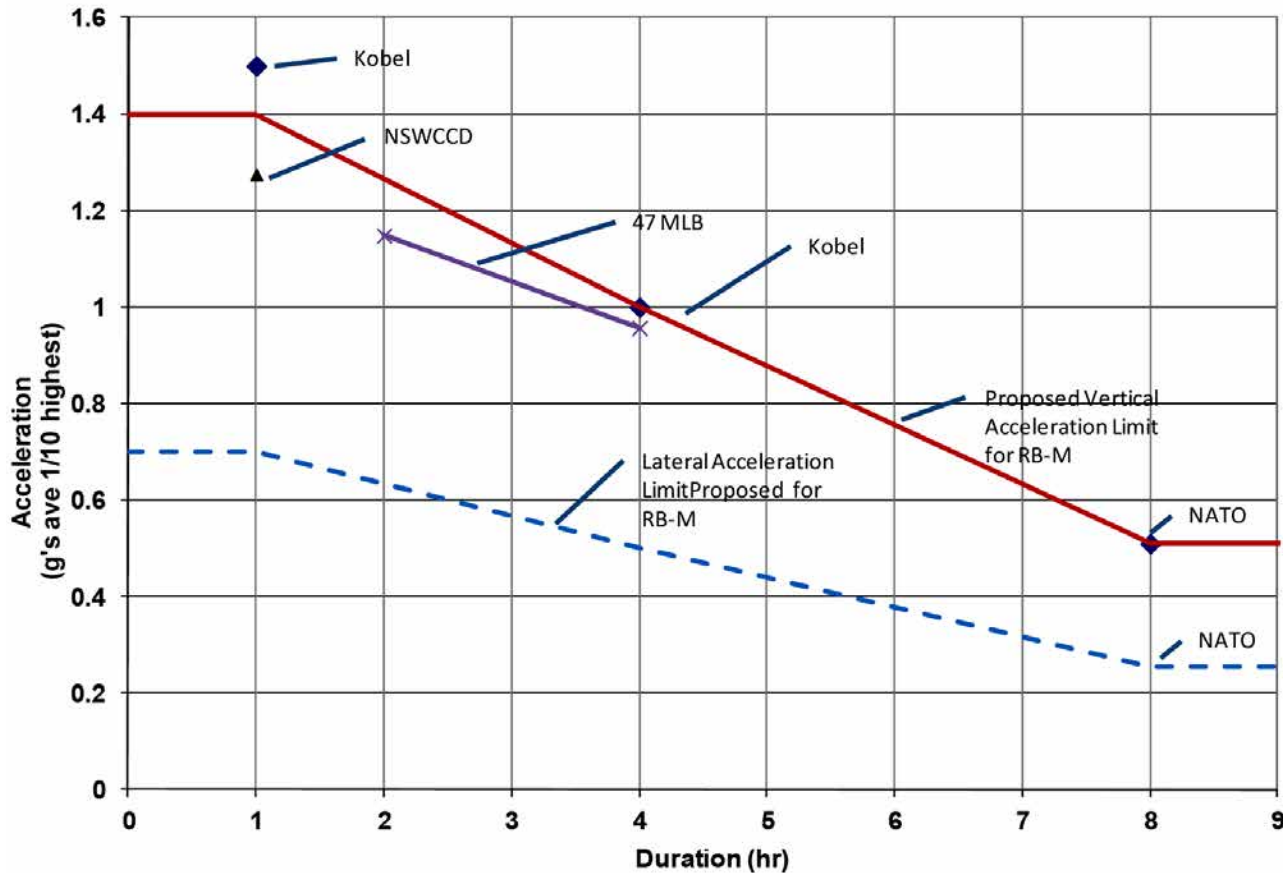
Acceleration limits for operator fatigue and injury

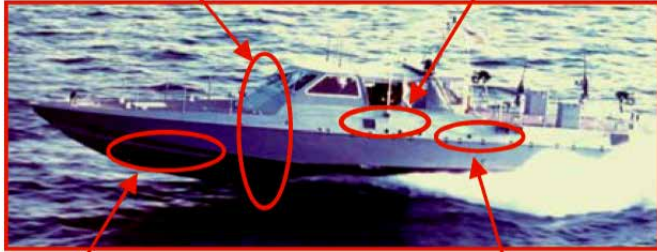
Hydro-Structural Shock Mitigation

1. Hull Form, Δ_{Form}

3. Deck Structure, Δ_{Deck}

2. Hull Structure, Δ_{Hull}

4. Hull-to-Deck Joint, Δ_{Joint}
