Marine Composites

Webb Institute
Senior Elective

Failure Modes

Eric Greene, Naval Architect

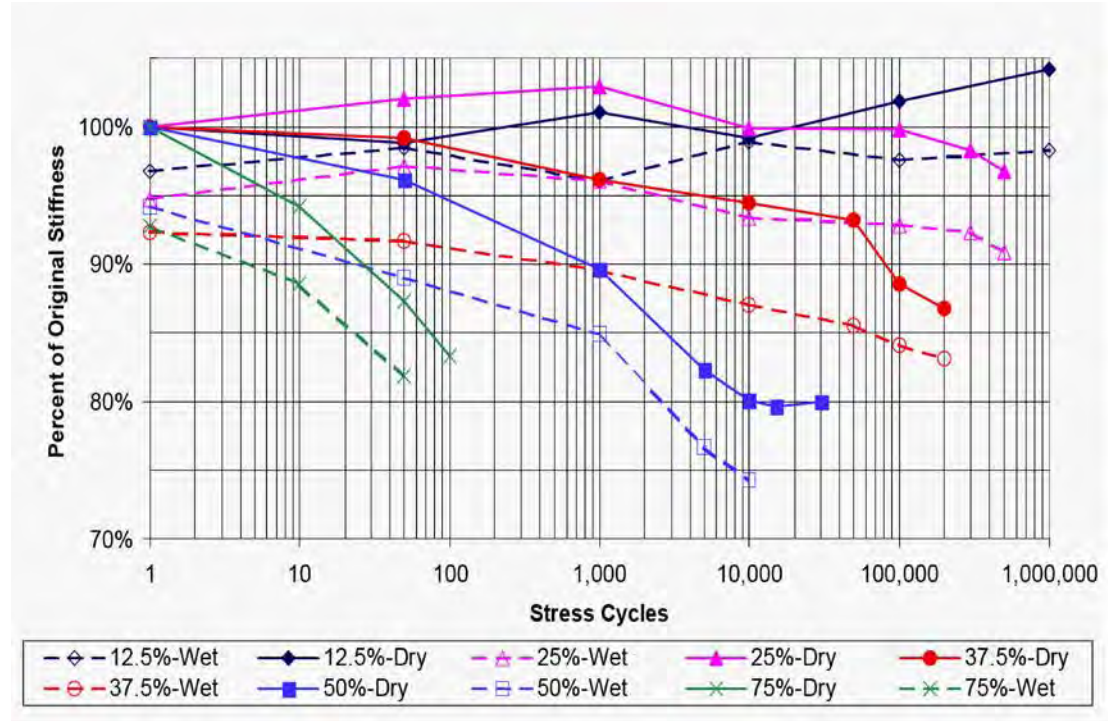
Stiffness S-N Curves

Stiffness S-N Curve for J/24 Sailboat Sandwich Laminate from Paul Miller's "Fatigue Prediction Verification of Fiberglass Hulls"

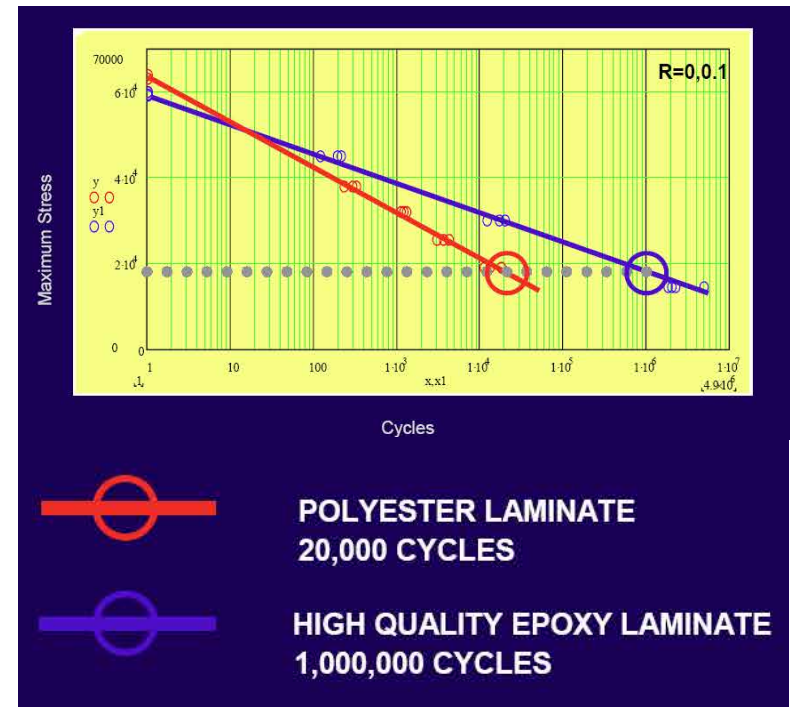
Resin Comparison S-N Curves

Comparison of Fatigue Behavior of Epoxy and Polyester Resin

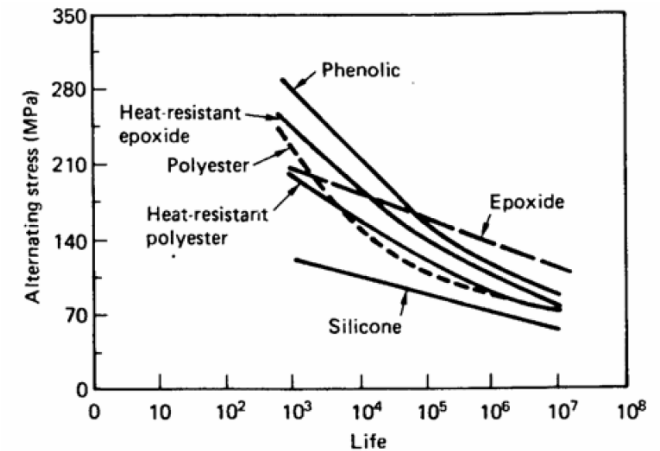
S-N Curves for various Resin Systems [Konur & Matthews "Effect of the properties of the constituents on the fatigue performance of composites: a review," Composites, vol 20, no 4, July, 1989]

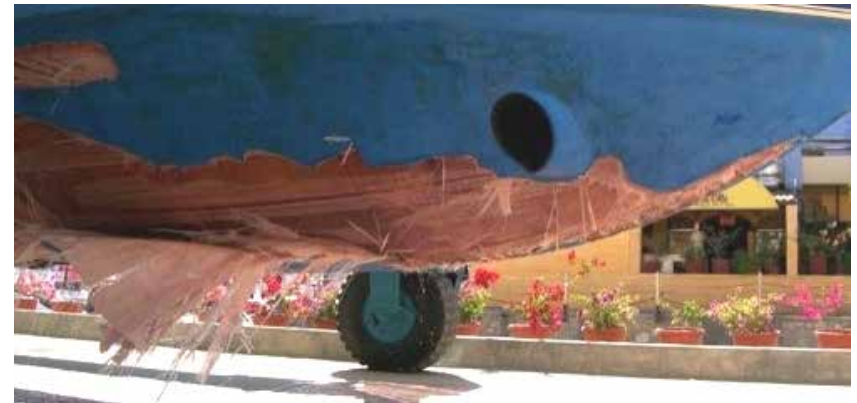
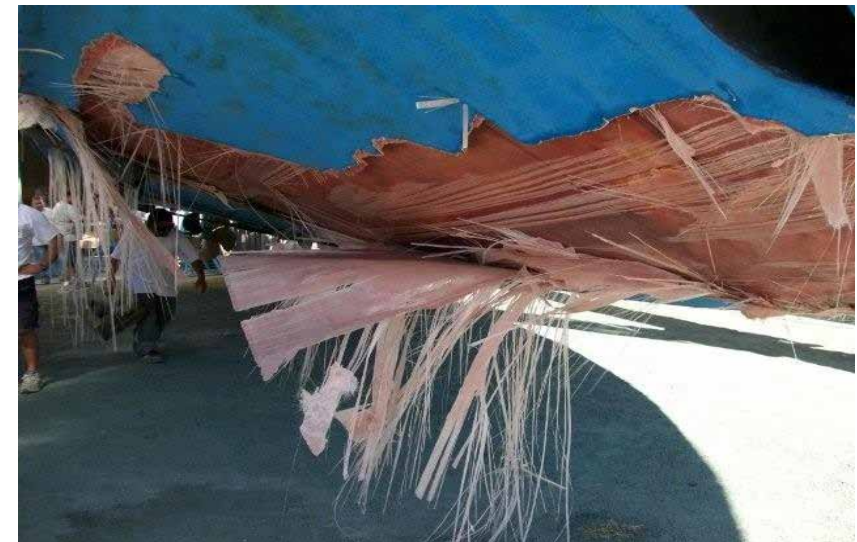
Damage to Viking 60 from
Collision with Whale

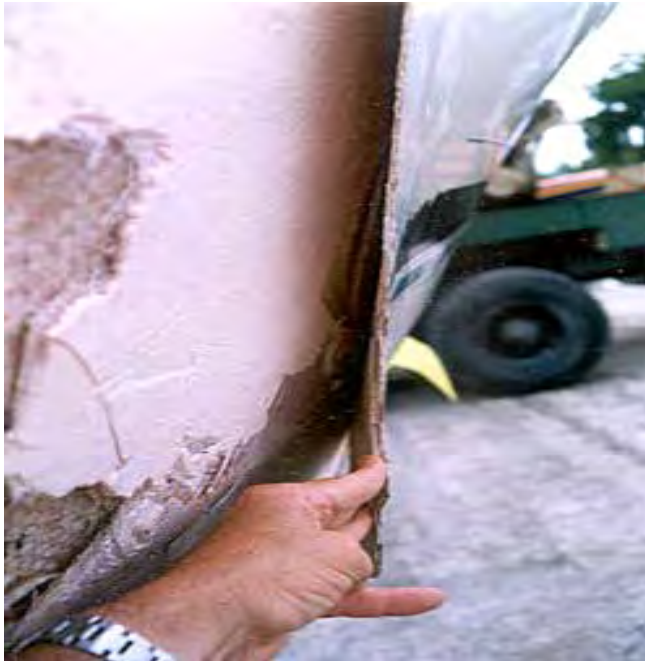
Hull Skin Delamination

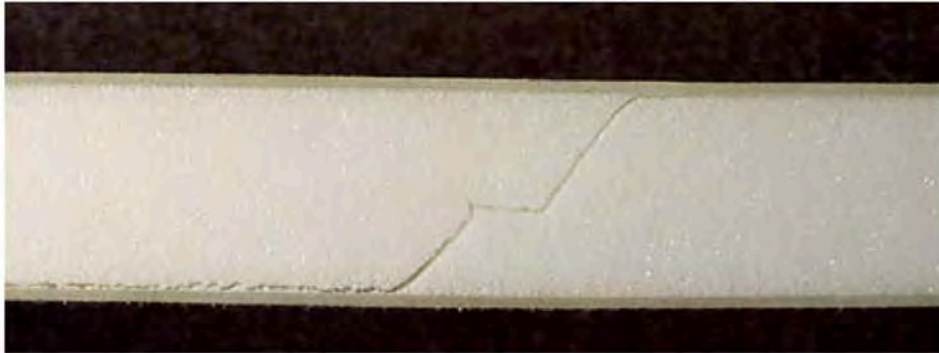
Shear Failure

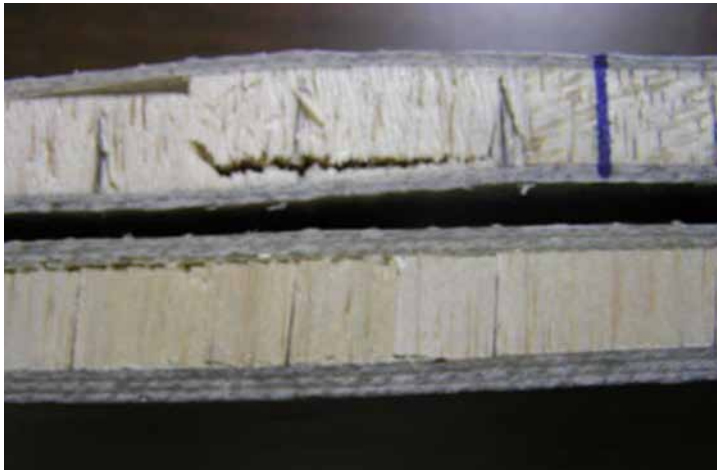
“EGB-150” Balsa Core Material, Vacuum-Infusion (top), Hand Lay-up (bottom)

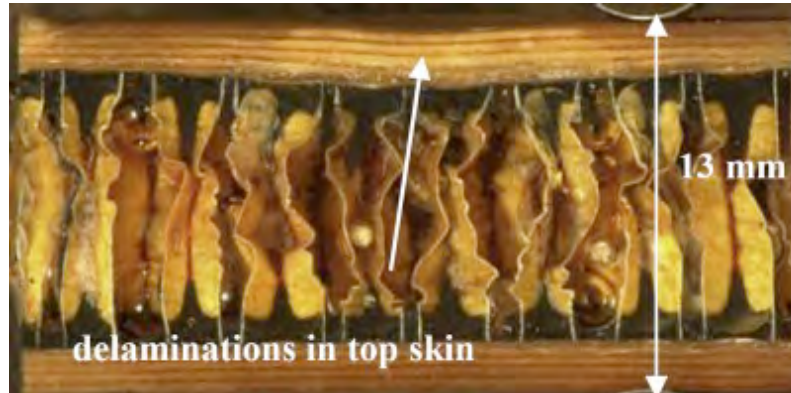
Digital photograph of impact delaminations in top skin of a sandwich construction

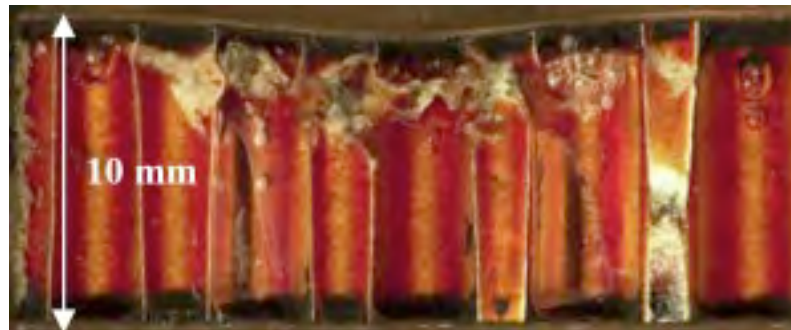
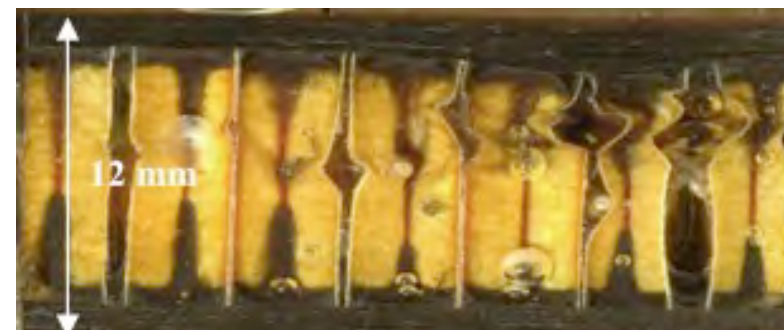
Digital photographs showing core crushing in (left) GRP-high density Nomex and (right) CFRP-medium density Nomex sandwich constructions

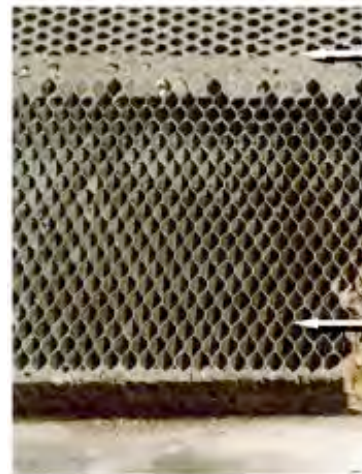
Cohesion failure (during panel strip down for repair)

Adhesion fillet bond failure

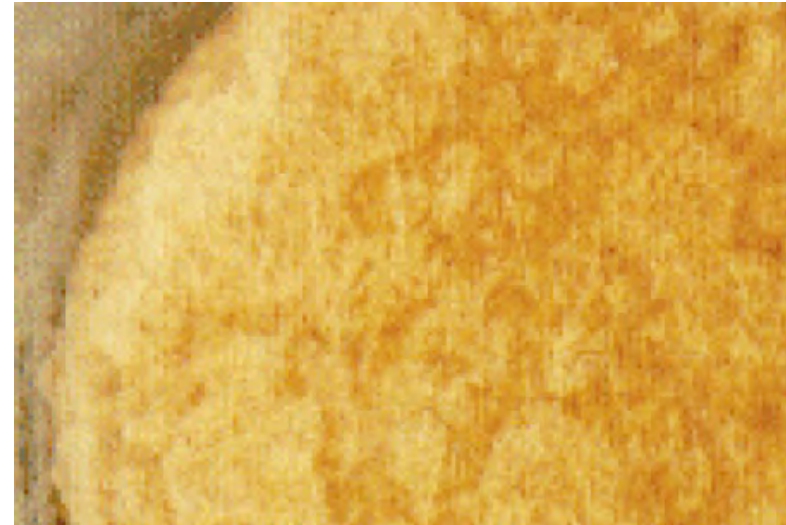
Blisters Rounded, sometimes sharply defined elevations of
laminate surface resembling blisters.

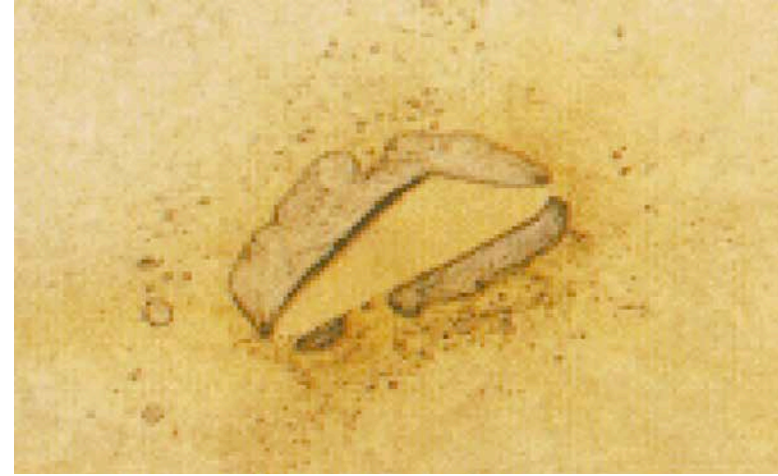
Resin pocket Apparent accumulation of excess resin in a small localized area

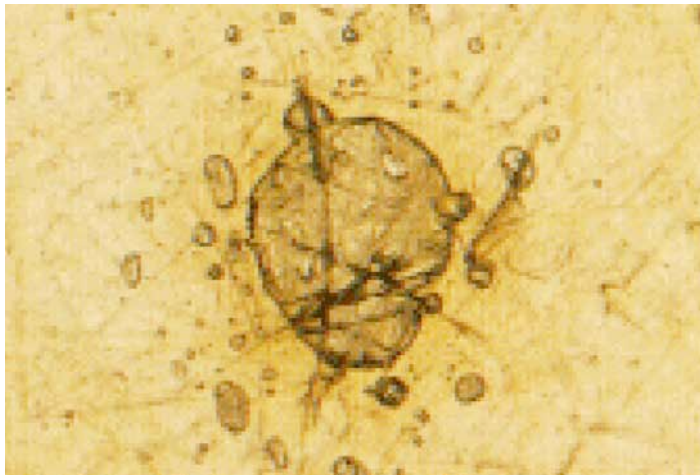
Worm hole Elongated void in surface or covered by thin film of cured resin.

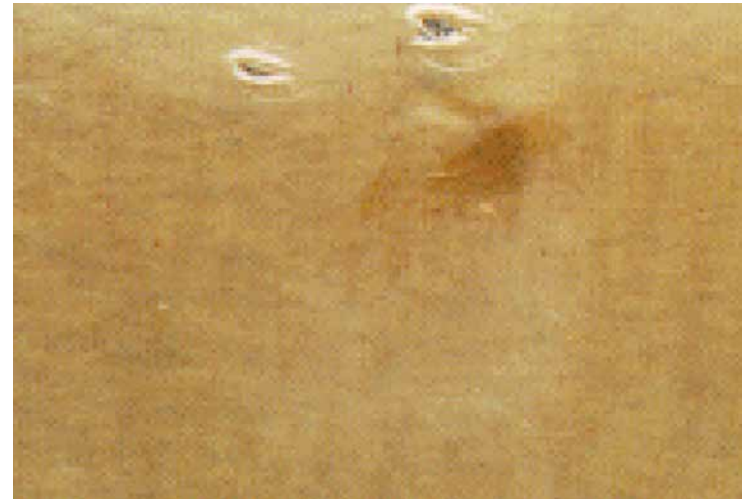
Fisheye Small globular mass that has not blended into surrounding material. Particularly evident in transparent or translucent materials

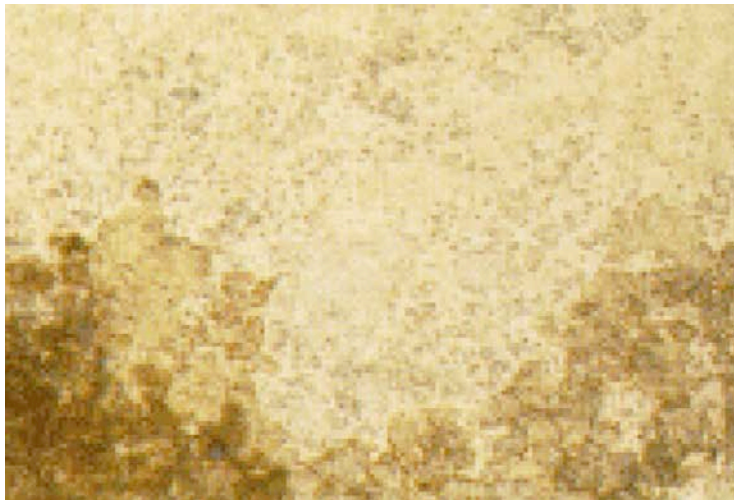
Dry Spots Area of reinforcement that was not wetted with resin. Usually at laminate edge.

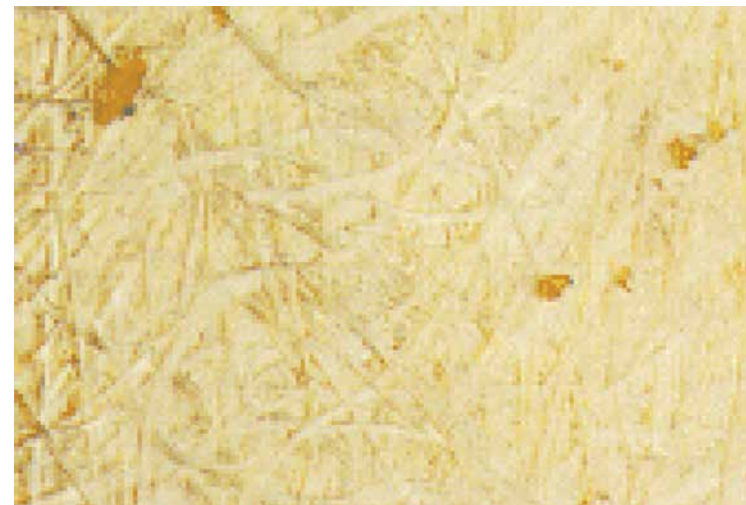
Pimple Small sharp or conical pimple-like elevation on surface. Usually resin-rich.

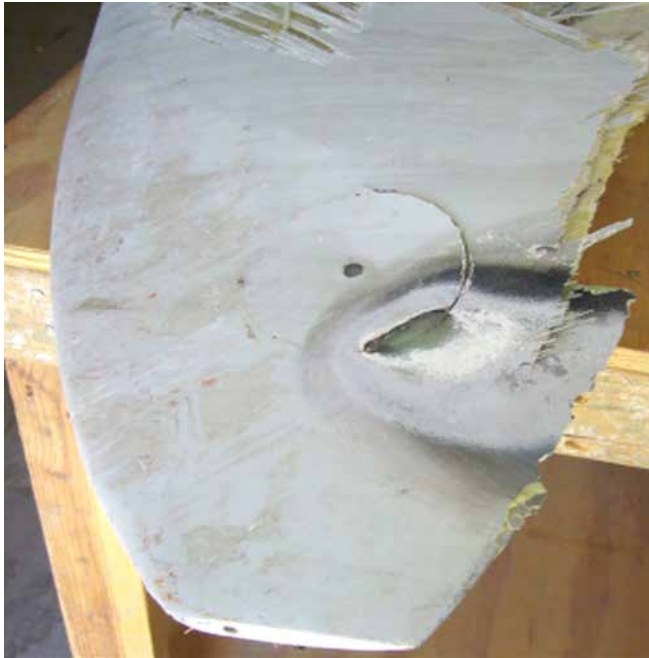
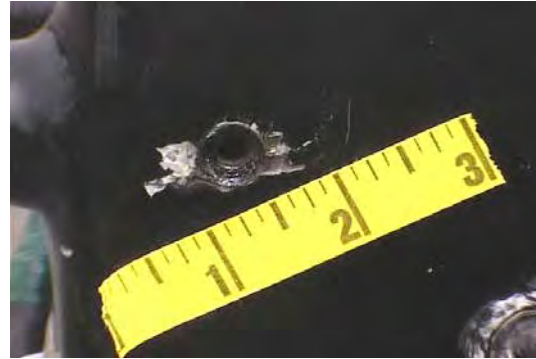
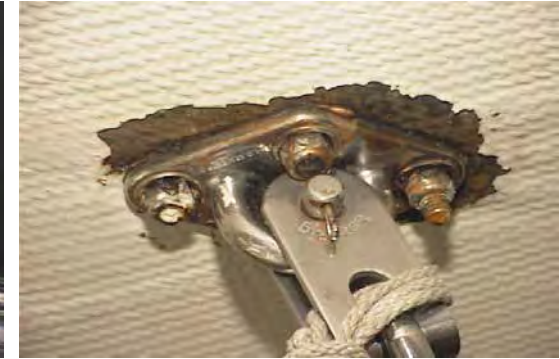
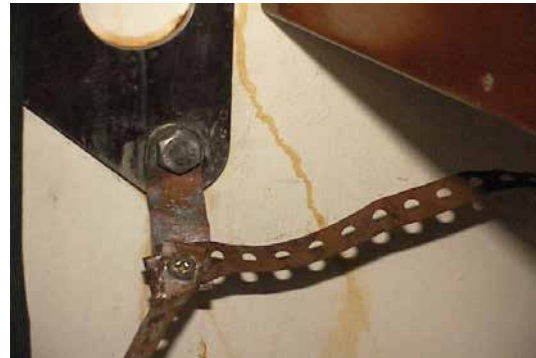
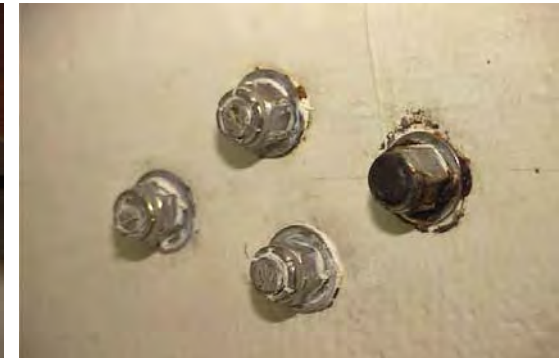
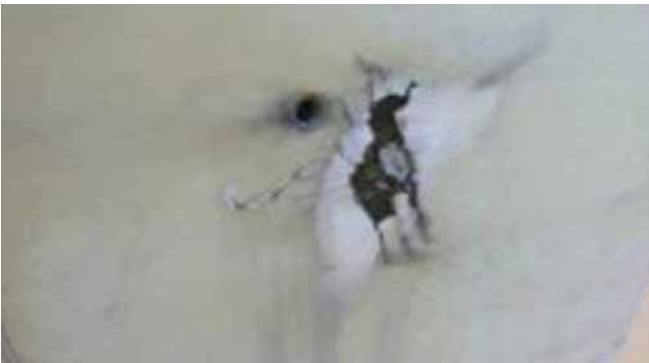
Lightning Damage

Lightning damage to wind turbine blades

Lightning damage to carbon fiber yacht mast showing discharge path

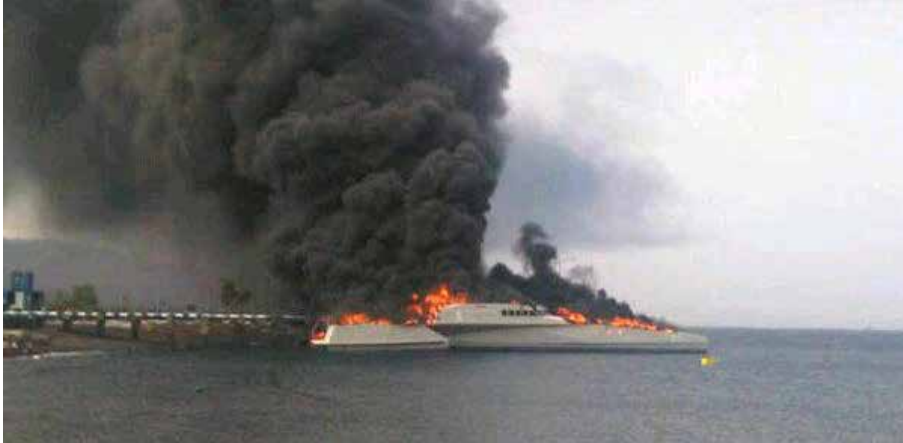
Indonesian Trimaran Fire

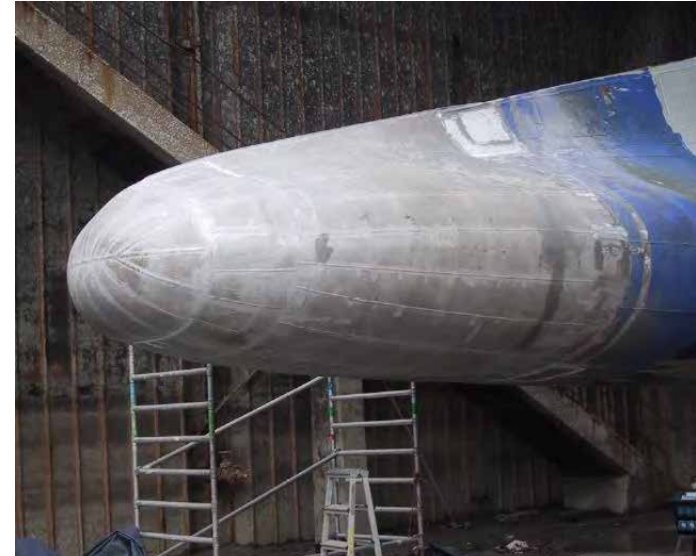
Bulbous Bow

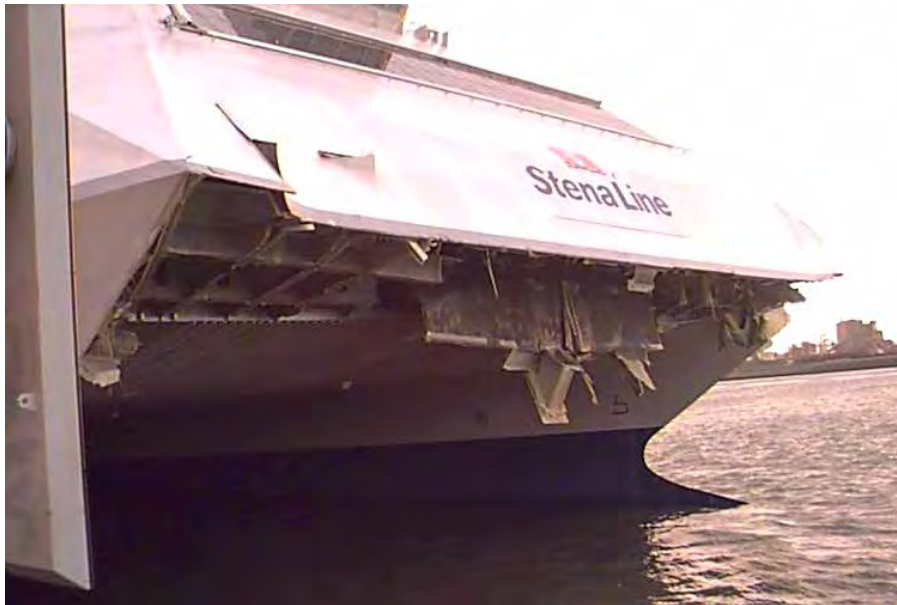
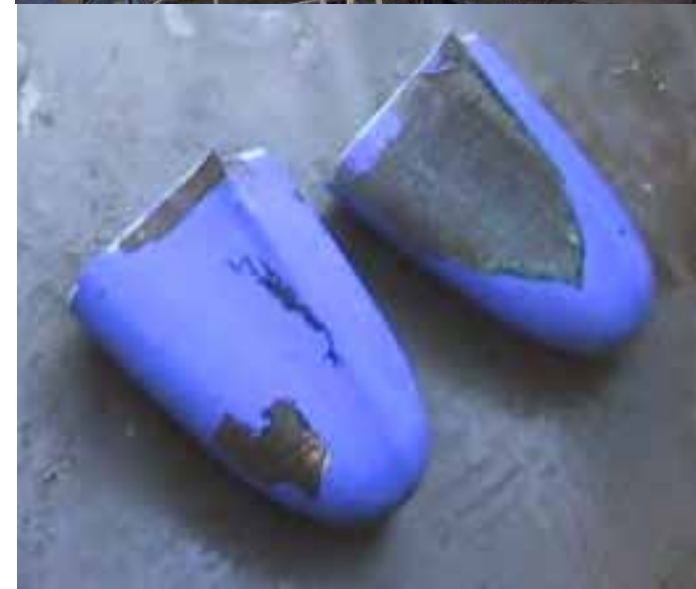
High-speed Catamaran Bow

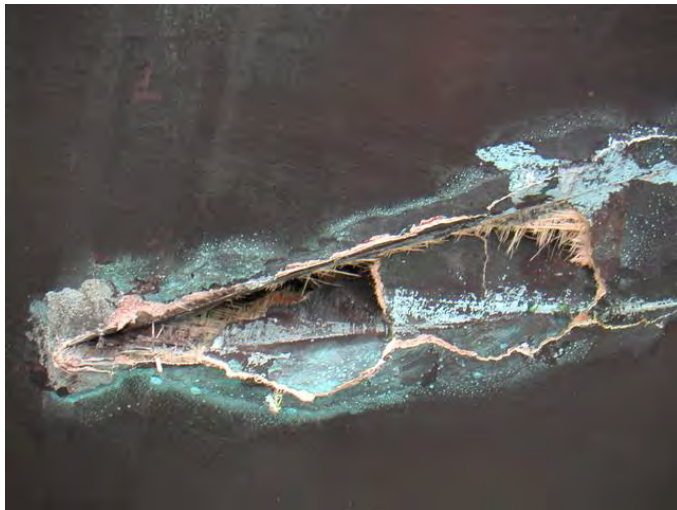
Roll stabilizer damaged after grounding (top) and resulting hull damage (below)

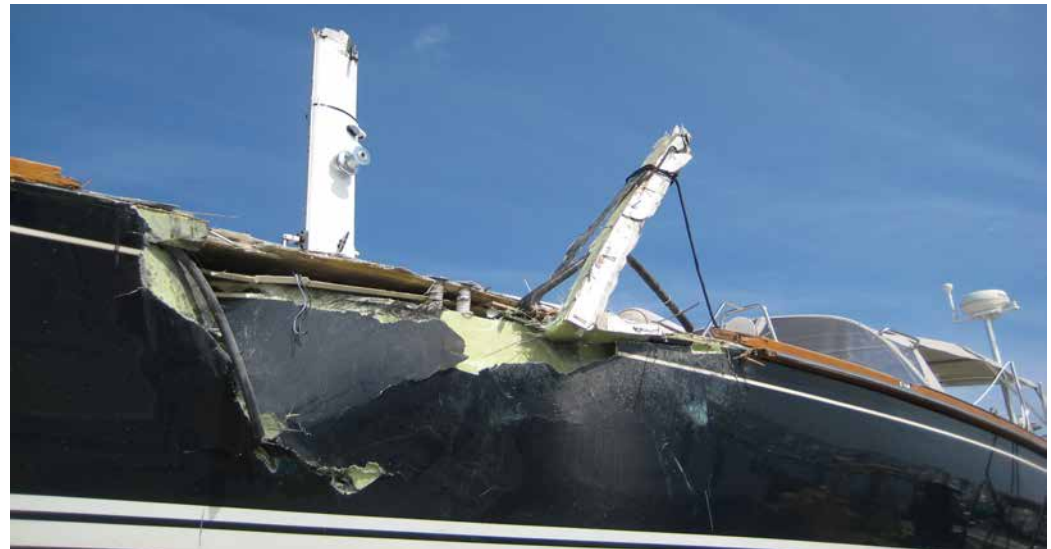
Just before 2 a.m., a 1992, 38-ft. Fountain power boat slammed into a fixed, channel marker, ripping a 17-ft. gash in the forward hull & becoming impaled on the steel piling holding the channel marker.

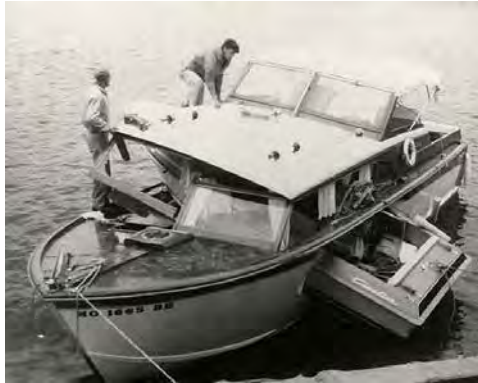
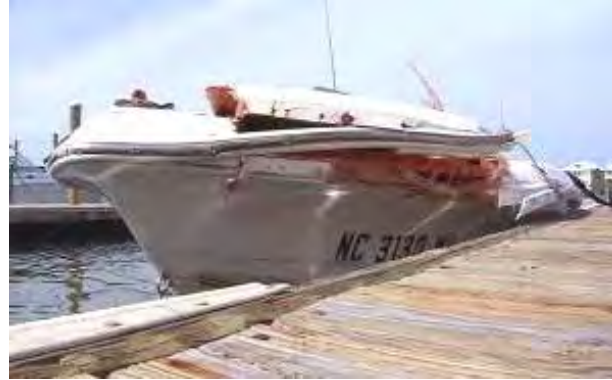
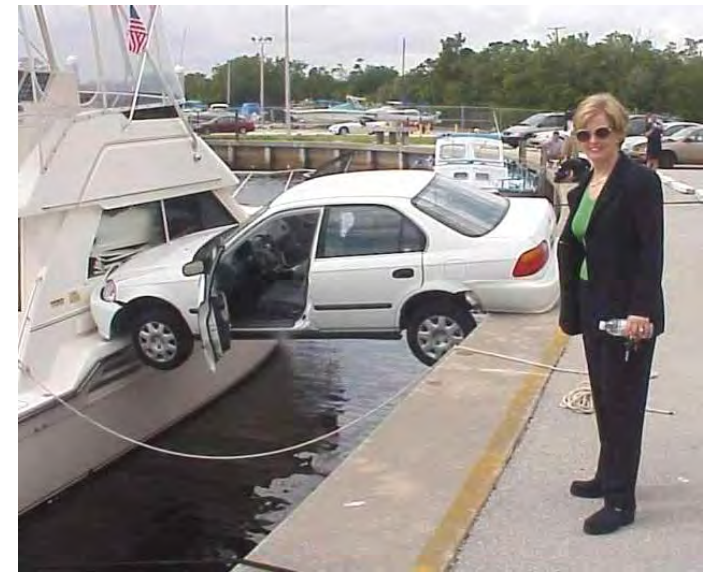
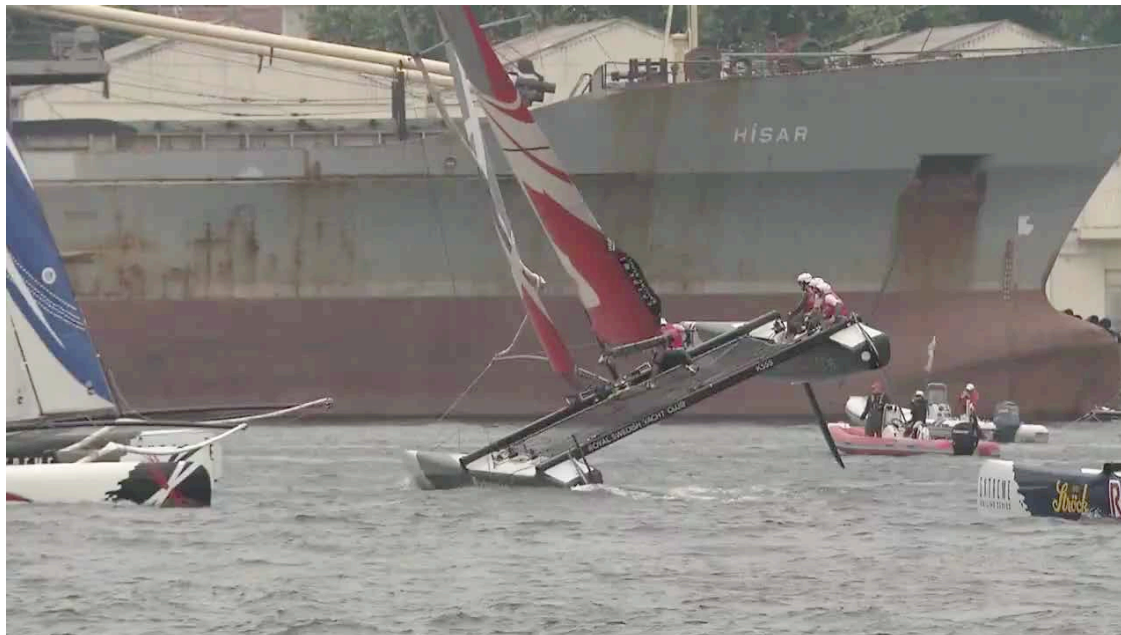
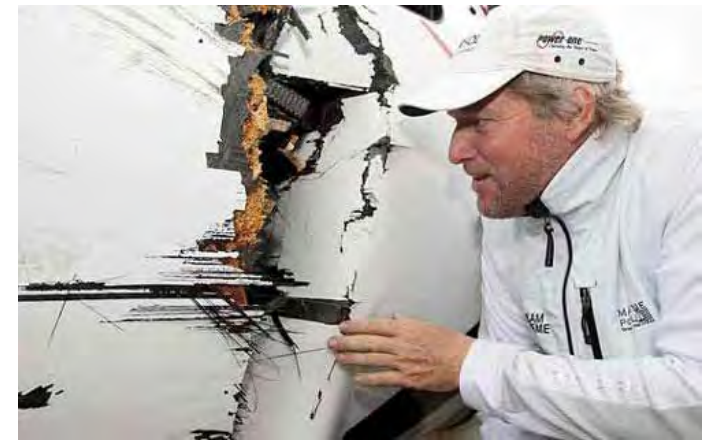
Impact Damaged Boats

Sailboat hit by powerboat on autopilot in the open ocean

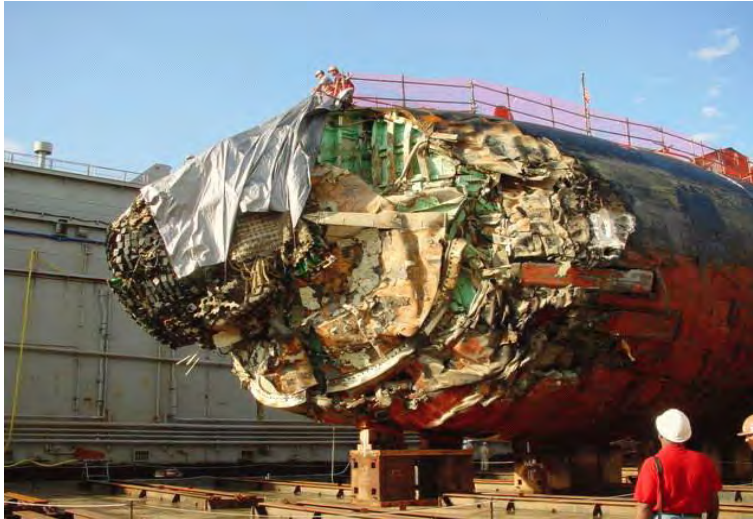
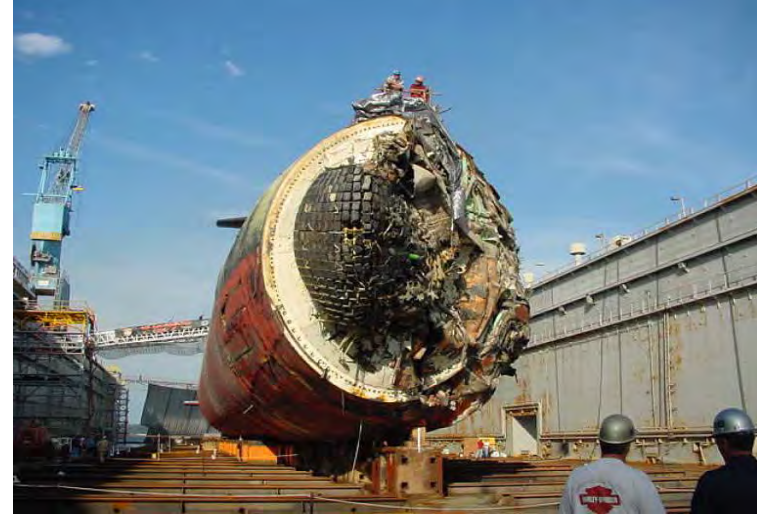
Submarine Impact Damage

SSN 711 *San Francisco* hit an uncharted seamount in Jan 2005

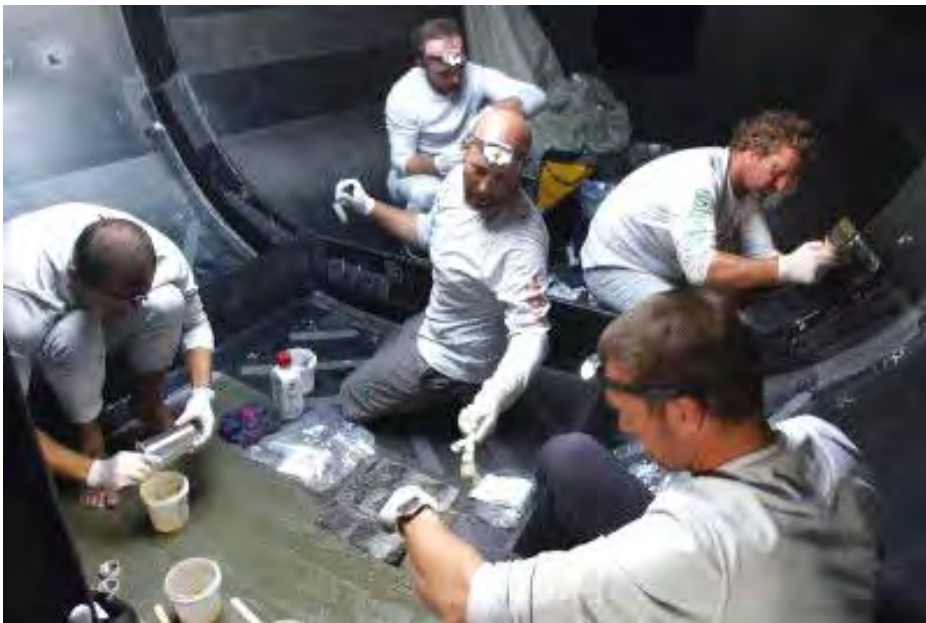
Internal Damage

Crew repairs damage to ring frame sustained in 50 knot winds on Irish entry in the 2011-12 edition of the Volvo Ocean Race

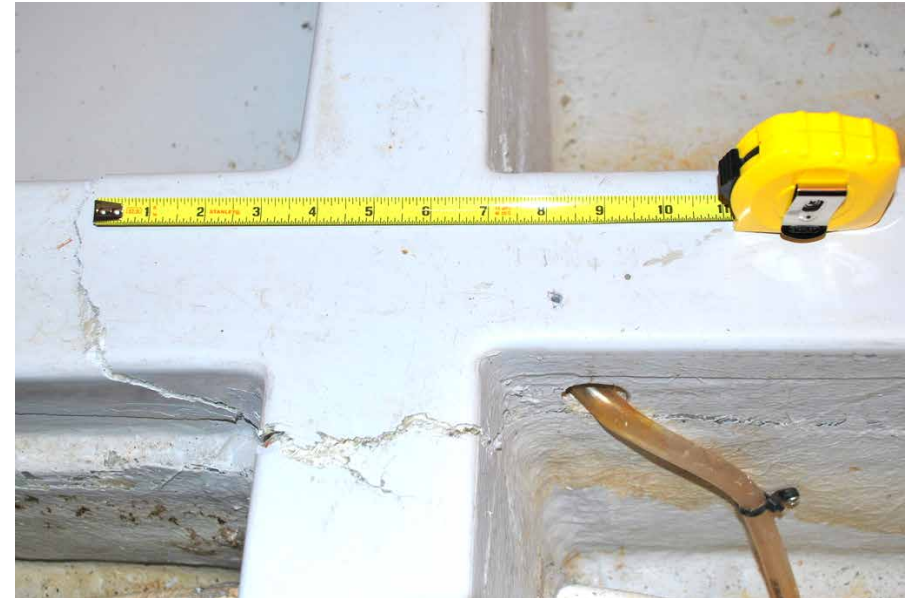
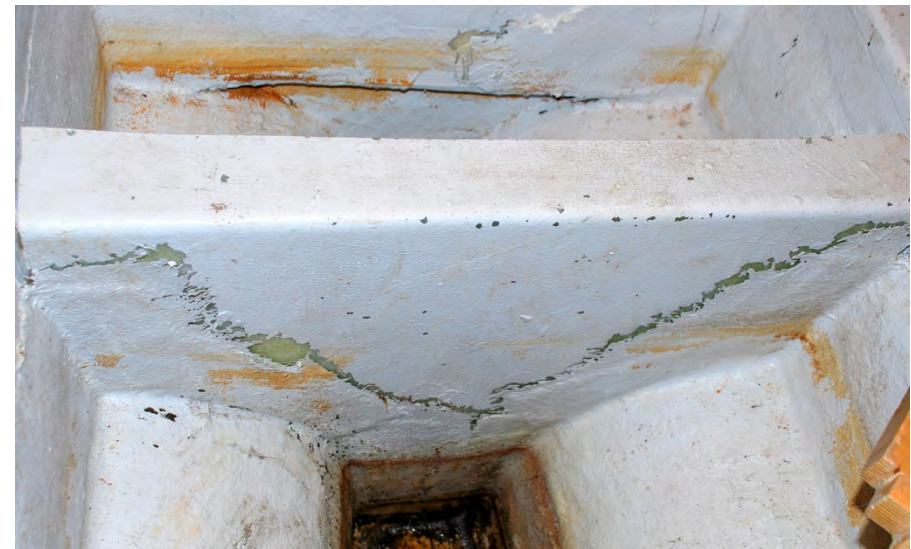
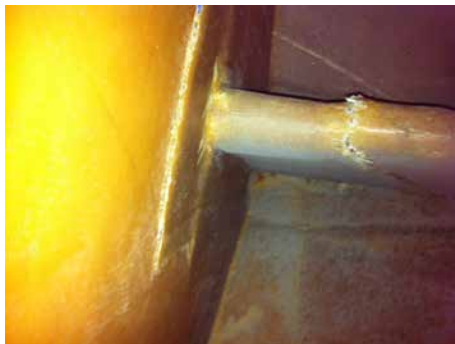
Stringer damaged from grounding event

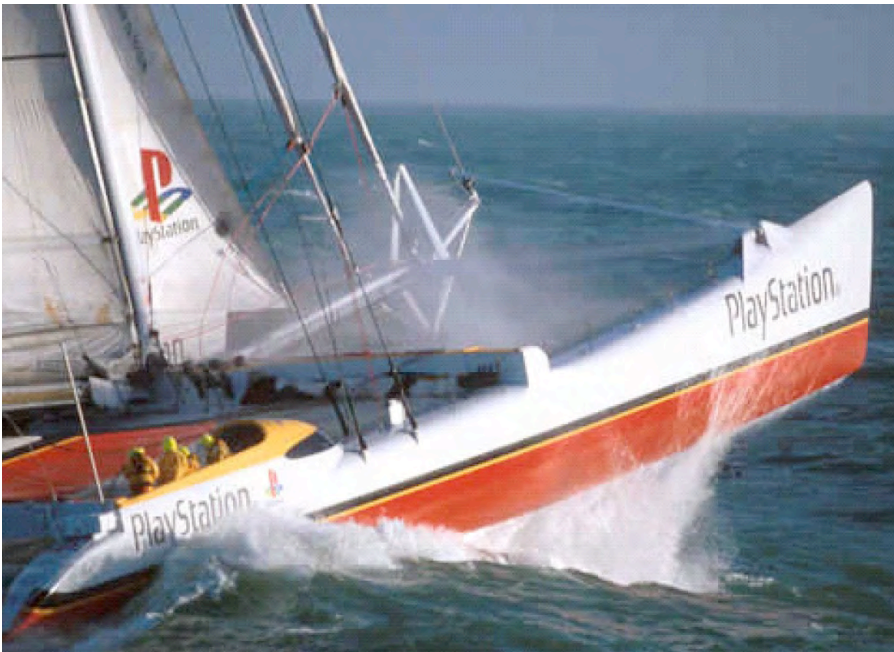
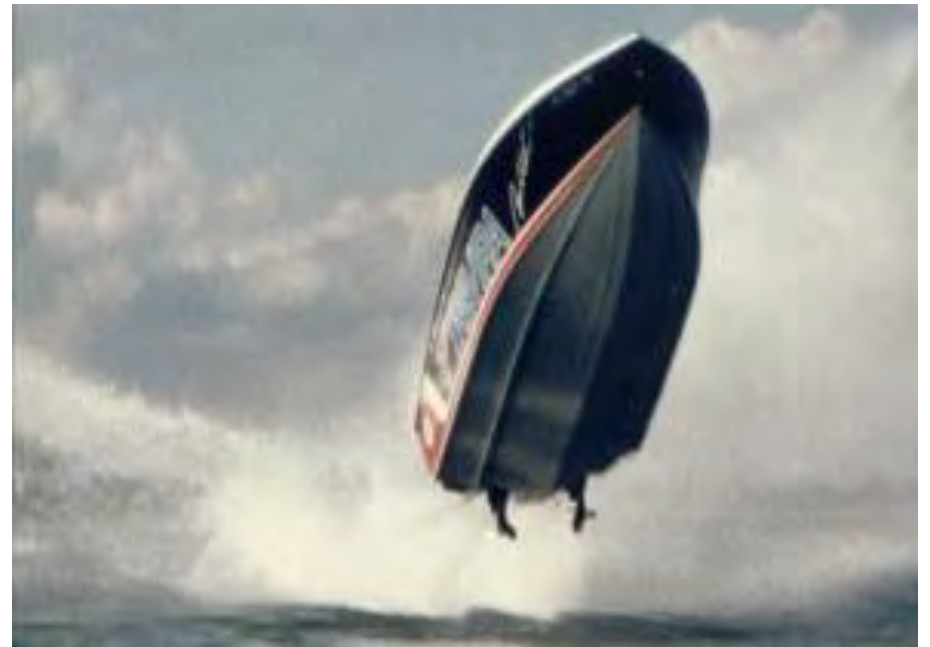
Examples of Slamming

Illustrations of Sail, left [High Modulus] and Power, right [Structural Composites] High-Speed Vessel Slamming Events

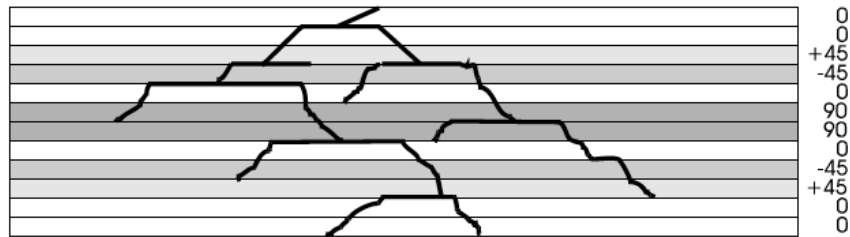
Low-Energy Impact

Pyramid Pattern Matrix Crack from impact.

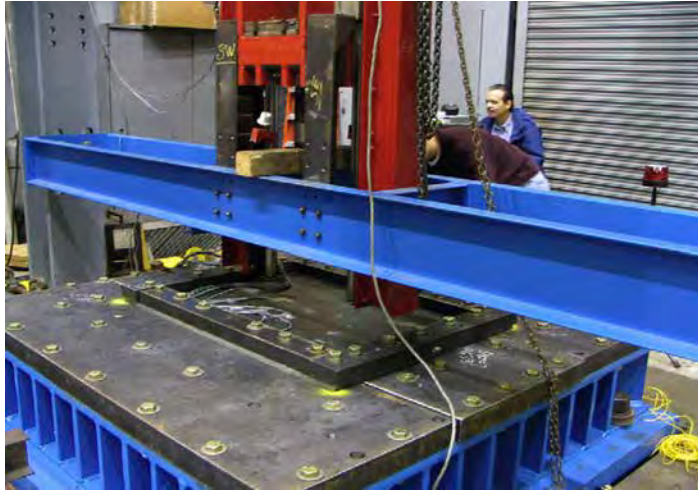
Impact rig for the large-scale plate tests

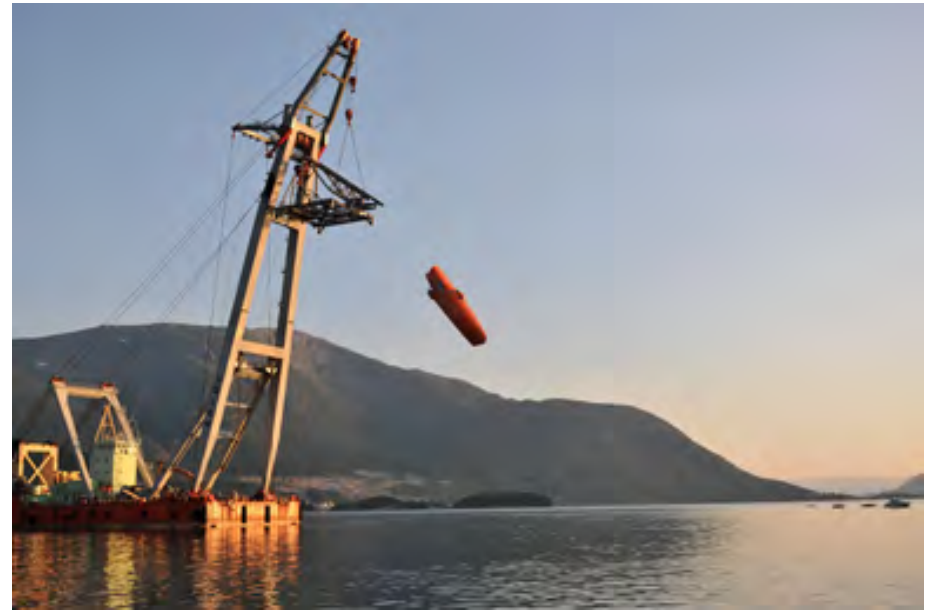
55 meter freefall test

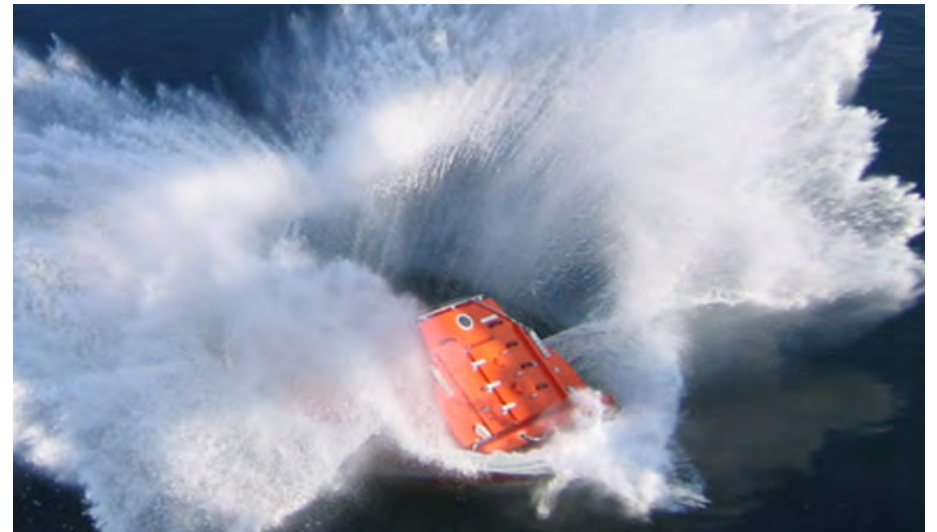
Norsafe lifeboat structural grid

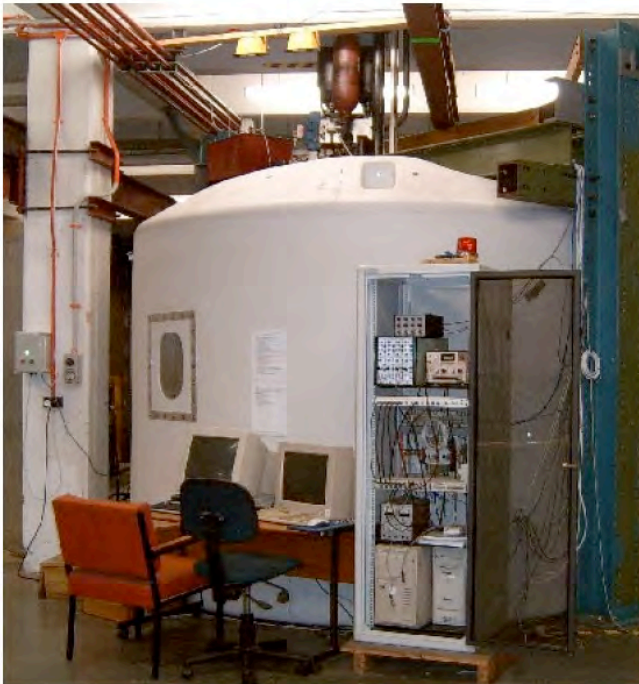
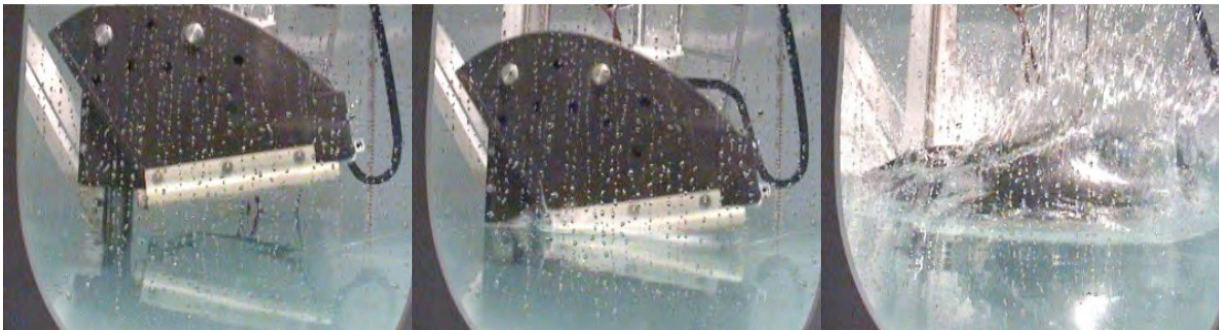
Elements of the Servo-hydraulic Slam Testing System (SSTS) including Ram (1), Load Cell (2), Specimen Fixture (3), Test Panel (4), Side Plates (5), and Back Plate (6).

Top left is Overall Equipment Setup with Computer Control and bottom Sequence is of Slam Test Event [Mark Battley, University of Auckland & Susan Lake, High Modulus]

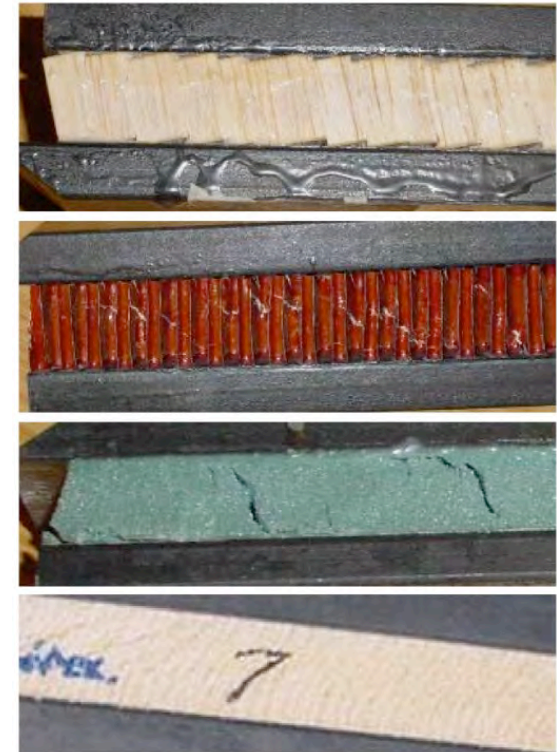
Slam Testing Results

Typical Results from Slam Testing in the SSTs [High Modulus]

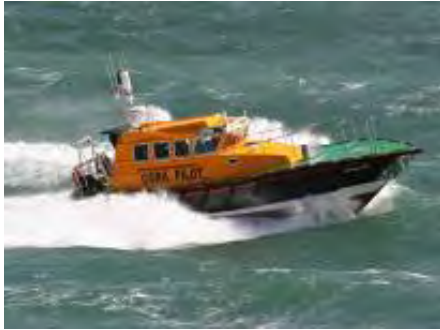
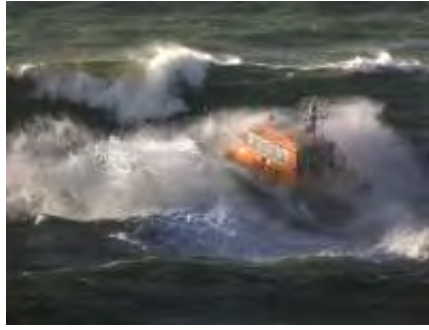
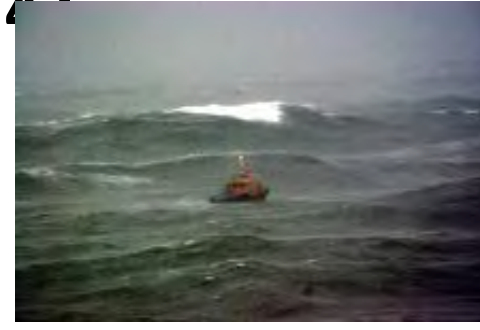
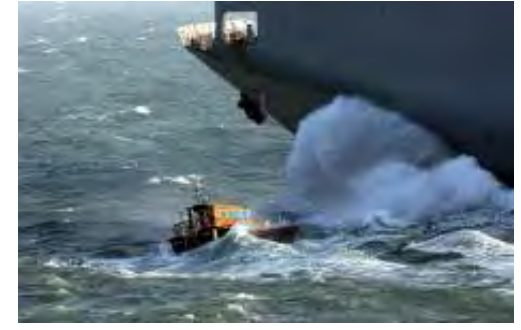
Design for Slamming Safe Haven Marine's Interceptor

Photographs showing Pilot Boat operating conditions, including storm with 100-knot wind gust and 10 m waves [www.safehavenmarine.com]

The hulls scantlings are very closely spaced @ 500mm centers giving a 4300mm panel width, the frames themselves are a huge 150 x 150mm resulting in a massively strong structure

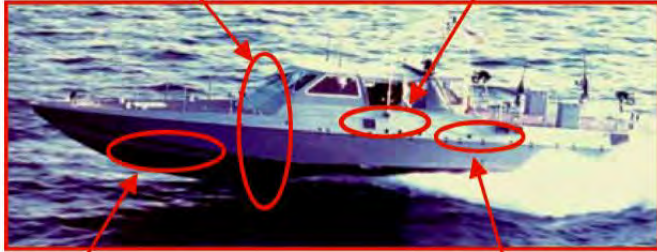
1. Hull Form, Δ_{Form}

3. Deck Structure, Δ_{Deck}

2. Hull Structure, Δ_{Hull}

4. Hull-to-Deck Joint, Δ_{Joint}

$$\text{Total Ride Improvement} = \Delta_{Form} + \Delta_{Hull} + \Delta_{Deck} + \Delta_{Joint}$$

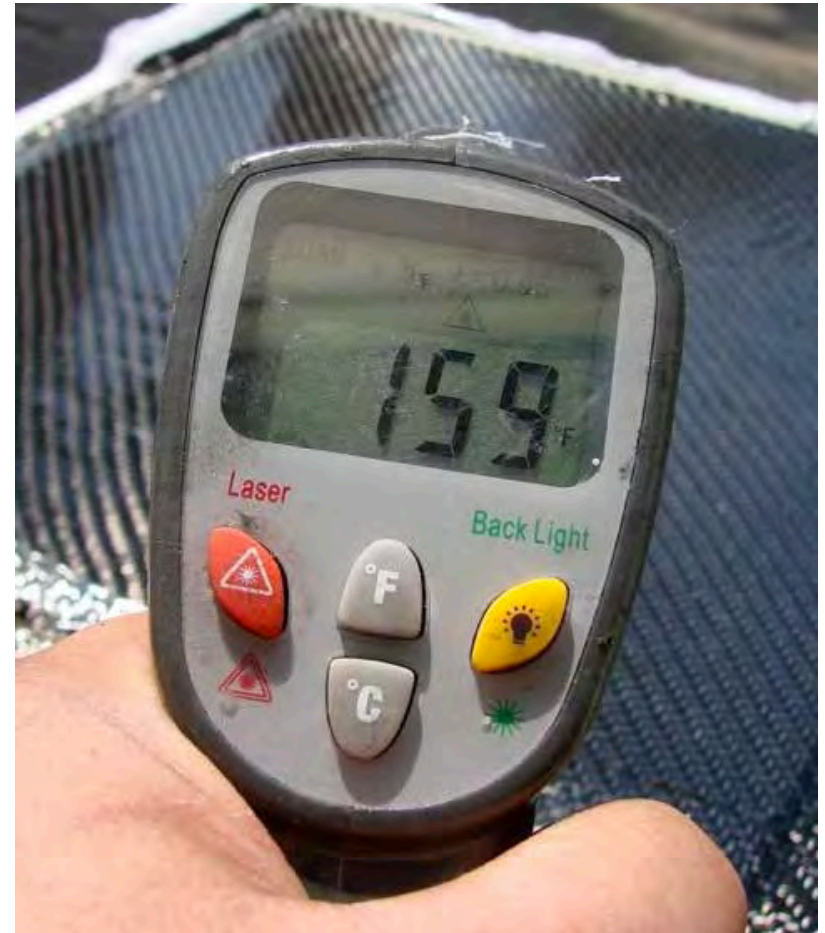
Surface temperature of curing laminate after 4 hours

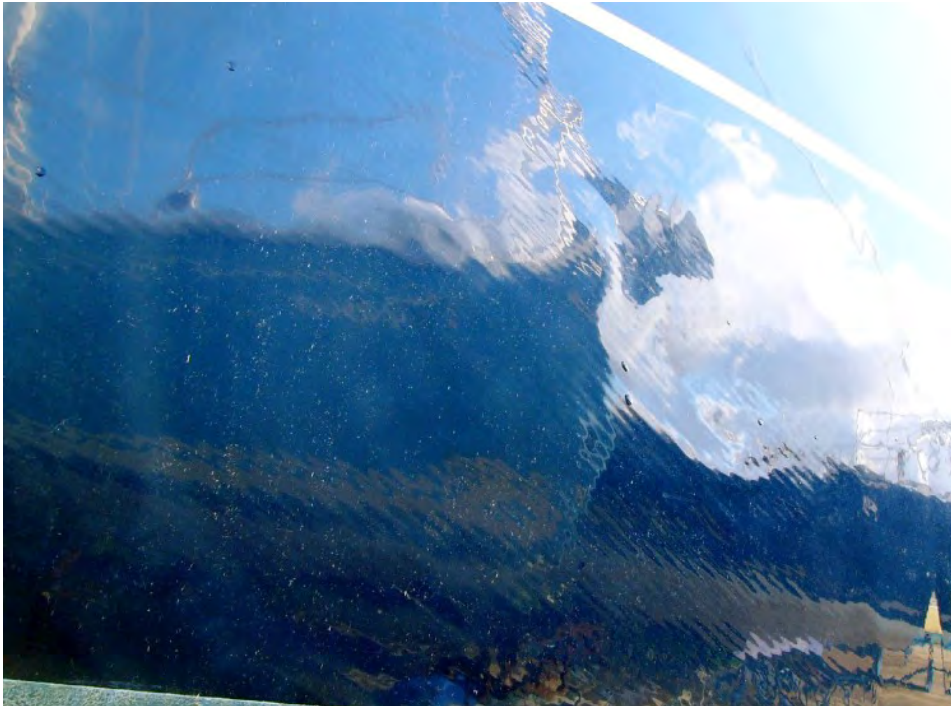
Typical reinforcement print-through problem when dark laminate “post cures”

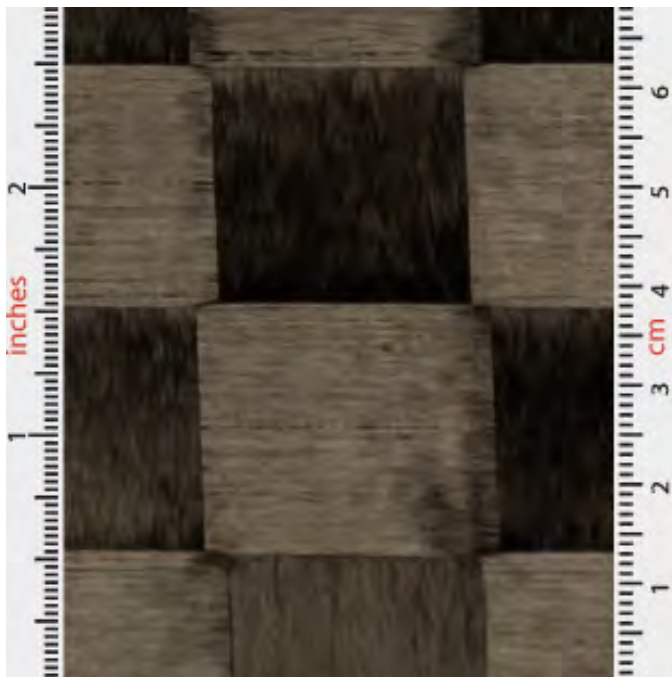
“Spread tow” is a new development in carbon fiber reinforcement whereby a sophisticated production process spreads out each tow (bundle) of carbon fibers making them significantly flatter and wider than they would be in a conventional woven fabric.

Surface Print-Through Characteristics of Conventional Woven Fabric and Spread-Tow Fabric
