Marine Composites

Webb Institute
Senior Elective

Failure Modes

Eric Greene, Naval Architect

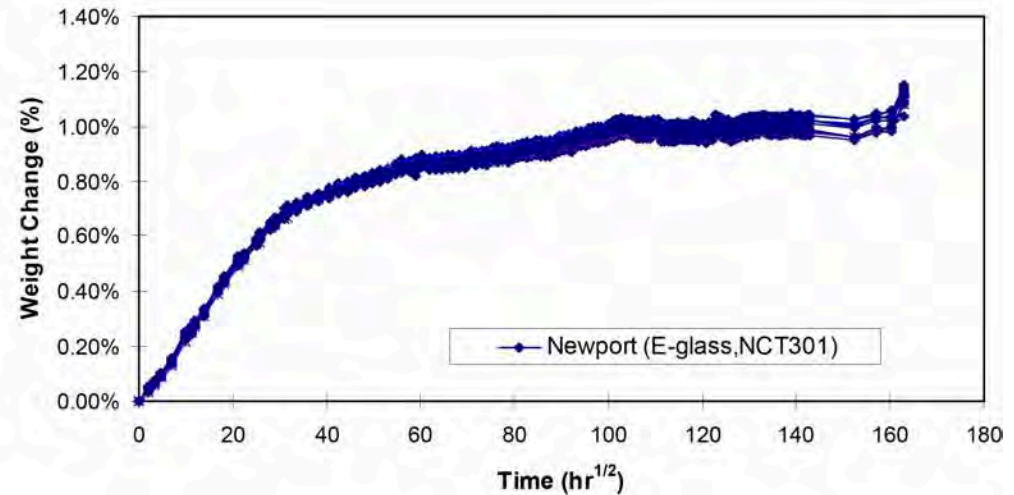
Four years weight-gain data for E-glass/NCT301 coupons immersed in simulated seawater

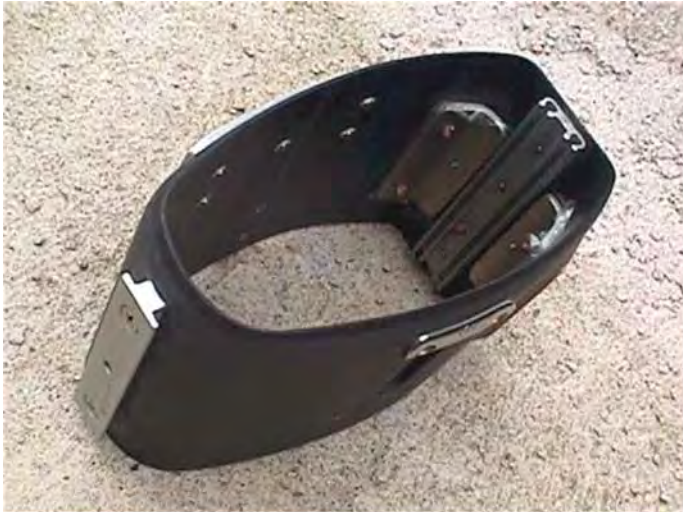
A portion of a carbon fiber mast is shown with metal couplings attached to it

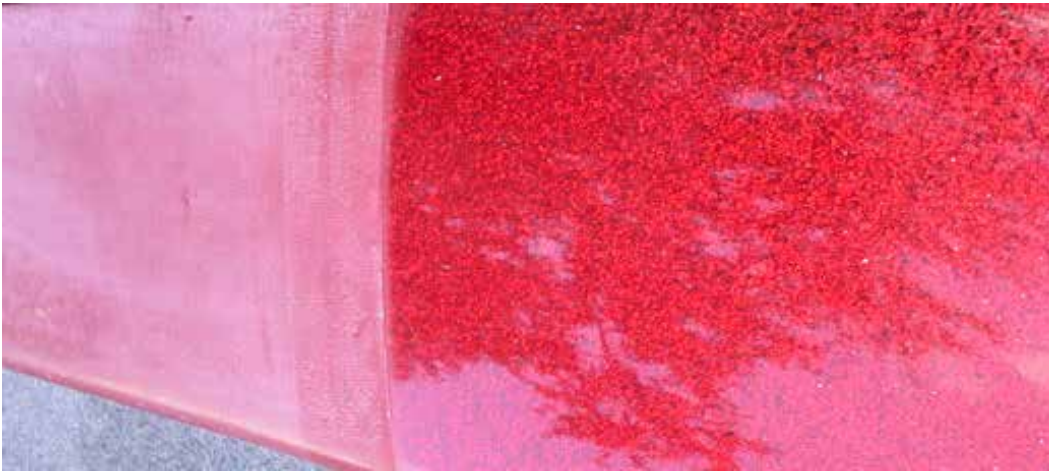
UV damaged (left) and restored gel coat (right)

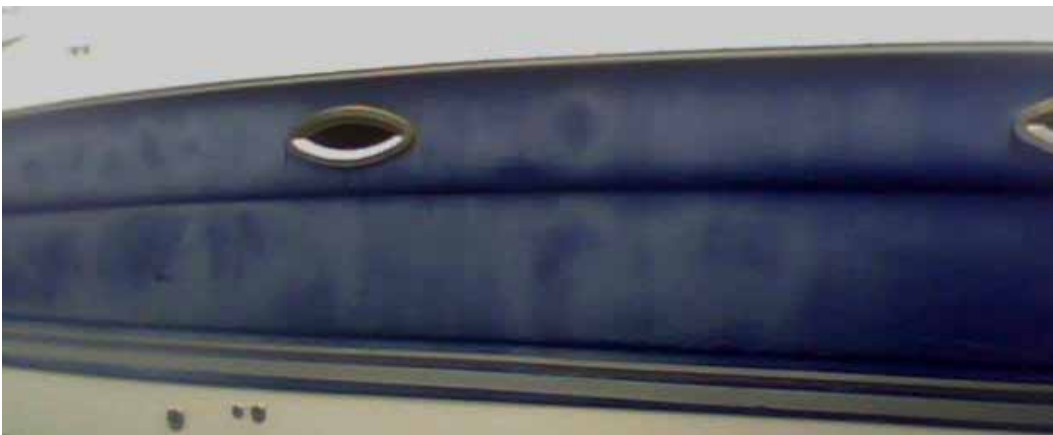
Typical whitening of colored gel coat
