## How Long do Fiberglass Boats Last?

But just what can we say is the expected lifespan of a fiberglass boat hull? The answer varies with type of construction, choice of materials, and overall workmanship. However, since we are reaching the 50-year milestone for some venerable classes of boats that are actively being used, we can step back in time with some of these boats that have either been maintained over the years or recently restored to get a feel for how long these structures hold up in a marine environment.

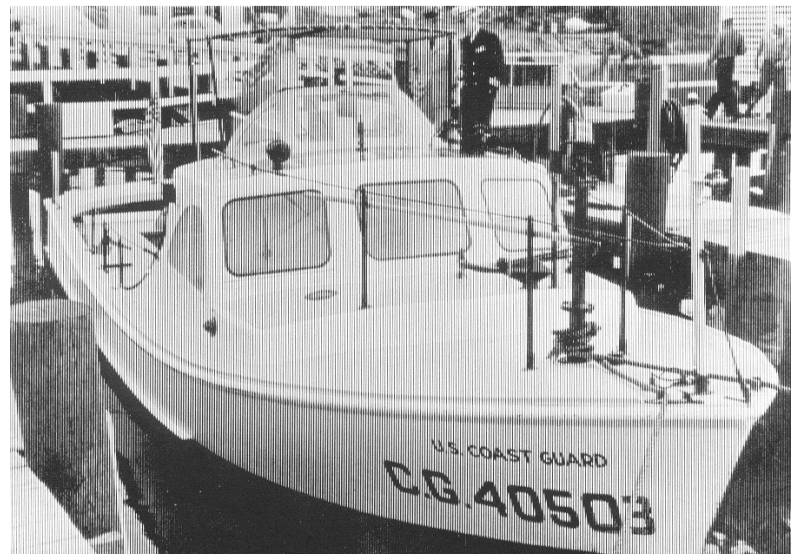
**Figure 3. USCG Hull 40503 [Owens-Corning Fiberglass, Fiber Glass Marine Laminates, 20 Years of Proven Durability]**

In 1962, Owens-Corning Fiberglass and the U.S. Coast Guard tested panels cut from three boats that had been in service 10 years. In 1972, more extensive tests were performed on a larger population of samples taken from CG Hull 40503, shown in Figure 3, which was being retired after 20 years in service. It should be noted that service included duty in an extremely polluted ship channel where contact with sulfuric acid was constant and exposure to extreme temperatures occurred during one fire fighting episode. Total operating hours for the vessel was 11,654. Visual examination of sliced specimens indicated that water or other chemical reactants had not entered the laminate. The comparative physical test data is presented in Table 1.

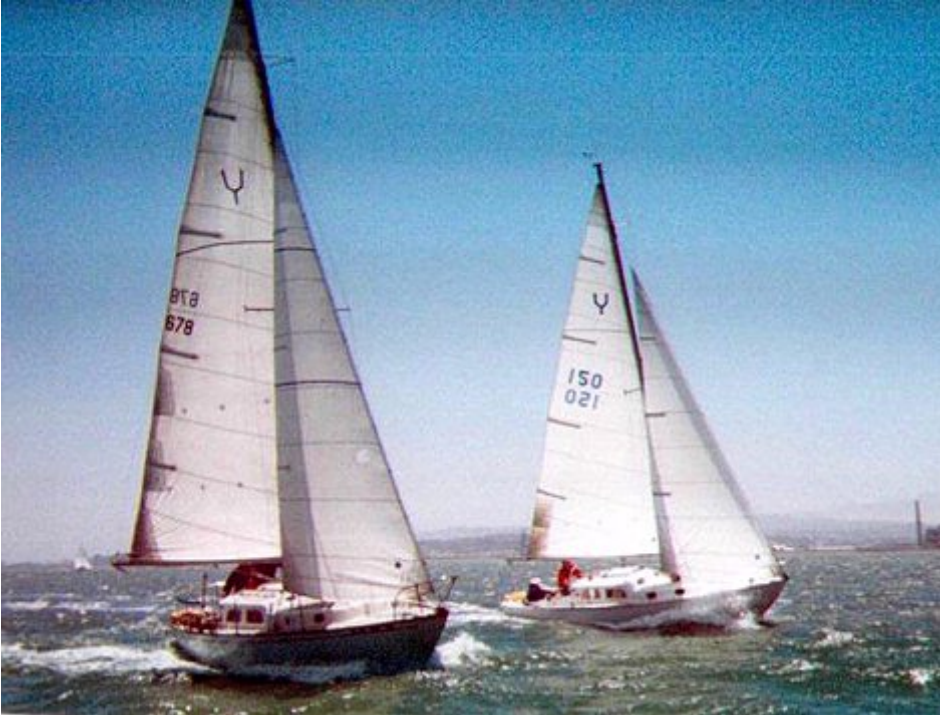
A Northrop and Johnson ad in the Aug '60 "Yachting" cites the Triton sailboat as being introduced in Jan 1959. Sales to June 1960 were listed at 173 at a production schedule of 3 boats per week. The listed price was \$9590 for the sloop. Everett Pearson developed the construction standards for fiberglass: "We designed the hull laminate from the waterline down so that the boat, laid over on its side with the entire weight of the boat resting on the keel and one square inch of the hull would yield not more than 1/2 inch and produce no structural damage to the boat." This is part of the reason so many of the early Tritons are still sailing today.

**Figure 4. Two Classic Triton Sloops**  
[<http://www.pearsontriton.com/history/billbell.shtml>]

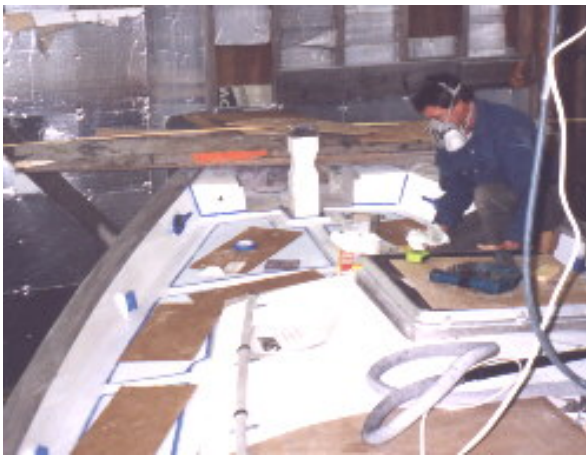
So what do all the tests and anecdotal evidence tell us about how long composites will last in a marine environment? Of course poor workmanship or improper use of materials can lead to premature structural failures, as observed by veteran repair shops such as Paul E. Luke. They find themselves working on aging fiberglass hulls that are often plagued with water impregnation of decks and bulkheads. They have extensive experience “re-coring” fiberglass decks and restoring the integrity of bulkheads with water damage, as shown in Figure 8.

**Figure 8. Deck “Re-coring” at Paul E. Luke, East Boothbay, Maine**  
[[http://www.peluke.com/Yacht\\_Repair/yacht\\_repair.html](http://www.peluke.com/Yacht_Repair/yacht_repair.html)]
