Composite Boat Repair: Part One, Damage Assessment

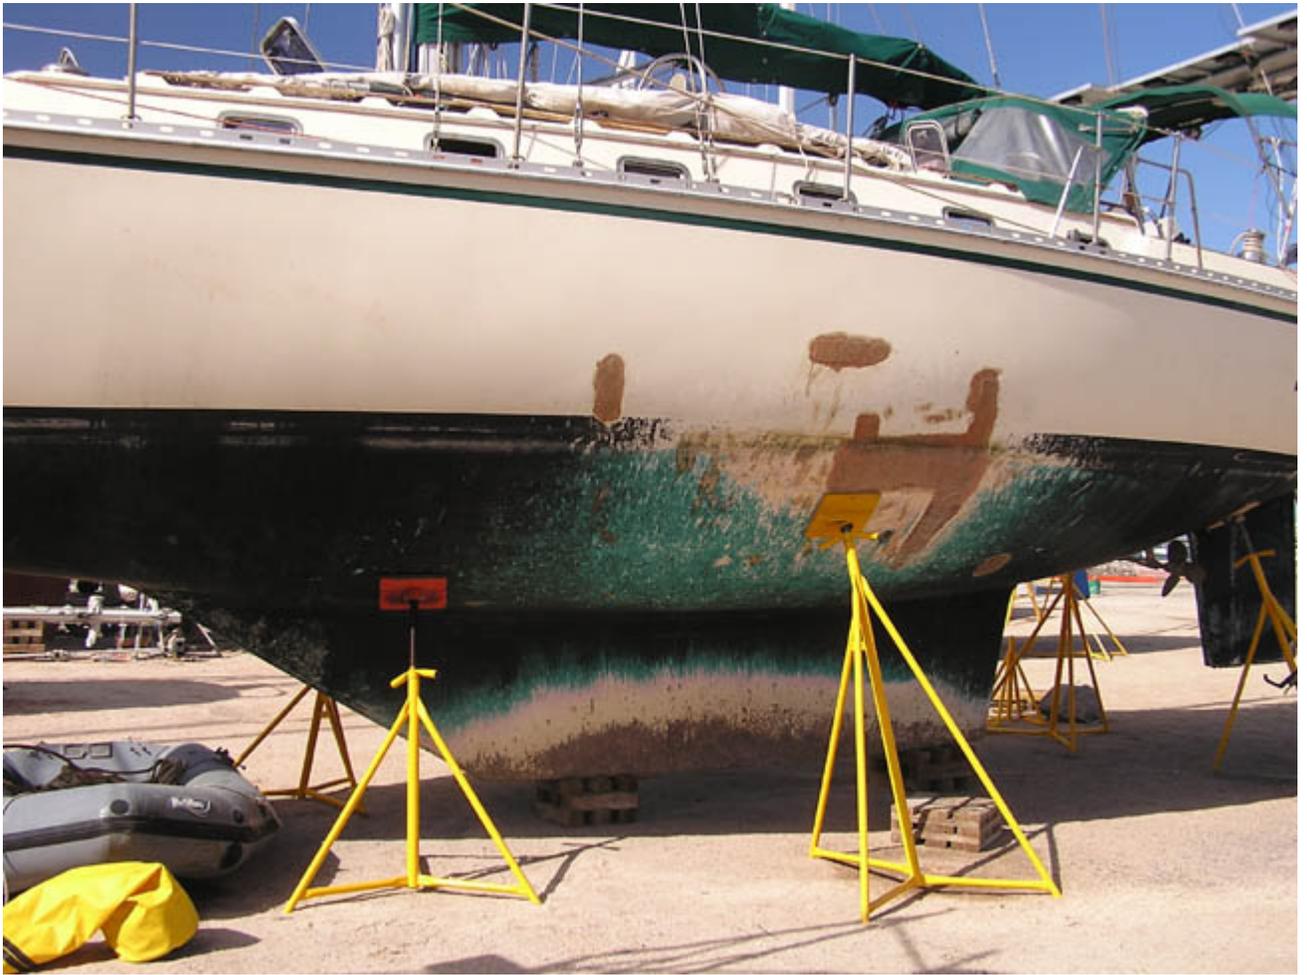
Figure 1. Visual Inspection of Hull Damage from Grounding Showing Temporary Repair [http://svmirador.net/February_8_2004.htm]

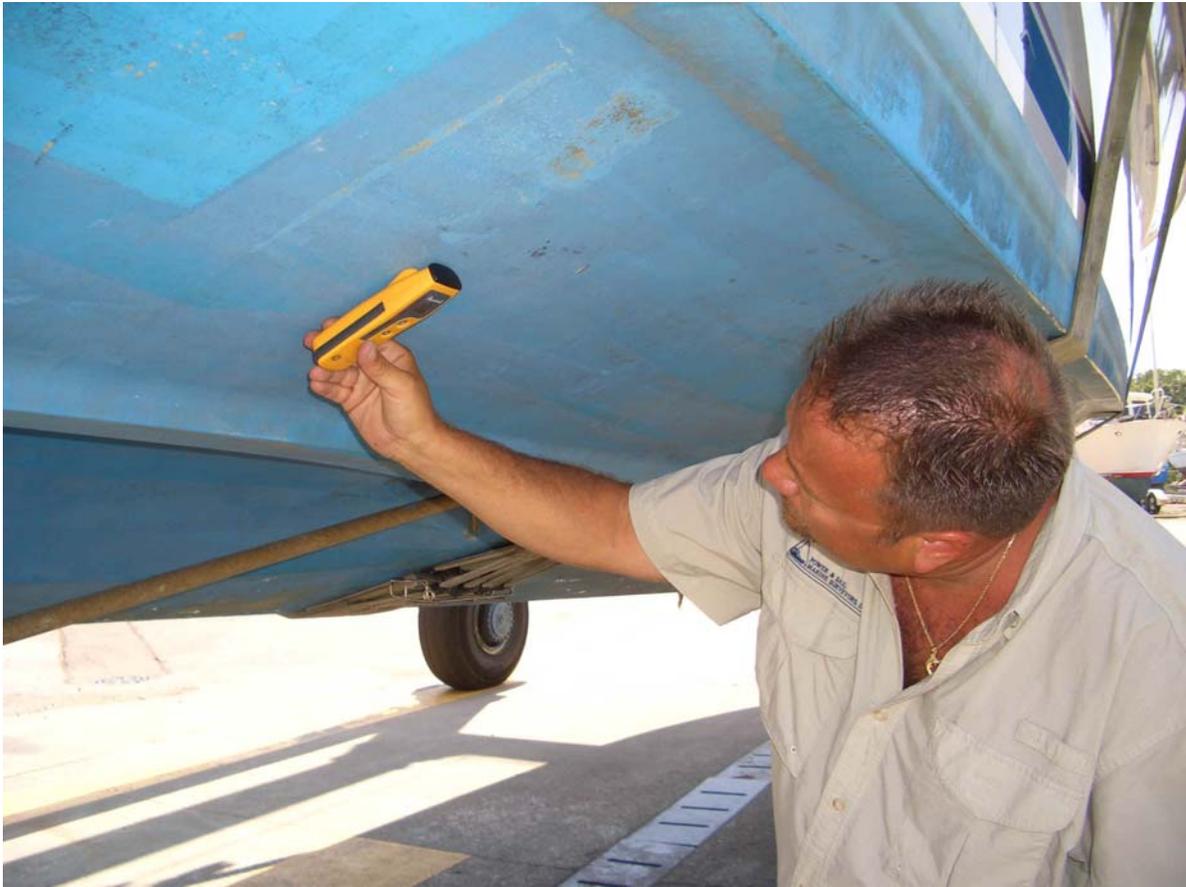
Figure 2. A Marine Surveyor Uses a Moisture Meter to Examine a Boat Bottom
[<http://www.powerandsailmarinesurveyors.com/serv01.htm>]

Moisture meters are perhaps the most debatable diagnostic tools used by marine surveyors. Yacht brokers hate them as many deals have fallen through because a survey concluded that moisture was trapped in a boat's skin laminate or core. Perspective buyers rely on moisture meter surveys to alert them to potential water in the laminate, especially with sandwich construction. James G. Merritt, a marine surveyor in Austin Texas tells us, "After using a moisture meter on over 1,000 surveys, I have yet to see a recently-hauled boat that indicated anything less than 'high' (7+ on a scale of 1 - 10) on surfaces below the waterline. These readings have been taken with a variety of meters..... The end result is that I ignore meter readings below the waterline while still paying close attention to exterior surfaces above the waterline, particularly around through-hull fittings and any deck hardware." With fiberglass, meter readings will always be on a "relative" scale and destructive testing (i.e. cutting open the laminate) is required to get an absolute reading.

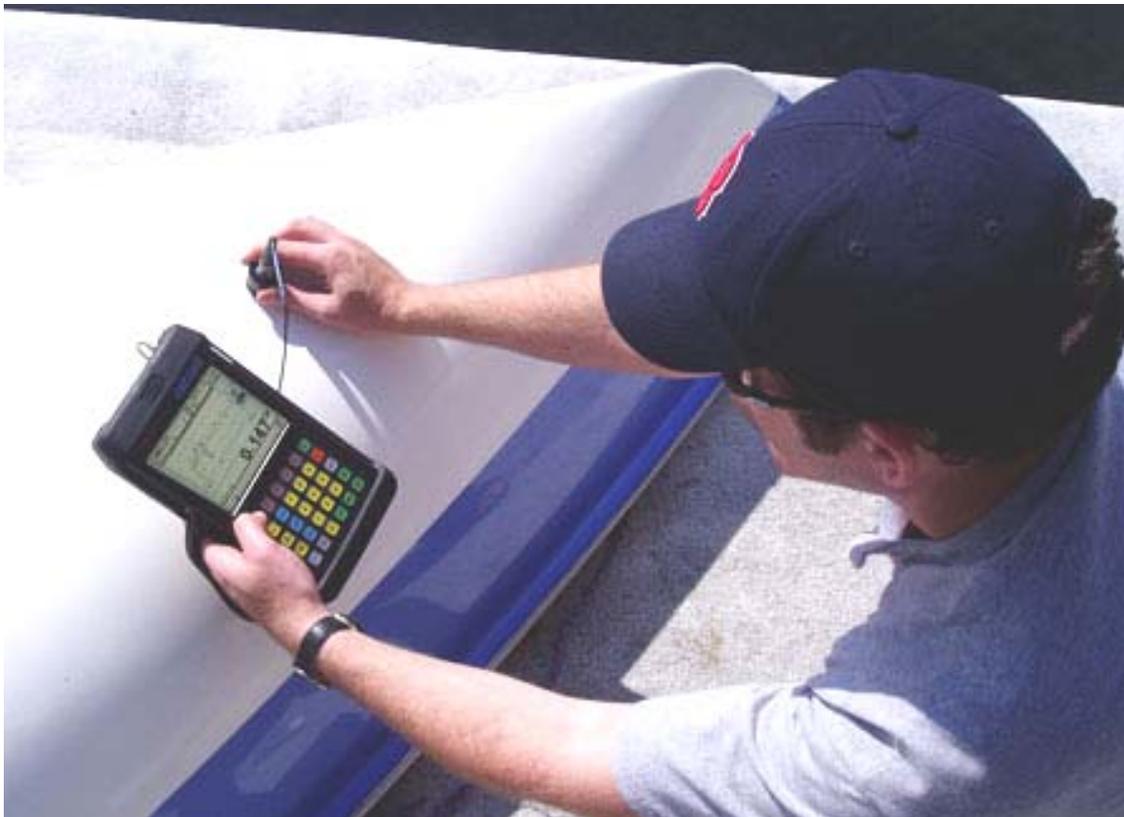
Figure 4. Ultrasonic Thickness Measurement Gage Used to Determine Thickness of a Sailboat Racing Hull [<http://www.olympusndt.com/en/ndt-application/87-id.209715260.html>]
