Marine Composites

Structural Failure Case Histories

Eric Greene, Naval Architect

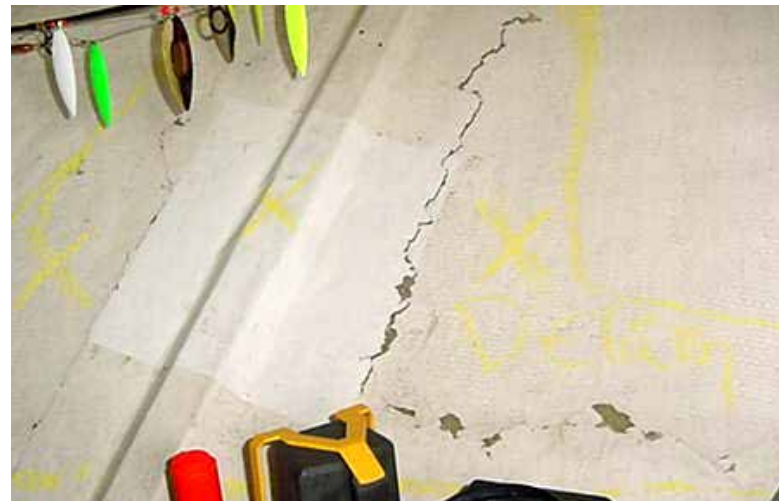
Stiffener Failure

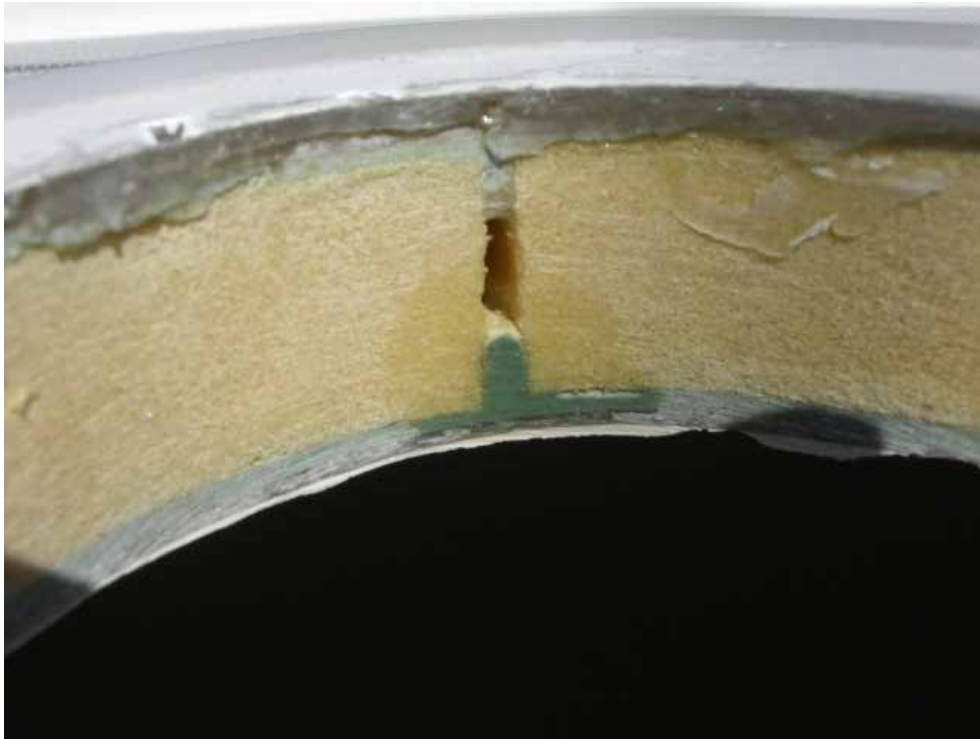
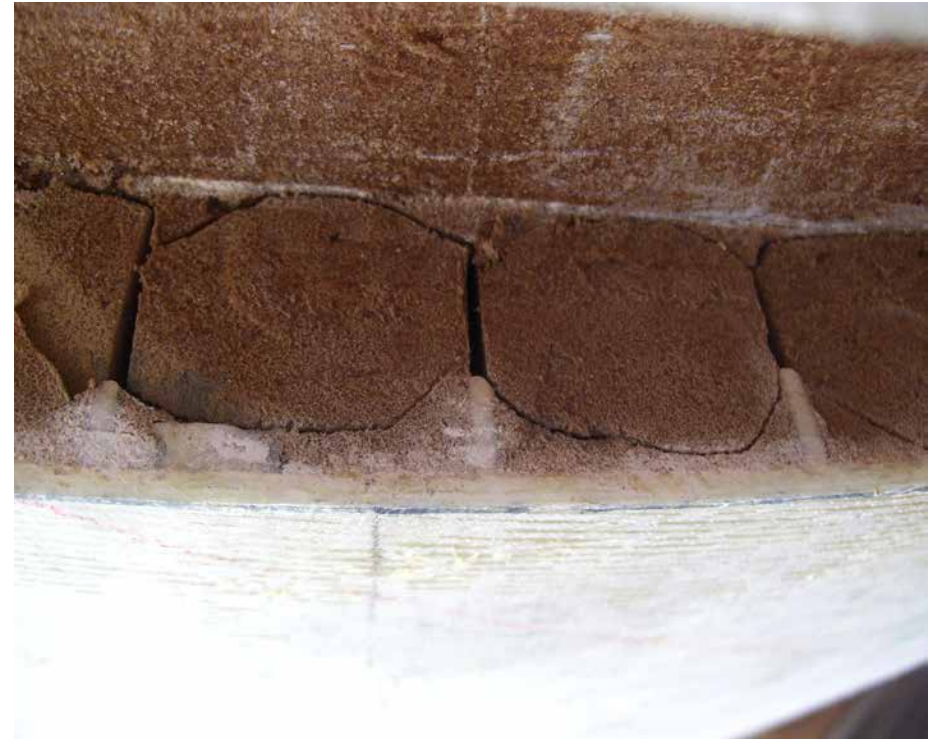
Unfilled Core Kerfs

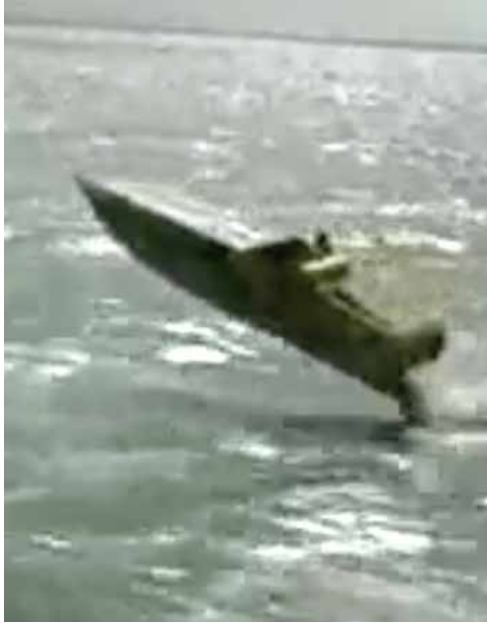
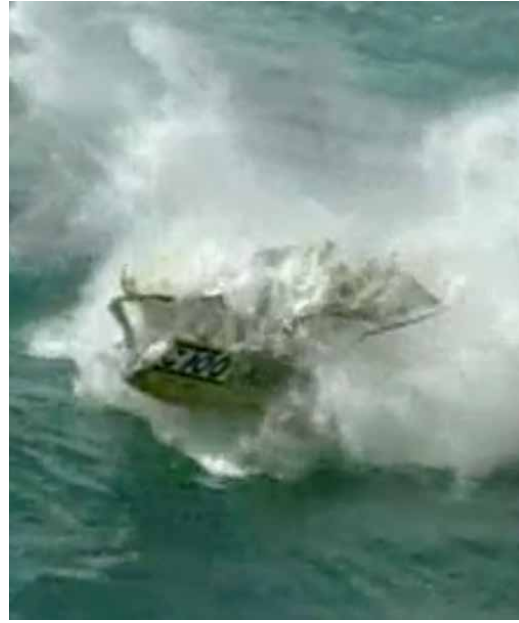
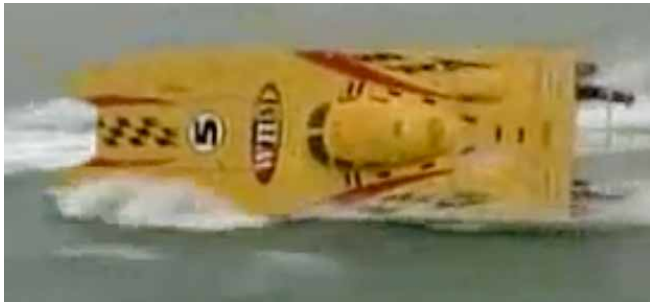
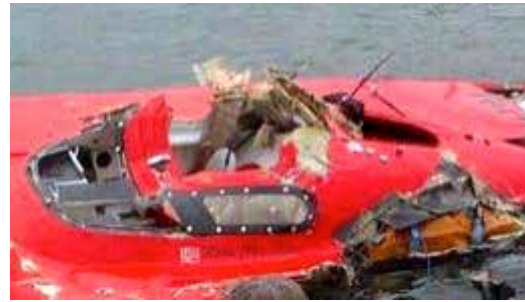
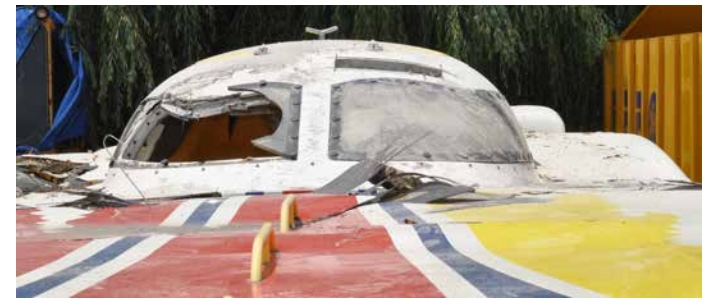
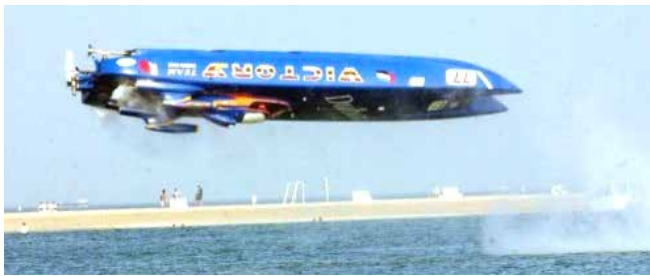
Crashed Racing Powerboats

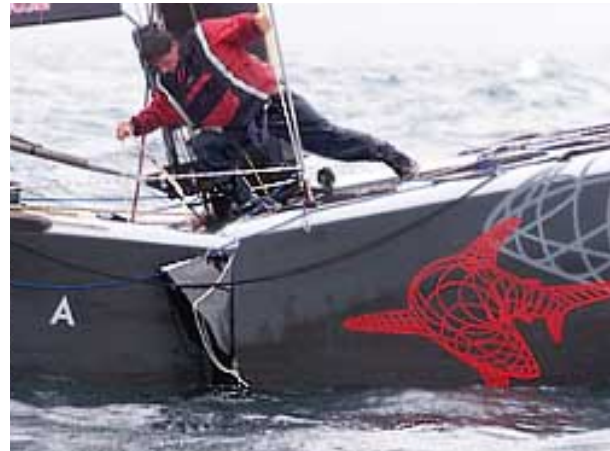
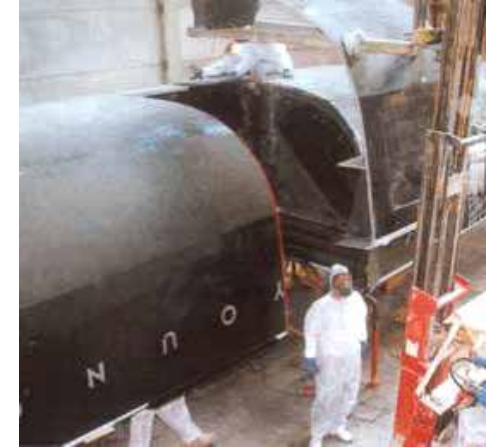
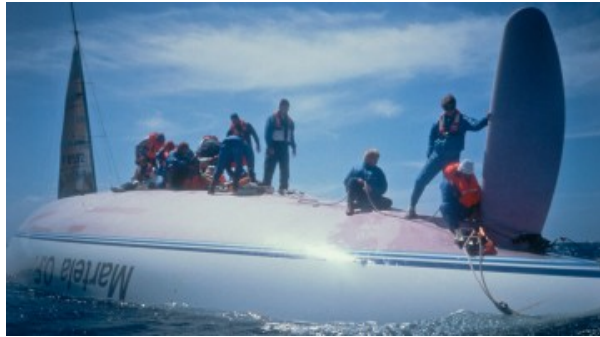
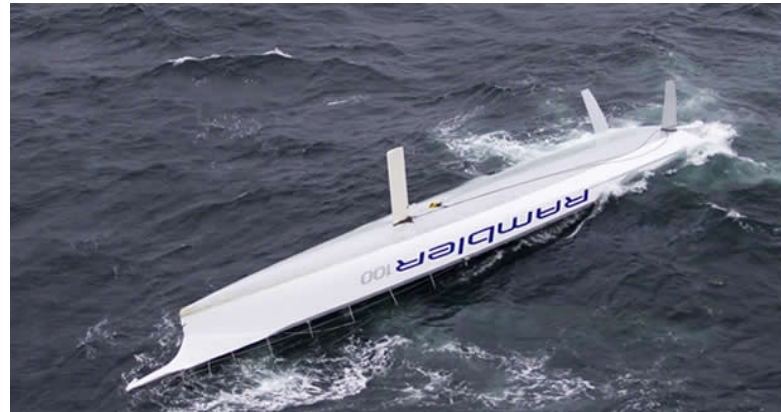
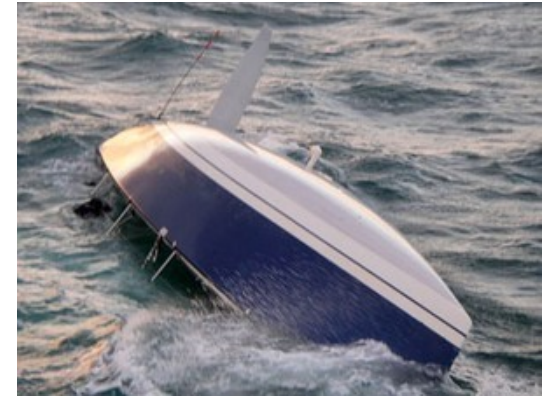
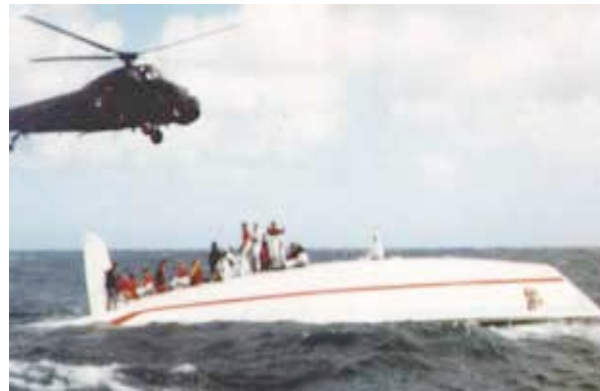
Racing Sailboat Damage

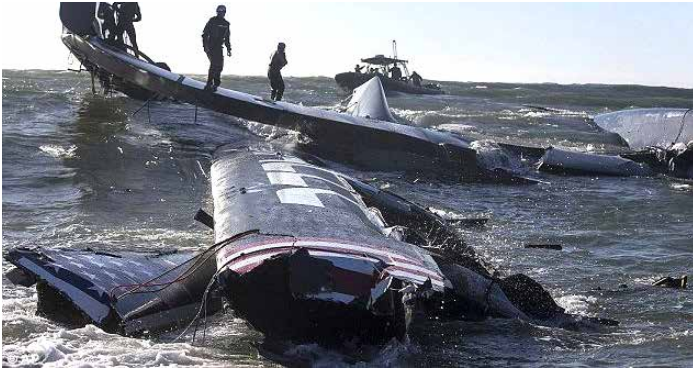
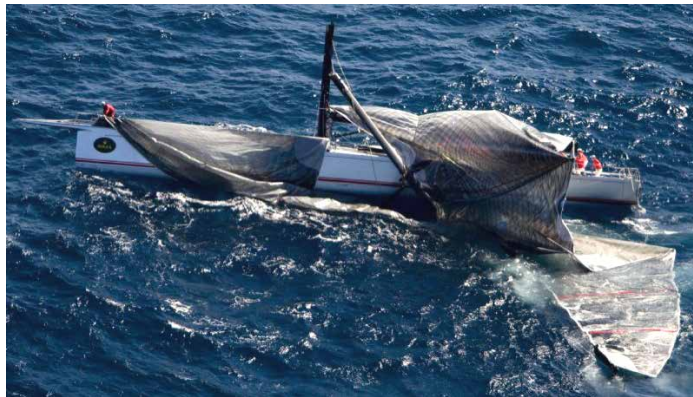
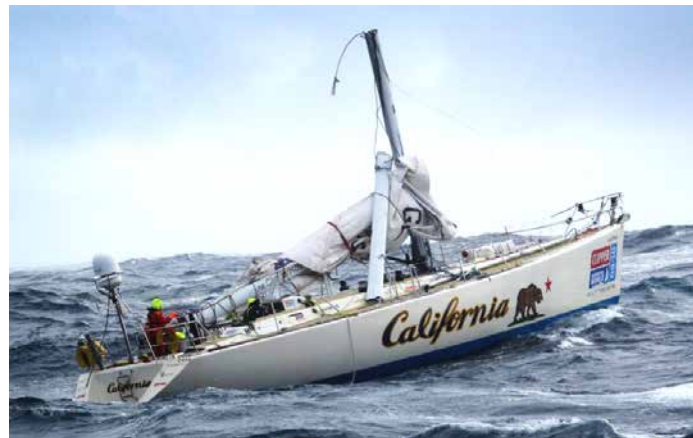
Eric Sponberg analysis of carbon fiber mast failure

The break showing eroded edges (red regions) and frayed fibers (blue regions with white arrows)

This is the other end of the same sample. Note the area of extreme thinness (white arrows) and air pockets in the laminate (red ovals).

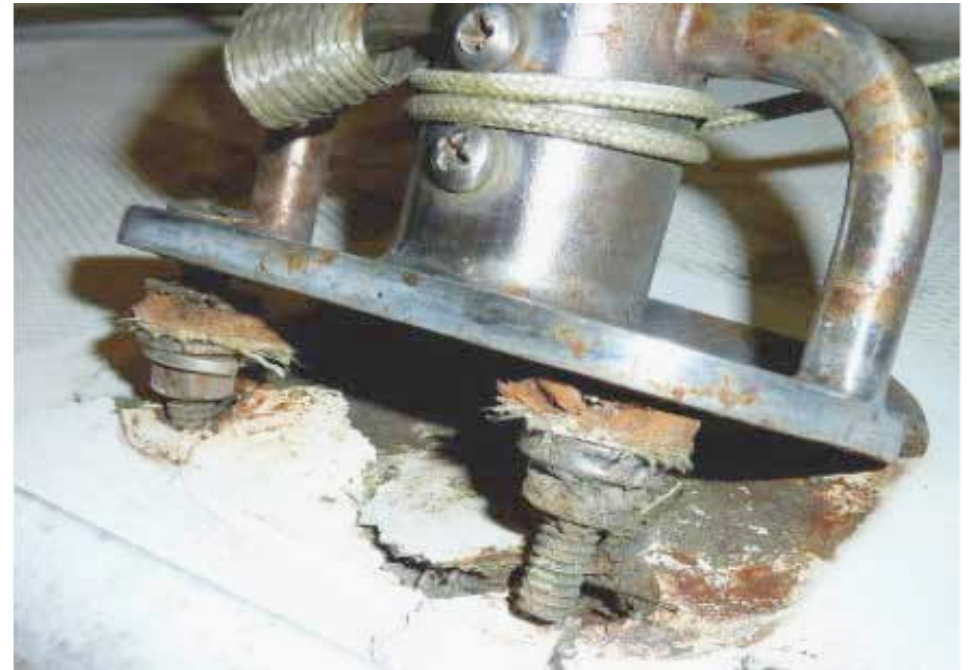
Laminate cracking and failure at stanchion bases

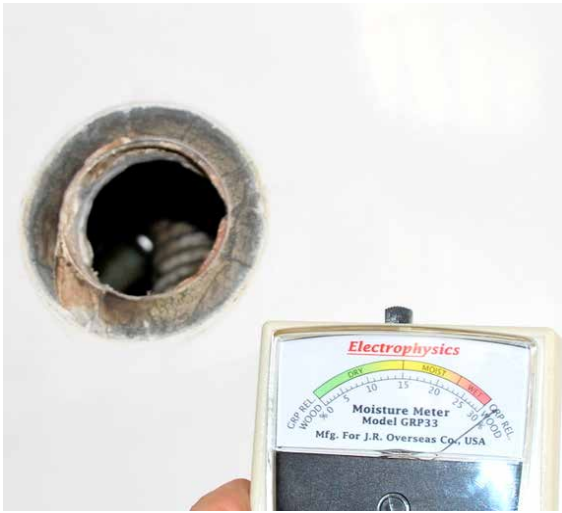
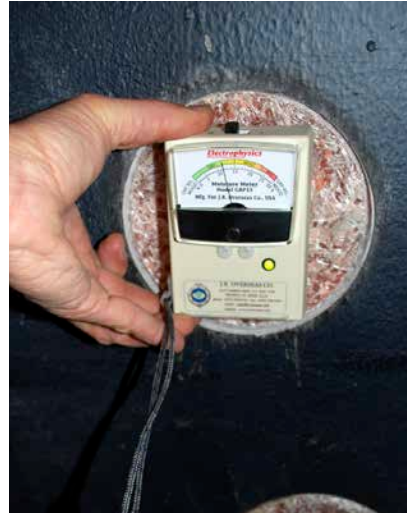
Moisture Ingress

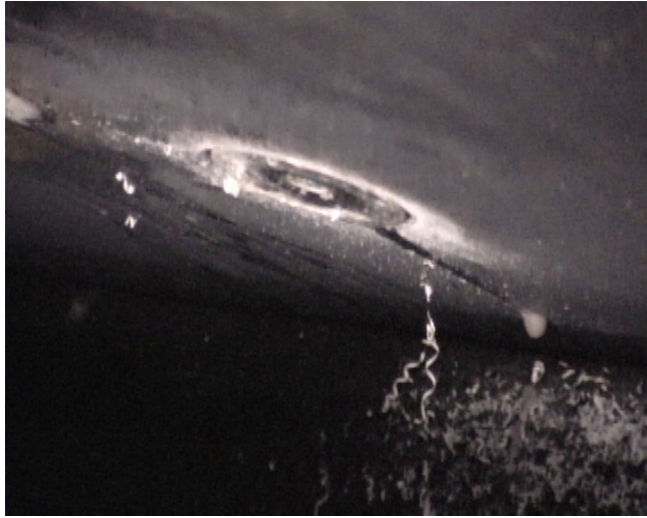
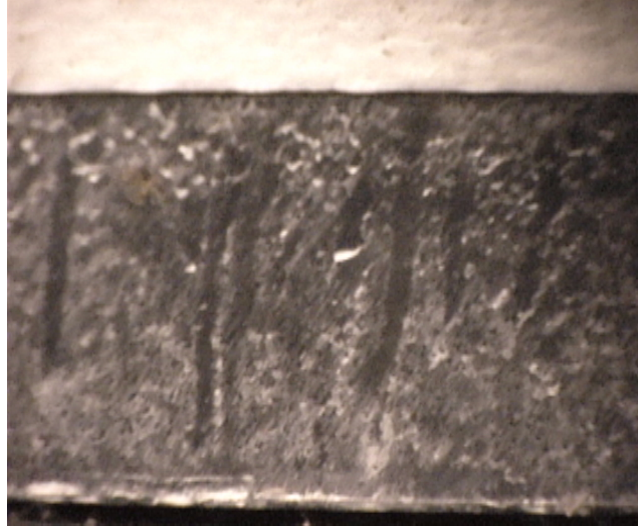
Moisture Ingress
